SACRIFICIAL ANODE VHS-8339 - ZN ALLOY - MODERN TIMES

Artefact name Sacrificial anode VHS-8339

Authors Marianne. Senn (EMPA, Dübendorf, Zurich, Switzerland) & Christian. Degrigny (HE-Arc CR, Neuchâtel, Neuchâtel,

Origin Submarine "Mesoscaph" from Auguste Piccard

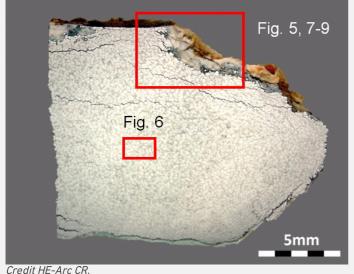
Fig. 3: Micrograph of the cross-section showing the location of Figs. 5

The sample (Fig. 3) shows a cross-section from the sacrificial anode (Fig. 2). The thickness of the corrosion crust is variable. Dimensions: L = 17mm; W = 14mm.

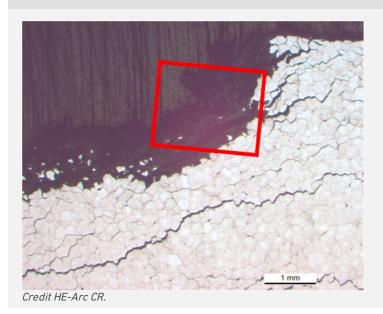
Fig. 5: Micrograph of the metal sample from Fig. 3 (reversed picture, detail), unetched, bright field. Extensive intergranular corrosion is visible. The rectangle marks Fig. 7,

Extended intergranular corrosion has developed in the metal structure (Figs. 5, 6). The metal is covered by a corrosion crust that is hardly visible in bright field and which contains remnant metal (Fig. 5). On most of the sample the corrosion crust is uniform. In areas we see cracks (Fig. 7) appearing as brown lines separating the corrosion crust (Fig. 8). In bright field the corrosion crust appears grey containing dark-grey zones (Fig. 7). Under polarized light, the corrosion crust appears white with darker parts including remnant metal (Fig. 8). It contains Zn and O as well as S along some cracks (Table 2 and Fig. 9).

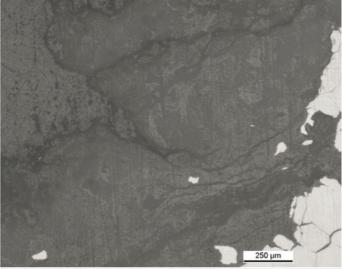
Table 2. Chemical composition (mass %) of the corrosion layer from Figs. 7 and 9. Method of analysis: SEM/EDS, Laboratory of Analytical Chemistry, Empa.

Fig. 7: Micrograph showing the metal - corrosion products interface from Fig. 5 (detail), unetched, bright field,

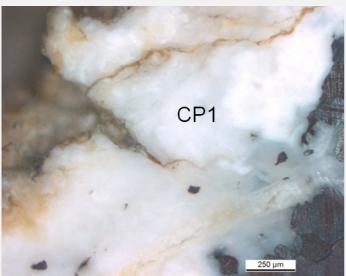
Fig. 8: Micrograph (same as Fig. 7) corresponding to the stratigraphy of Fig. 4, unetched, polarised light. We observe in dark-grey the metal, in white the corrosion crust separated by brown cracks including remnant metal,

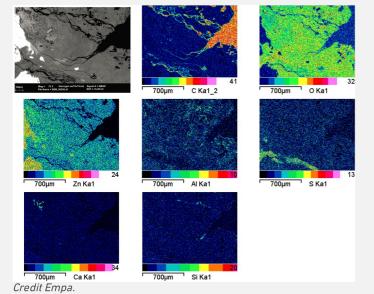
Fig. 9: SEM image, BSE-mode, and elemental chemical distribution of $\,$ most of the area of Fig. 7 (reversed picture). Method of examination: SEM/EDS, Laboratory of Analytical Chemistry, Empa,
