SACRIFICIAL ANODE VHS-8339 - ZN ALLOY - MODERN TIMES

Artefact name	Sacrificial anode VHS-8339
Authors	Marianne. Senn (EMPA, Dübendorf, Zurich, Switzerland) & Christian. Degrieny (HE-Arc CR, Neuchâtel, Neuchâtel, Switzerland)
Url	/artefacts/367/

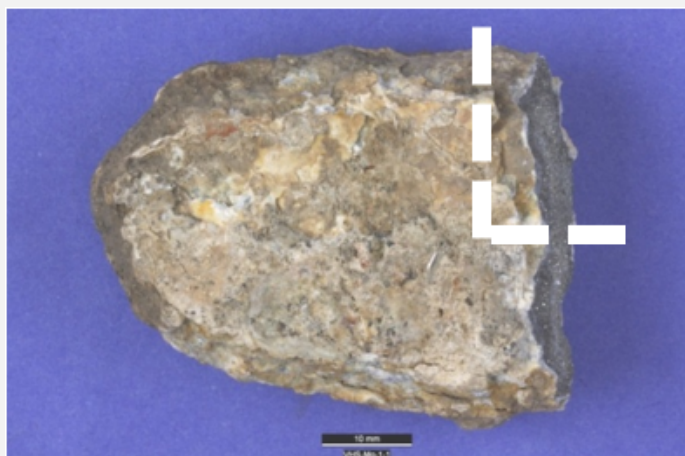
Fig. 2: Location of sampling area,

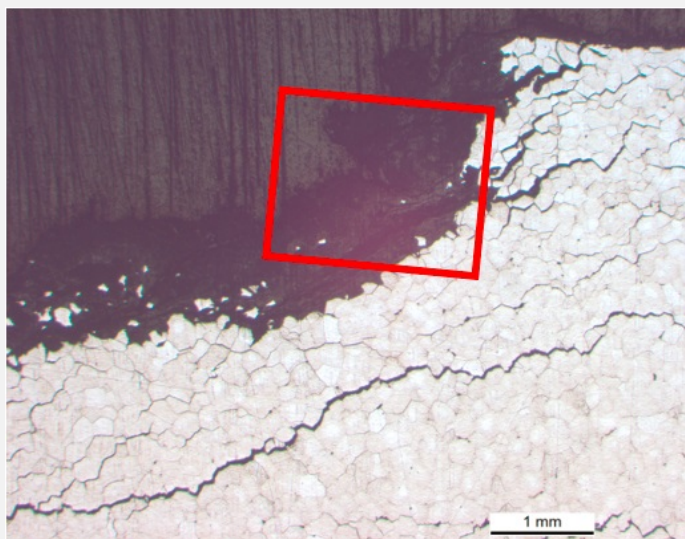
The remaining metal is an almost pure zinc alloy (Table 1). The oxygen content is not from the original alloy, but is due to secondary corrosion. The metal grains are visible without etching and present a polygonal structure (Figs. 5 and 6). The structure is recrystallised after annealing. The recrystallization of zinc alloys begins at room temperature.

Fig. 5: Micrograph of the metal sample from Fig. 3 (reversed picture, detail), unetched, bright field. Extensive intergranular corrosion is visible. The rectangle marks Fig. 7,

Extended intergranular corrosion has developed in the metal structure (Figs. 5, 6). The metal is covered by a corrosion crust that is hardly visible in bright field and which contains remnant metal (Fig. 5). On most of the sample the corrosion crust is uniform. In areas we see cracks (Fig. 7) appearing as brown lines separating the corrosion crust (Fig. 8). In bright field the corrosion crust appears grey containing dark-grey zones (Fig. 7). Under polarized light, the corrosion crust appears white with darker parts including remnant metal (Fig. 8). It contains Zn and O as well as S along some cracks (Table 2 and Fig. 9).
