SACRIFICIAL ANODE VHS-8339 - ZN ALLOY - MODERN TIMES

Artefact name Sacrificial anode VHS-8339

Authors Marianne. Senn (EMPA, Dübendorf, Zurich, Switzerland) & Christian. Degriigny (HE-Arc CR, Neuchâtel, Neuchâtel, Switzerland)

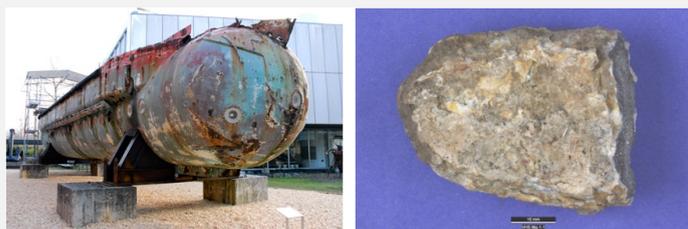
Fig. 1: The submarine and the anode (www.verkehrshaus.ch),

Description of the artefact	The artefact could be a weight or sacrificial anode of a submarine (Fig. 1). It is surrounded by a whitish brown-grey corrosion crust. The broken metal has a greyish shiny colour, whereas the metal part that is cut has a silvery appearance. Dimensions: L = 4.9cm ; WT = 95g.
Type of artefact	Submarine part
Origin	Submarine "Mesoscaph" from Auguste Piccard
Recovering date	The sacrificial anodes (?) might have been added when the submarine was used in the sea.
Chronology category	Modern Times
chronology tpq	<input type="text" value="1970"/> A.D. ▾
chronology taq	<input type="text" value="1974"/> A.D. ▾
Chronology comment	1970 _ 1974
Burial conditions / environment	Outdoor atmosphere
Artefact location	Swiss Museum of Transport, Luzern, Lucerne
Owner	Swiss Museum of Transport, Luzern, Lucerne
Inv. number	VHS-8339
Recorded conservation data	Not conserved

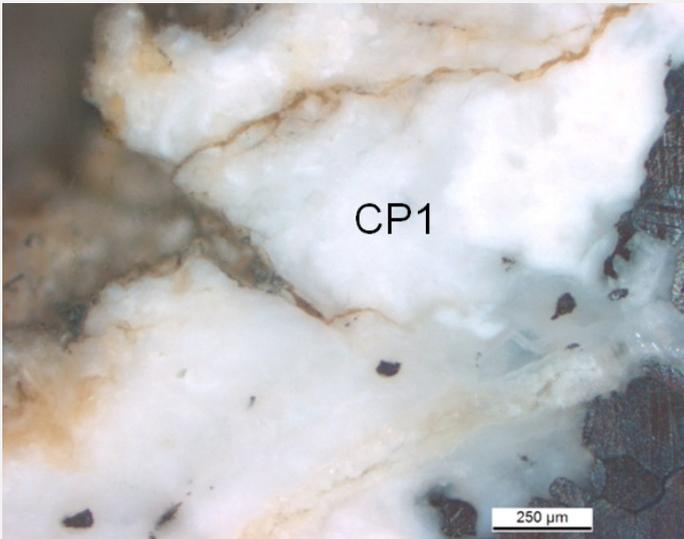
Extended intergranular corrosion has developed in the metal structure (Figs. 5, 6). The metal is covered by a corrosion crust that is hardly visible in bright field and which contains remnant metal (Fig. 5). On most of the sample the corrosion crust is uniform. In areas we see cracks (Fig. 7) appearing as brown lines separating the corrosion crust (Fig. 8). In bright field the corrosion crust appears grey containing dark-grey zones (Fig. 7). Under polarized light, the corrosion crust appears white with darker parts including remnant metal (Fig. 8). It contains Zn and O as well as S along some cracks (Table 2 and Fig. 9).

Fig. 8: Micrograph (same as Fig. 7) corresponding to the stratigraphy of Fig. 4, unetched, polarised light. We observe in dark-grey the metal, in white the corrosion crust separated by brown cracks including remnant metal,
