SACRIFICIAL ANODE VHS-8339 – ZN ALLOY – MODERN TIMES

Artefact name Sacrificial anode VHS-8339

Authors Marianne. Senn (EMPA, Dübendorf, Zurich, Switzerland) & Christian. Degrigny (HE-Arc CR, Neuchâtel, Neuchâtel, Switzerland)

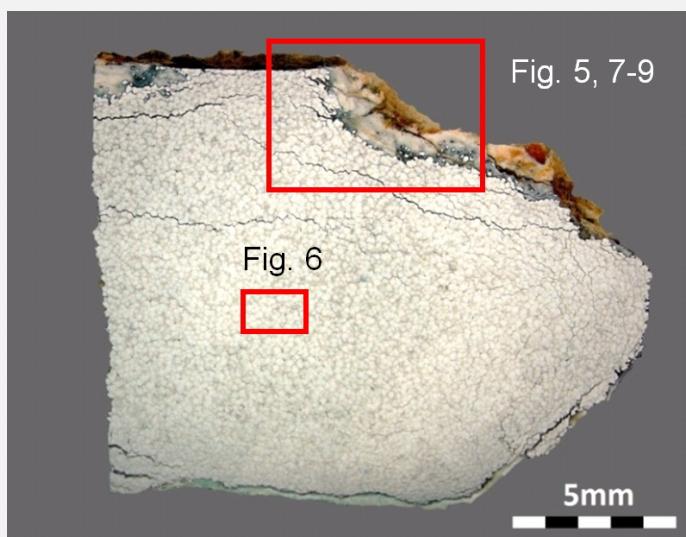
Fig. 3: Micrograph of the cross-section showing the location of Figs. 5 to 9,

The sample (Fig. 3) shows a cross-section from the sacrificial anode (Fig. 2). The thickness of the corrosion crust is variable. Dimensions: L = 17mm; W = 14mm.

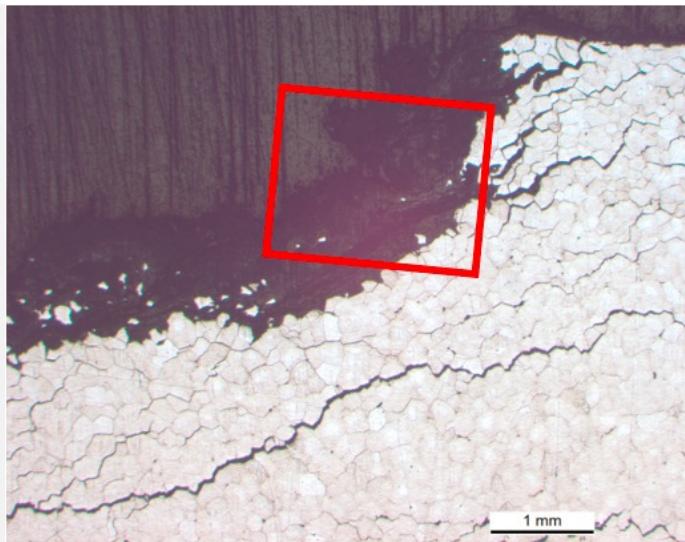
The remaining metal is an almost pure zinc alloy (Table 1). The oxygen content is not from the original alloy, but is due to secondary corrosion. The metal grains are visible without etching and present a polygonal structure (Figs. 5 and 6). The structure is recrystallised after annealing. The recrystallization of zinc alloys begins at room temperature.

Fig. 5: Micrograph of the metal sample from Fig. 3 (reversed picture, detail), unetched, bright field. Extensive intergranular corrosion is visible. The rectangle marks Fig. 7.

Extended intergranular corrosion has developed in the metal structure (Figs. 5, 6). The metal is covered by a corrosion crust that is hardly visible in bright field and which contains remnant metal (Fig. 5). On most of the sample the corrosion crust is uniform. In areas we see cracks (Fig. 7) appearing as brown lines separating the corrosion crust (Fig. 8). In bright field the corrosion crust appears grey containing dark-grey zones (Fig. 7). Under polarized light, the corrosion crust appears white with darker parts including remnant metal (Fig. 8). It contains Zn and O as well as S along some cracks (Table 2 and Fig. 9).

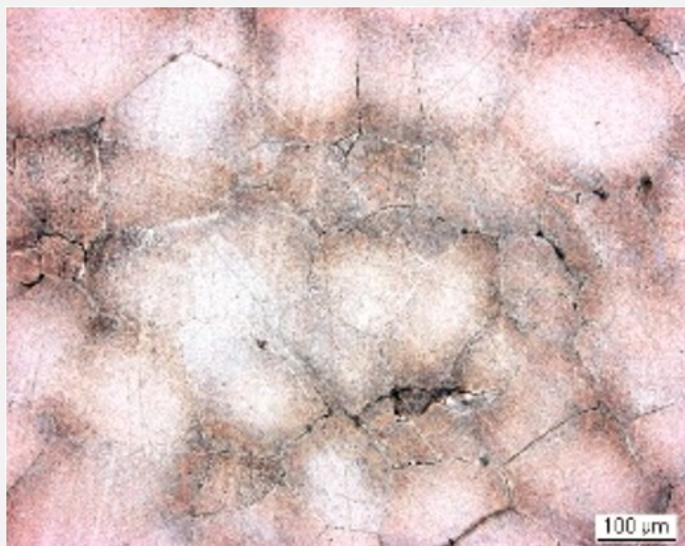
Fig. 6: Micrograph of the metal sample from Fig. 3 (detail), etched,

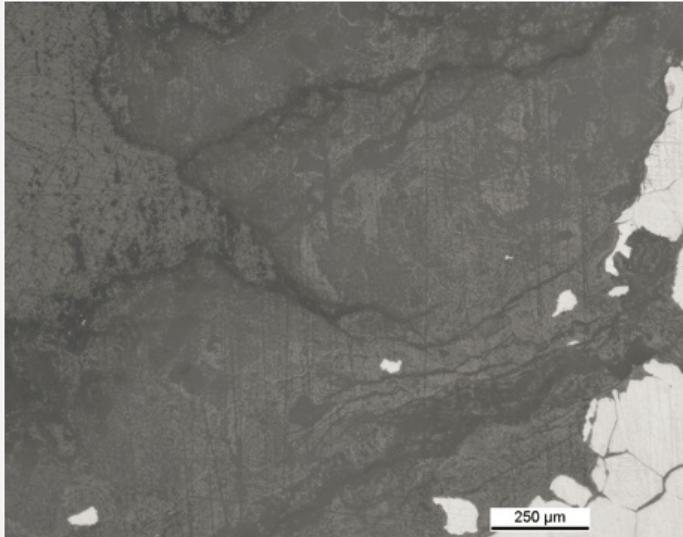
Elements	O	Al	Zn	Total
Light-grey corrosion part	23	<	77	98
Dark grey corrosion part	38	0.6	68	106

Fig. 7: Micrograph showing the metal - corrosion products interface from Fig. 5 (detail), unetched, bright field,

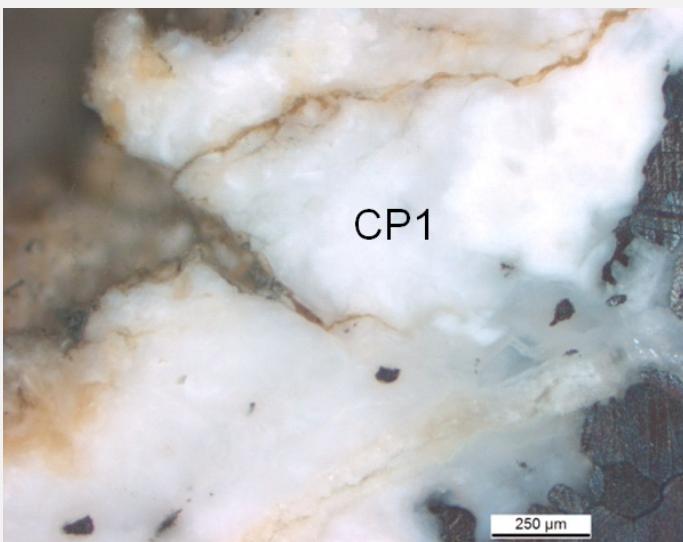
Fig. 8: Micrograph (same as Fig. 7) corresponding to the stratigraphy of Fig. 4, unetched, polarised light. We observe in dark-grey the metal, in white the corrosion crust separated by brown cracks including remnant metal,

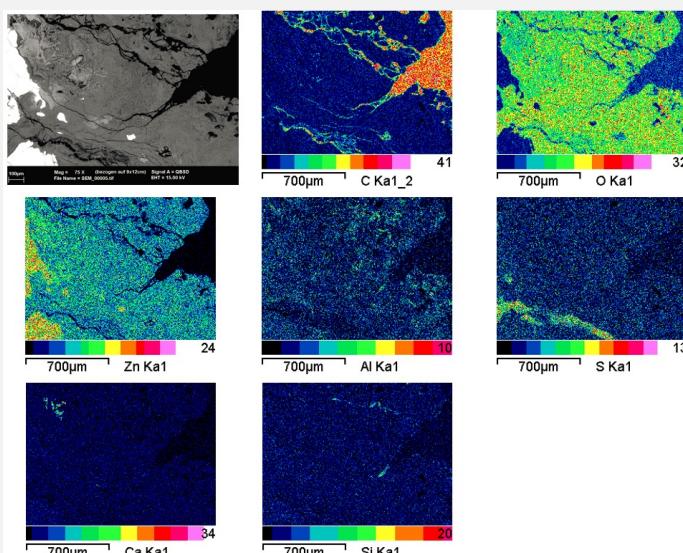
Fig. 9: SEM image, BSE-mode, and elemental chemical distribution of most of the area of Fig. 7 (reversed picture). Method of examination: SEM/EDS, Laboratory of Analytical Chemistry, Empa,

The artefact is possibly either a weight or a sacrificial anode. However, it is made of a cast and annealed zinc alloy which makes the interpretation as a weight implausible. In contrast an interpretation as a sacrificial anode is more likely. It is known that zinc alloy sacrificial anodes are used to protect marine propellers especially in salt water. The thick corrosion layer seems to consist of oxides or hydroxides. The origin of the sulphur along some of the cracks is unclear.
