# SACRIFICIAL ANODE VHS-8339 - ZN ALLOY - MODERN TIMES

**Artefact name** Sacrificial anode VHS-8339

**Authors** Marianne. Senn (EMPA, Dübendorf, Zurich, Switzerland) & Christian. Degrigny (HE-Arc CR, Neuchâtel, Neuchâtel, Switzerland)

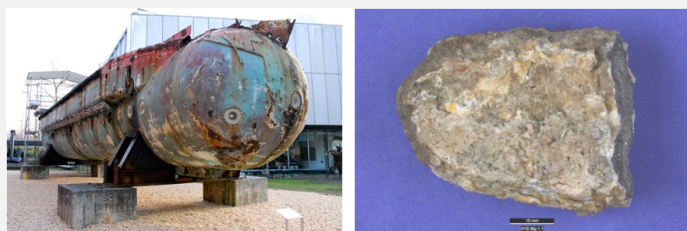
Fig. 1: The submarine and the anode (www.verkehrshaus.ch),

<b>Description of the artefact</b>	The artefact could be a weight or sacrificial anode of a submarine (Fig. 1). It is surrounded by a whitish brown-grey corrosion crust. The broken metal has a greyish shiny colour, whereas the metal part that is cut has a silvery appearance. Dimensions: L = 4.9cm ; WT = 95g.
<b>Type of artefact</b>	Submarine part
<b>Origin</b>	Submarine "Mesoscaph" from Auguste Piccard
<b>Recovering date</b>	The sacrificial anodes (?) might have been added when the submarine was used in the sea.
<b>Chronology category</b>	Modern Times
<b>chronology tpq</b>	<input type="text" value="1970"/> A.D. ▾
<b>chronology taq</b>	<input type="text" value="1974"/> A.D. ▾
<b>Chronology comment</b>	1970 _ 1974
<b>Burial conditions / environment</b>	Outdoor atmosphere
<b>Artefact location</b>	Swiss Museum of Transport, Luzern, Lucerne
<b>Owner</b>	Swiss Museum of Transport, Luzern, Lucerne
<b>Inv. number</b>	VHS-8339

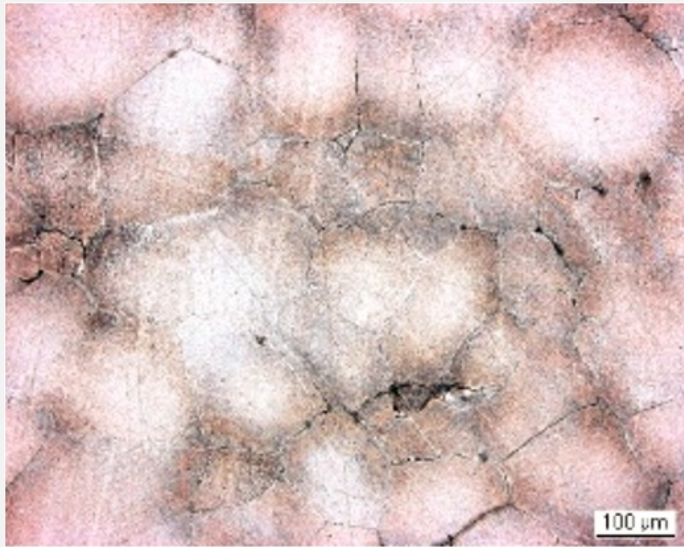
The remaining metal is an almost pure zinc alloy (Table 1). The oxygen content is not from the original alloy, but is due to secondary corrosion. The metal grains are visible without etching and present a polygonal structure (Figs. 5 and 6). The structure is recrystallised after annealing. The recrystallization of zinc alloys begins at room temperature.

Fig. 6: Micrograph of the metal sample from Fig. 3 (detail), etched,
