TOWEL BAR – AL ALLOY – MODERN TIMES – FRANCE

Artefact name Towel bar

Authors Christian. Degriigny (HE-Arc CR, Neuchâtel, Neuchâtel, Switzerland)

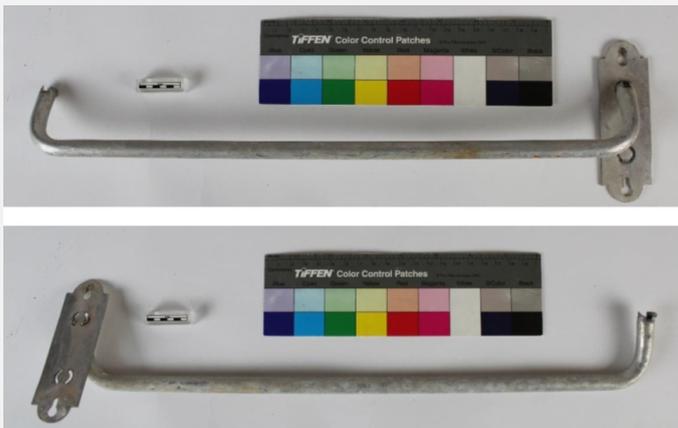
Fig. 1: Front and back sides of a towel bar,

Description of the artefact	Towel bar with traces of use and a broken section (Fig. 1). White deposits have developed on the metal surface. Dimensions: L = 45cm.
Type of artefact	Household implement
Origin	Château de Germolles, Mellecey, Bourgogne, France
Recovering date	Unknown
Chronology category	Modern Times
chronology tpq	<input type="text" value="1801"/> <input type="text" value="A.D. ▼"/>
chronology taq	<input type="text" value="2000"/> <input type="text" value="A.D. ▼"/>
Chronology comment	19th - 20th century

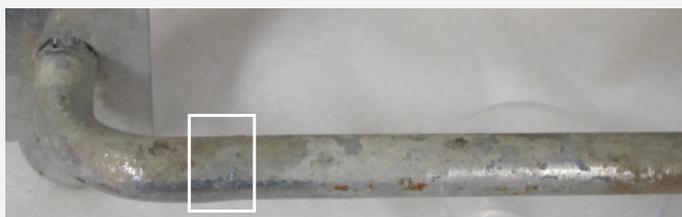
Fig. 2: Detail of the back side of the towel bar showing the location of the sampling area,

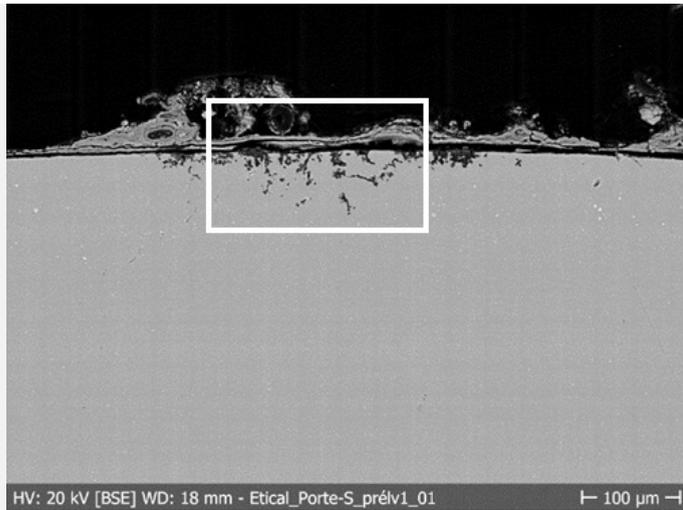
Fig. 3: SEM image of the cross-section showing the location of Fig. 5,

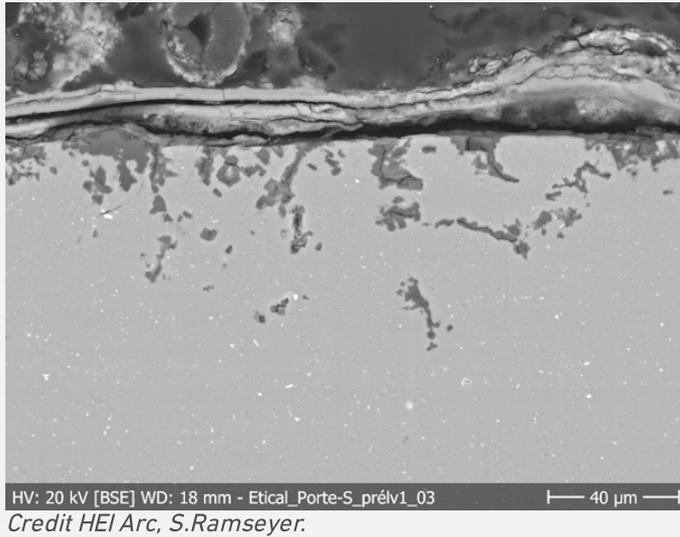
The metal is a relatively pure aluminium alloy with numerous inclusions (Fig. 5). From their chemical composition they can be interpreted as Al₃Fe intermetallic compounds (Fig. 6). Pitting corrosion as well as a start of intergranular

corrosion develops locally under the deposits, outlining some of the grains (Fig. 5).

Fig. 5: SEM image of the metal sample from Fig. 3 (detail), BSE-mode. We observe the presence of numerous inclusions,

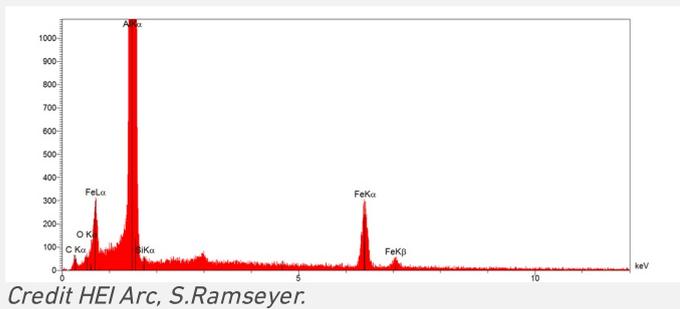
Fig. 6: EDS spectrum of the inclusions of Fig. 5,

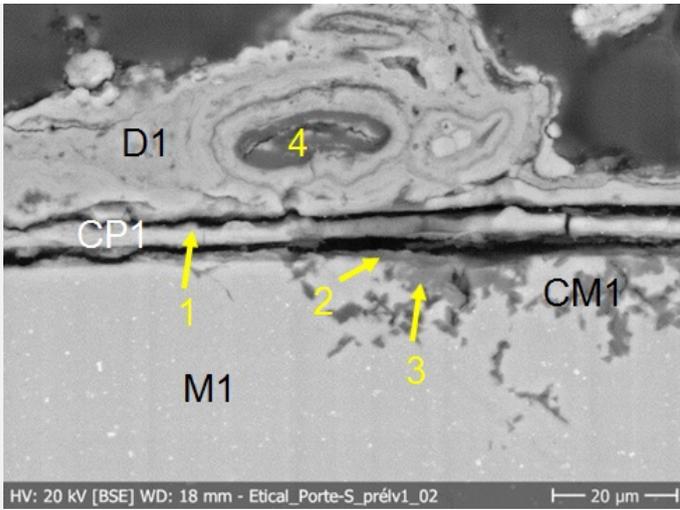
A very thin and loose oxide film has formed on the metal surface (CP1) and is locally covered by white deposits (D1). Intergranular corrosion has developed under the deposits (Fig. 7). Analysis by SEM-EDS indicates that the Al and O-rich oxide layer is contaminated with P and Si (area 1 on Fig. 7 and Fig. 8). These elements are even more present at the interface between CM1 and CP1 with Cl and S (area 2 on Fig. 7 and Fig. 9). The concentration of P and Si decreases in CM1 (area 3 on Fig. 7 and Fig. 10) while the concentration of S and Cl increases (Fig. 11). The deposit is mainly constituted of Ca, O, C and Si (probably CaCO₃ and SiO₂, area 4 on Fig. 7 and Fig. 12).

Fig. 7: SEM picture with location of EDS analyses of areas 1 to 4), BSE-mode. From bottom to top: the metal (M1) in light grey, the corroded metal (CM1), CP1 and D1,

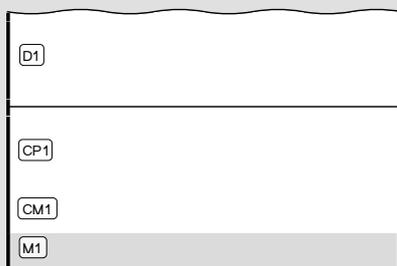
Fig. 4: Stratigraphic representation of the object in cross-section using the MiCorr application. This representation can be compared to Fig. 9, Credit HE-Arc CR, C.Degrigny.
