TOWEL BAR – AL ALLOY – MODERN TIMES – FRANCE

Artefact name Towel bar

Authors Christian. Degriigny (HE-Arc CR, Neuchâtel, Neuchâtel, Switzerland)

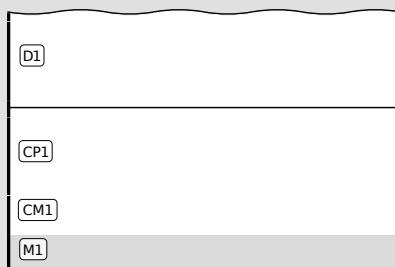
Fig. 4: Stratigraphic representation of the object in cross-section using the MiCorr application. This representation can be compared to Fig. 9, Credit HE-Arc CR, C.Degrigny.
