TOWEL BAR – AL ALLOY – MODERN TIMES – FRANCE

Artefact name	Towel bar
Authors	Christian. Degriigny (HE-Arc CR, Neuchâtel, Neuchâtel, Switzerland)
Url	/artefacts/368/

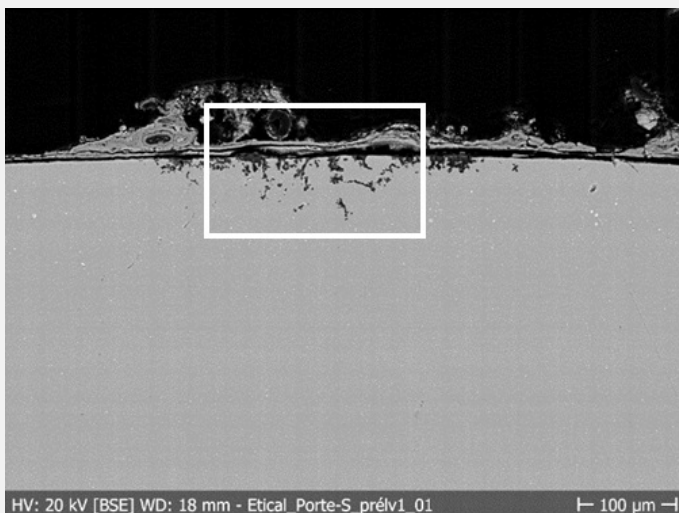
Fig. 3: SEM image of the cross-section showing the location of Fig. 5,

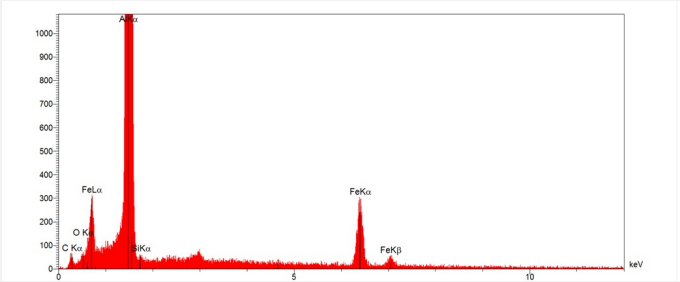
Fig. 6: EDS spectrum of the inclusions of Fig. 5,

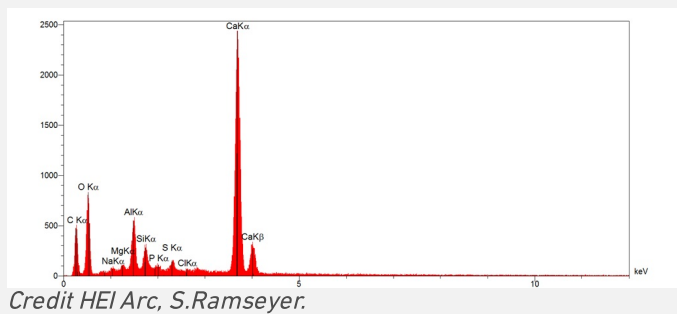
Fig. 8: EDS spectrum of area 1 of Fig. 7,

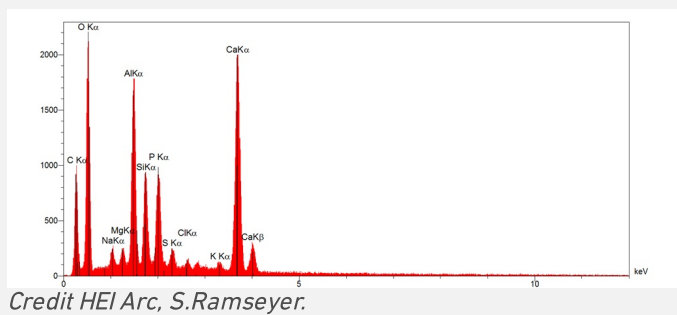
Fig. 9: EDS spectrum of area 2 of Fig. 7,

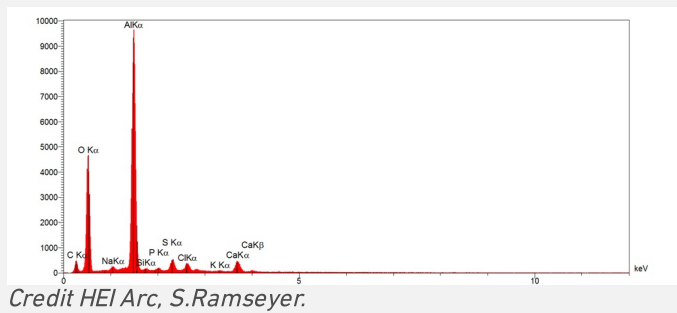
Fig. 10: EDS spectrum of area 3 of Fig. 7,

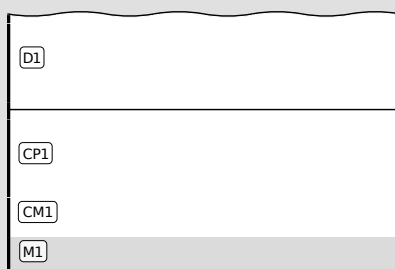
Fig. 4: Stratigraphic representation of the object in cross-section using the MiCorr application. This representation can be compared to Fig. 9, Credit HE-Arc CR, C.Degrigny.
