TOWEL BAR – AL ALLOY – MODERN TIMES – FRANCE

Artefact name Towel bar

Authors Christian. Degriigny (HE-Arc CR, Neuchâtel, Neuchâtel, Switzerland)

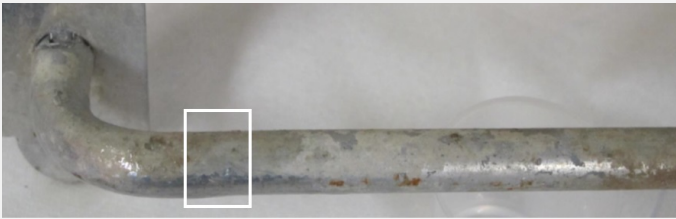
Fig. 2: Detail of the back side of the towel bar showing the location of the sampling area,

Description of sample	Sample cut from the back side of the towel bar (Fig. 2).
Alloy	Al Alloy
Technology	None
Lab number of sample	
Sample location	HE-Arc CR, Neuchâtel, Neuchâtel
Responsible institution	HE-Arc CR, Neuchâtel, Neuchâtel
Date and aim of sampling	2017, the EtICAL project (a study of corrosion forms of aluminium alloys)

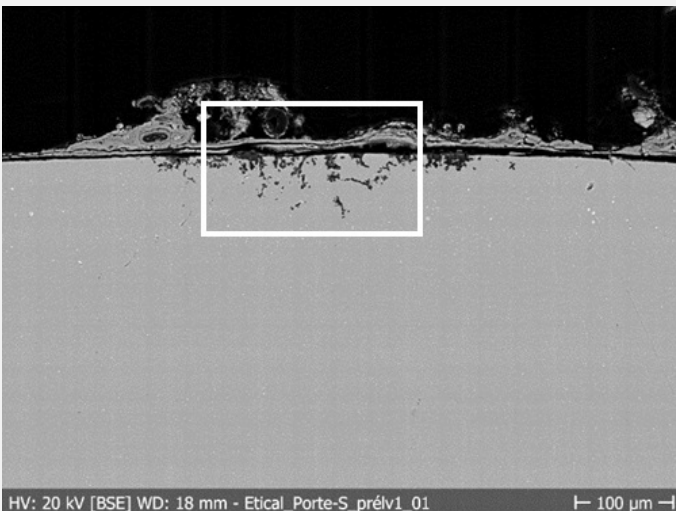
Fig. 3: SEM image of the cross-section showing the location of Fig. 5,
