## TOWEL BAR – AL ALLOY – MODERN TIMES – FRANCE

Artefact name	Towel bar
Authors	Christian. Degriigny (HE-Arc CR, Neuchâtel, Neuchâtel, Switzerland)
Url	/artefacts/368/

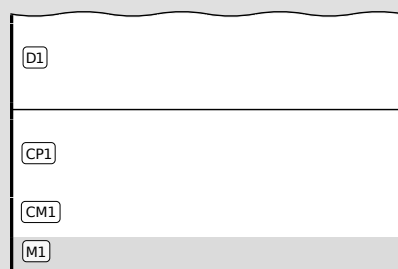
Fig. 4: Stratigraphic representation of the object in cross-section using the MiCorr application. This representation can be compared to Fig. 9, Credit HE-Arc CR, C.Degrigny.
