COFFEE FILTER – AL ALLOY – MODERN TIMES – FRANCE

Artefact name Coffee filter

Authors Christian. Degriigny (HE-Arc CR, Neuchâtel, Neuchâtel, Switzerland)

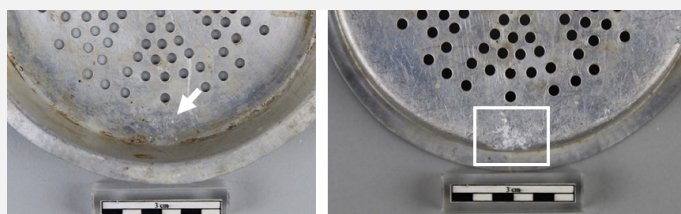
Fig. 2: Detail of the front and back sides of the coffee filter showing the location of Fig. 3,

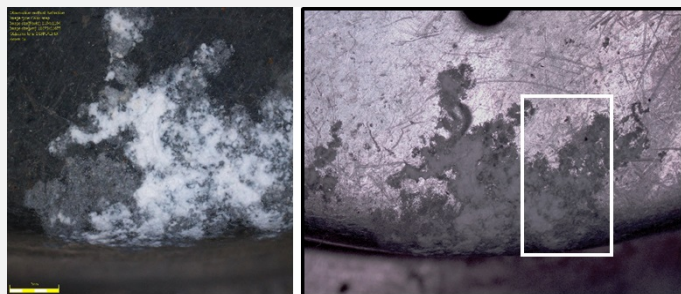
Fig. 3: Detail of the back side of the coffee filter showing the location of the sampling area,

Description of sample	Sample cut from the back side of the coffee filter (Fig. 3).
Alloy	Al Alloy
Technology	None
Lab number of sample	
Sample location	HE-Arc CR, Neuchâtel, Neuchâtel
Responsible institution	HE-Arc CR, Neuchâtel, Neuchâtel
Date and aim of sampling	2017, the EtICAL project (a study of corrosion forms of aluminium alloys)

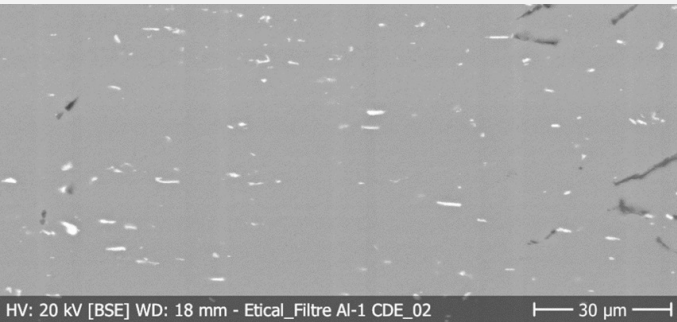
The metal is a relatively pure aluminium alloy with numerous elongated inclusions (Fig. 6). From their chemical composition they can be interpreted as Al_3Fe intermetallic compounds (Fig. 7). Inter- and transgranular corrosion has

Fig. 6: SEM image of the metal sample from Fig. 4 (detail), BSE-mode. We observe the presence of numerous elongated inclusions,

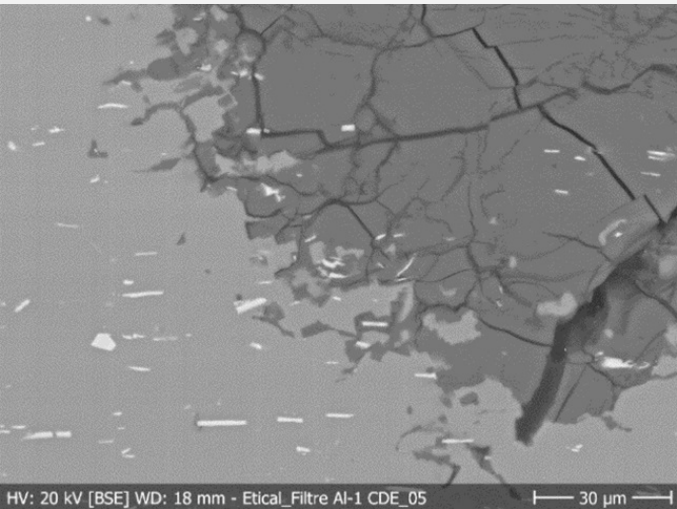
developed so extensively that some grains (not elongated) are outlined (Fig. 8).

Fig. 8: SEM image of the metal sample from Fig. 4 (detail), BSE-mode. Extensive inter- and transgranular corrosion has developed within the metal,

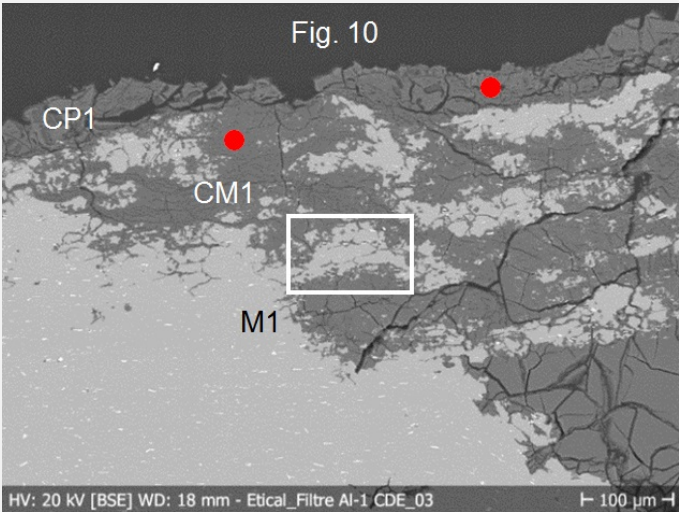
The average thickness of the corrosion layer (CP1) is about 50mm, but may be thinner or thicker depending on the area. Intergranular corrosion has developed locally to extend the whole thickness of the metal. Analysis by SEM-EDS

indicates that the metal is, as expected, covered by an Al and O-rich layer containing chlorides (red spots on Fig. 9) and surprisingly Na (Figs. 10 and 11). Chlorides do not seem to form active corrosion. A new examination carried out after 4 months (Fig. 12) shows new forms of alteration with a local enrichment of Na, C and O (Na₂CO₃?).

Fig. 9: SEM picture (detail of Fig. 4 with location of EDS analyses of Fig. 10), BSE-mode. From bottom to top left: the metal (M1) in light grey, the corroded metal (CM1) and CP1. The mapped area of Fig. 11 is marked by a rectangle,

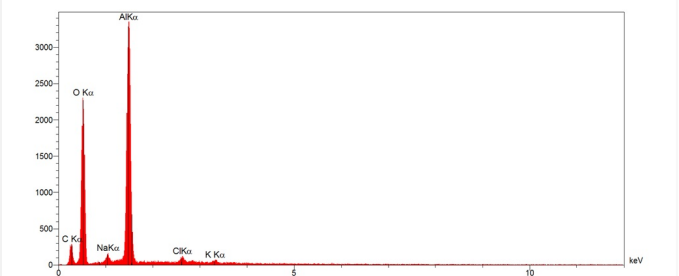
Fig. 10: EDS spectrum of red spots in Fig. 9,

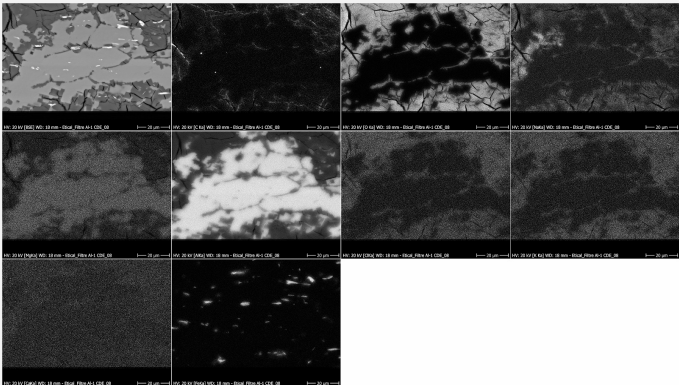
Fig. 12: SEM image, BSE-mode, and elemental chemical distribution of the selected area of Fig. 9 after 4 months. Method of examination: SEM-EDS, Lab of Electronic Microscopy and Microanalysis, IMA (Néode), HEI Arc,

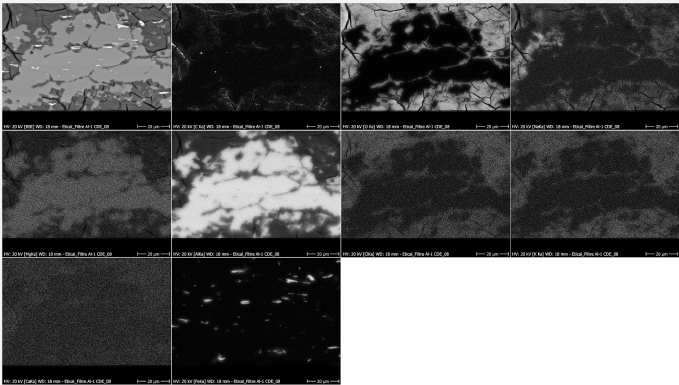
Fig. 11: SEM image, BSE-mode, and elemental chemical distribution of the selected area of Fig. 9. Method of examination: SEM-EDS, Lab of Electronic Microscopy and Microanalysis, IMA (Néode), HEI Arc,

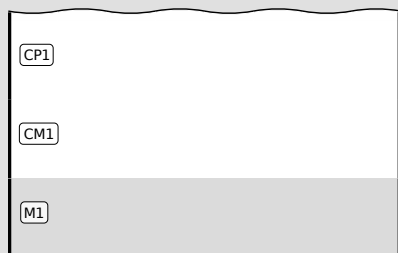
Fig. 5: Stratigraphic representation of the object in cross-section using the MiCorr application. This representation can be compared to Fig. 9, Credit HE-Arc CR, C.Degrigny.
