COFFEE FILTER – AL ALLOY – MODERN TIMES – FRANCE

Artefact name Coffee filter

Authors Christian. Degriigny (HE-Arc CR, Neuchâtel, Neuchâtel, Switzerland)

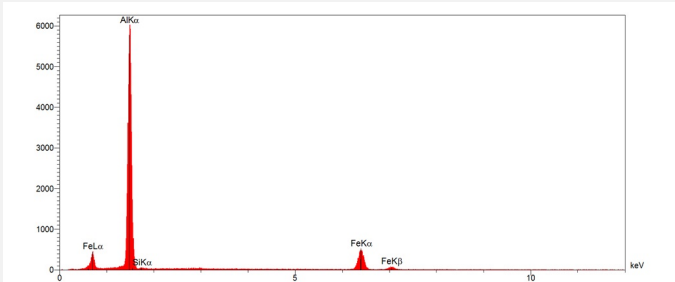
The metal is a relatively pure aluminium alloy with numerous elongated inclusions (Fig. 6). From their chemical composition they can be interpreted as Al₃Fe intermetallic compounds (Fig. 7). Inter- and transgranular corrosion has

Fig. 7: EDS spectrum of the elongated inclusions of Fig. 6,
