COFFEE FILTER – AL ALLOY – MODERN TIMES – FRANCE

Artefact name Coffee filter

Authors Christian. Degriigny (HE-Arc CR, Neuchâtel, Neuchâtel, Switzerland)

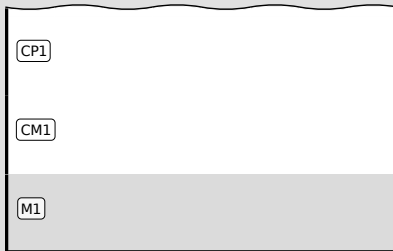
Fig. 5: Stratigraphic representation of the object in cross-section using the MiCorr application. This representation can be compared to Fig. 9, Credit HE-Arc CR, C.Degrigny.
