SHINGLE OF A ROOF – CU ALLOY – MODERN TIMES – SWITZERLAND

Artefact name	Shingle of a roof
Authors	Marianne. Senn (EMPA, Dübendorf, Zurich, Switzerland) & Christian. Degryny (HE-Arc CR, Neuchâtel, Neuchâtel, Switzerland)
Url	/artefacts/370/

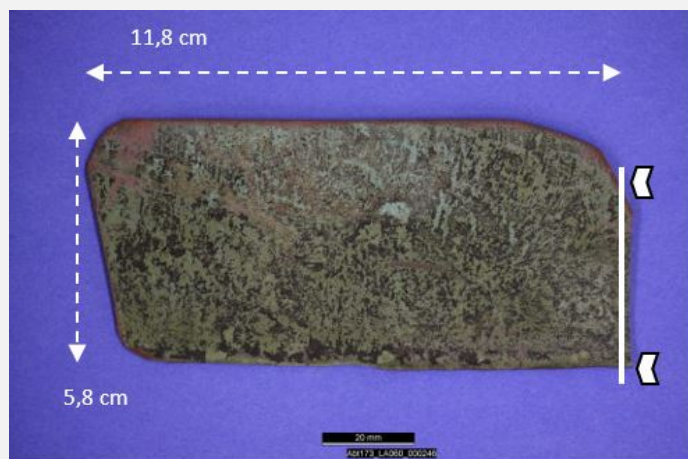
Fig. 2: showing the location of sampling area,

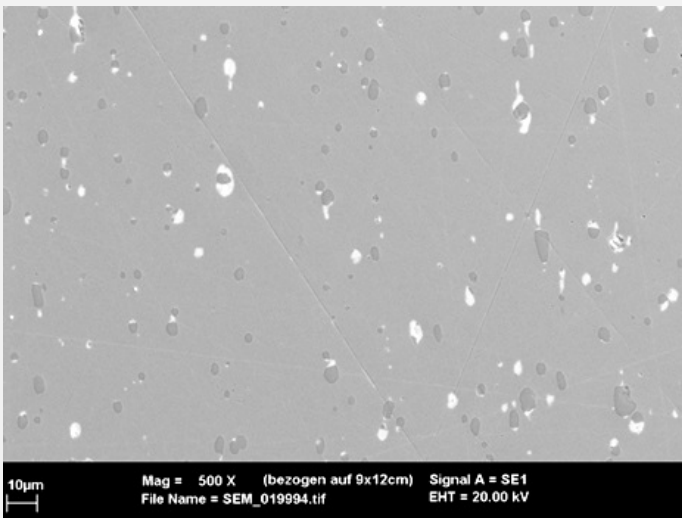
The remaining metal is a copper alloy (Table 1). The evenly distributed inclusions observed under SEM, SE-mode, are either light-grey or white (Fig. 5). The oval shape of the light-grey inclusions is due to deformation, probably by hot rolling (a common technique in the 18th century). Under polarised light they look red (Fig. 7) and their analysis reveals a composition similar to cuprite/Cu₂O (Table 2). The white inclusions are rich in Pb and are remnants of the refining process (Table 2). The etched copper shows a structure of polygonal and twinned grains (Fig. 6). The grain size is variable. The average hardness of the metal is about HV1 70.

Fig. 5: SEM image, SE-mode, of the metal sample from Fig. 3 (detail). Light-grey and white inclusions are distributed evenly,

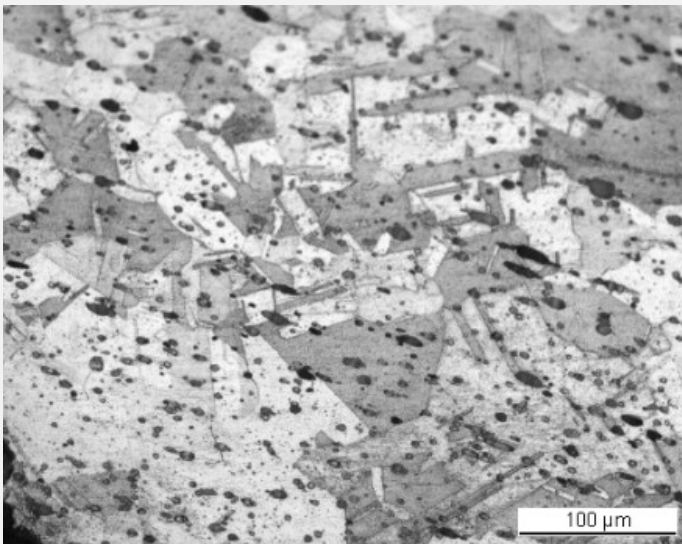
Fig. 6: Micrograph of the metal sample from Fig. 3 (detail), etched, bright field. The metal shows a structure of polygonal and twinned grains. Cuprite inclusions appear as dark spots,

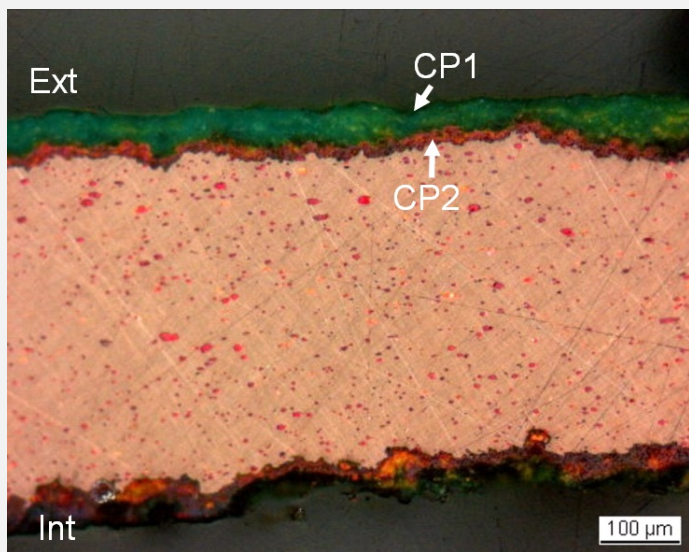
The corrosion crusts of the external and internal sides are distinctively different (Fig. 7). On the internal side an irregular red-orange corrosion layer has developed, and pitting corrosion has occurred. The more uniform corrosion layers on the external side are composed of a red-orange layer, followed by a thicker green outer layer. In some areas, dark-red corrosion products can be observed between the green and red-orange sub-layers. The same dark-red sub-layer can be seen in areas on the internal side covering the red-orange corrosion products. The red-orange corrosion layer on both sides (CP2) has a chemical composition similar to cuprite/Cu₂O, while the green layer on the external side (CP1) contains Cu, S and O and is enriched on its upper surface with Si (Table 3 and Fig. 8). XRD analysis of the corrosion products on the external side of another shingle fragment from the same roof identified brochantite/Cu₄SO₄(OH)₆ and cuprite as corrosion products (Rapport d'analyse no. MAH 98-257). These results are confirmed by Raman spectroscopy of the external side of this sample where the same compounds were clearly identified (Figs. 9 and 10).

Fig. 7: Micrograph of the metal sample from Fig. 3 and corresponding to the stratigraphy of Fig. 4, polarised light. External side: the regular corrosion crust with outer green, inner red-orange corrosion products and intermediate dark-red corrosion products. Internal side: the irregular corrosion crust with inner red-orange and outer dark-red corrosion products,

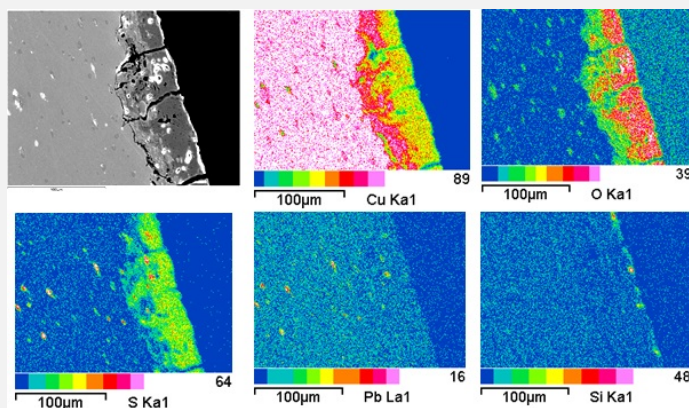
Fig. 8: SEM image, SE-mode, and elemental chemical distribution of the selected area of Fig. 3 (rotated image, detail). Method of examination: SEM/EDS, Laboratory of Analytical Chemistry, Empa,

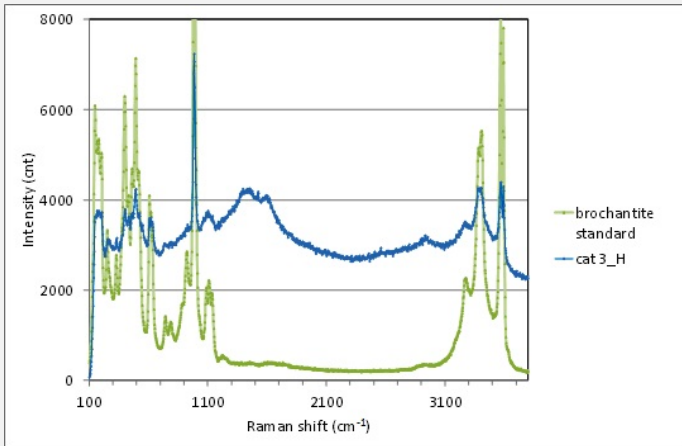
Fig. 10: Raman spectrum of the green outer corrosion layer (CP1) of the external side (cat3_H) compared to a brochantite standard spectrum. Settings: laser wavelength 532nm, acquisition time 100s, one accumulation, filter D2 (0.75-0.8 mW), hole 500, slit 80, grating 600. The peak indicated with an arrow on the cat3_H spectrum is due to fluorescence. Method of analysis: Raman spectroscopy, Lab Swiss National Museum, Affoltern a. Albis ZH,

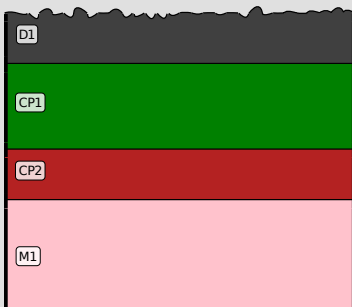
Fig. 4: Stratigraphic representation of the object in cross-section using the MiCorr application. This representation can be compared to Fig. 7, Credit HE-Arc CR.
