SHINGLE OF A ROOF – CU ALLOY – MODERN TIMES – SWITZERLAND

Artefact name	Shingle of a roof
Authors	Marianne. Senn (EMPA, Dübendorf, Zurich, Switzerland) & Christian. Degriany (HE-Arc CR, Neuchâtel, Neuchâtel, Switzerland)
Url	/artefacts/370/

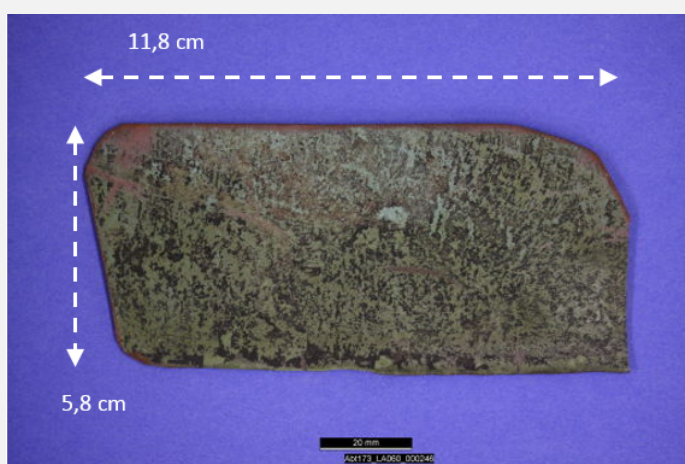
Fig. 1: Copper alloy shingle, internal side,

Description of the artefact	Shingle, slightly curved, the internal side is covered with heterogeneously distributed green and black corrosion products (Fig. 1). The external side shows a regular dark green corrosion crust. Dimensions: L = 11.8cm; W = 5.8cm.
Type of artefact	Architectural element
Origin	Roof of the Abbey of St Gallen, Sankt Gallen, Saint Gallen, Switzerland
Recovering date	None
Chronology category	Modern Times
chronology tpq	<input type="text" value="1780"/> A.D. ▼
chronology taq	<input type="text" value=""/> ---- ▼
Chronology comment	1780
Burial conditions / environment	Outdoor atmosphere
Artefact location	Conservation Department of the Musées d'art et d'histoire, Genève, Geneva
Owner	Abbey of St Gallen, Sankt Gallen, Saint Gallen

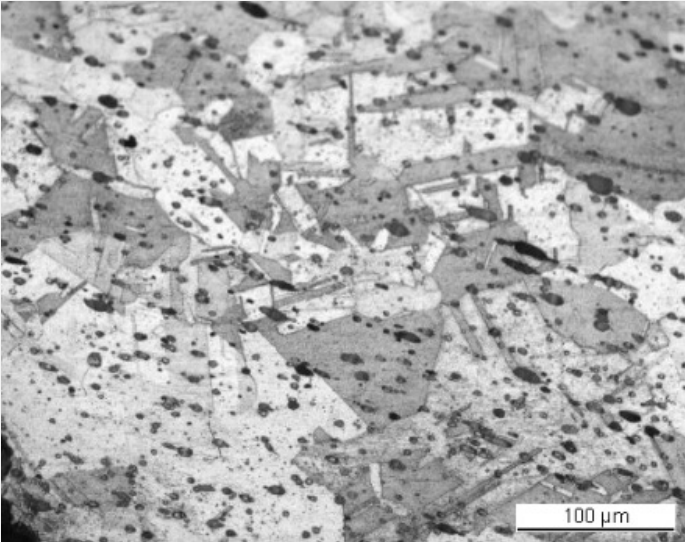
Fig. 6: Micrograph of the metal sample from Fig. 3 (detail), etched, bright field. The metal shows a structure of polygonal and twinned grains. Cuprite inclusions appear as dark spots,

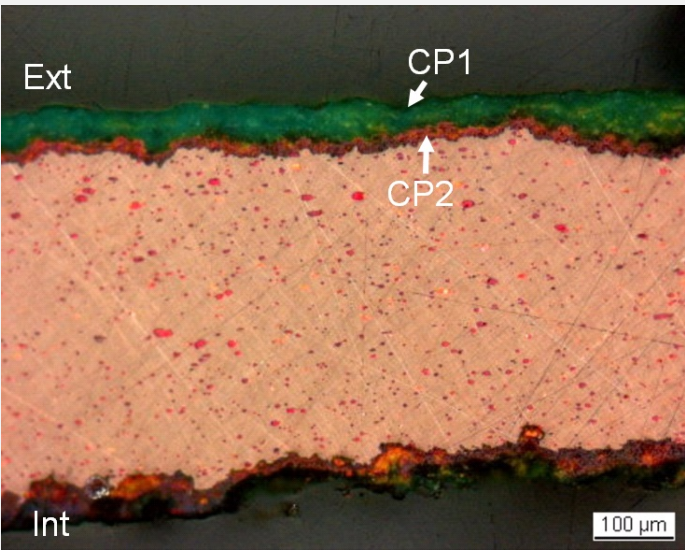
The corrosion crusts of the external and internal sides are distinctively different (Fig. 7). On the internal side an irregular red-orange corrosion layer has developed, and pitting corrosion has occurred. The more uniform corrosion layers on the external side are composed of a red-orange layer, followed by a thicker green outer layer. In some areas, dark-red corrosion products can be observed between the green and red-orange sub-layers. The same dark-red sub-layer can be seen in areas on the internal side covering the red-orange corrosion products. The red-orange corrosion layer on both sides (CP2) has a chemical composition similar to cuprite/ Cu_2O , while the green layer on the external side (CP1) contains Cu, S and O and is enriched on its upper surface with Si (Table 3 and Fig. 8). XRD analysis of the corrosion products on the external side of another shingle fragment from the same roof identified brochantite/ $\text{Cu}_4\text{SO}_4(\text{OH})_6$ and cuprite as corrosion products (Rapport d'analyse no. MAH 98-257). These results are confirmed by Raman spectroscopy of the external side of this sample where the same compounds were clearly identified (Figs. 9 and 10).

Fig. 7: Micrograph of the metal sample from Fig. 3 and corresponding to the stratigraphy of Fig. 4, polarised light. External side: the regular corrosion crust with outer green, inner red-orange corrosion products and intermediate dark-red corrosion products. Internal side: the irregular corrosion crust with inner red-orange and outer dark-red corrosion products,

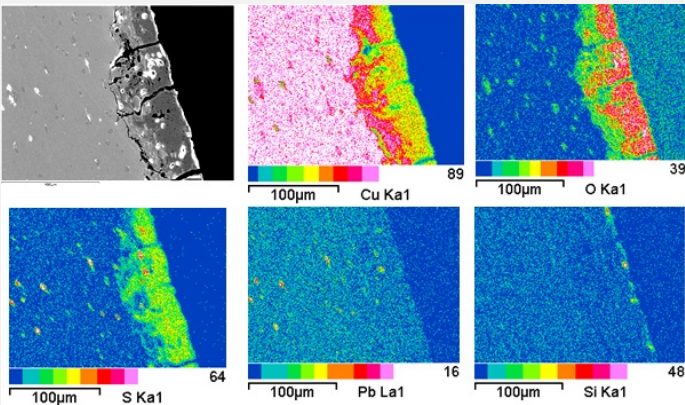
Fig. 8: SEM image, SE-mode, and elemental chemical distribution of the selected area of Fig. 3 (rotated image, detail). Method of examination: SEM/EDS, Laboratory of Analytical Chemistry, Empa,

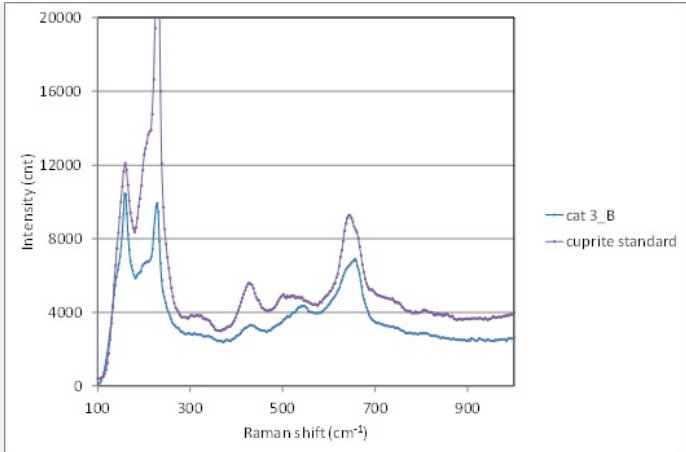
Fig. 9: Raman spectrum of the red-orange inner corrosion layer (CP2) of the external side (cat3_B) compared to a cuprite standard spectrum. Settings: laser wavelength 532nm, acquisition time 100s,

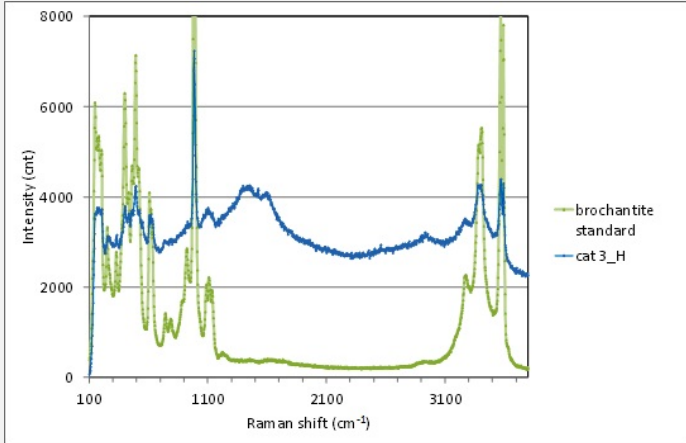
Fig. 10: Raman spectrum of the green outer corrosion layer (CP1) of the external side (cat3_H) compared to a brochantite standard spectrum. Settings: laser wavelength 532nm, acquisition time 100s, one accumulation, filter D2 (0.75-0.8 mW), hole 500, slit 80, grating 600. The peak indicated with an arrow on the cat3_H spectrum is due to fluorescence. Method of analysis: Raman spectroscopy, Lab Swiss National Museum, Affoltern a. Albis ZH,

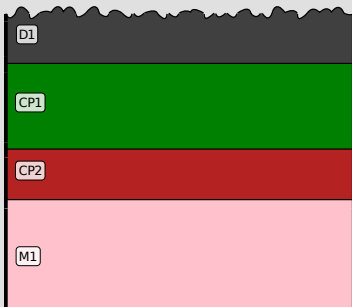
Fig. 4: Stratigraphic representation of the object in cross-section using the MiCorr application. This representation can be compared to Fig. 7, Credit HE-Arc CR.
