SHINGLE OF A ROOF – CU ALLOY – MODERN TIMES – SWITZERLAND

Artefact name	Shingle of a roof
Authors	Marianne. Senn (EMPA, Dübendorf, Zurich, Switzerland) & Christian. Degriigny (HE-Arc CR, Neuchâtel, Neuchâtel, Switzerland)
Url	/artefacts/370/

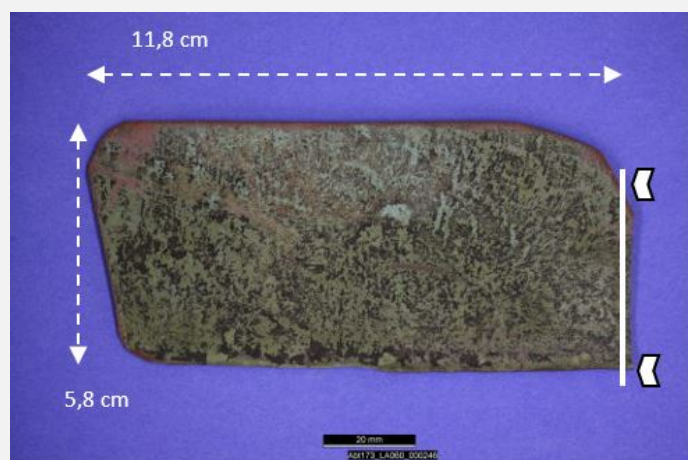
Fig. 2: showing the location of sampling area,

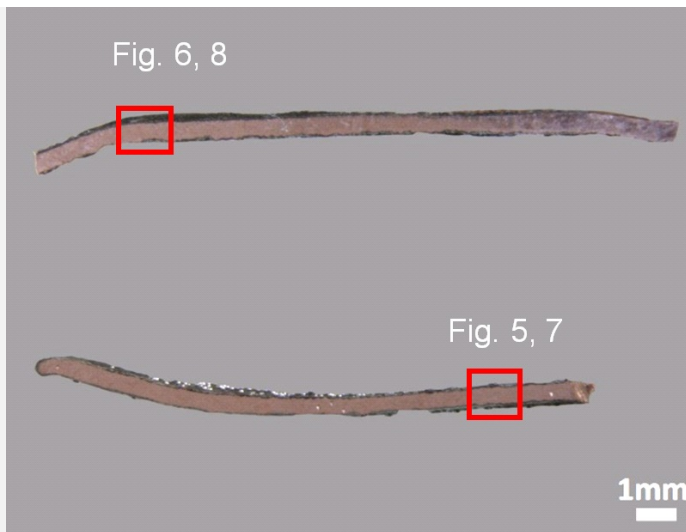
Fig. 3: Micrograph of the cross-sections showing the location of Figs. 5 to 8,

Description of sample	Two samples were taken (Fig. 2). The polished samples show a well-preserved metal surface with a thin corrosion crust (Fig. 3). T = 0.5mm.
Alloy	Cu Alloy
Technology	Rolled (probably hot rolling) and annealed
Lab number of sample	MAH-98-257
Sample location	Empa (Marianne Senn)
Responsible institution	Conservation Department of the Musées d'art et d'histoire, Genève, Geneva
Date and aim of sampling	2009, integration of sample to the MIFAC-Métal project

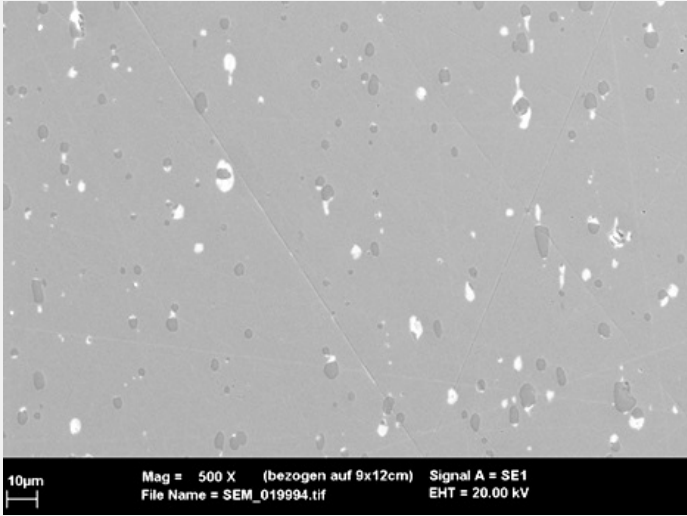
The remaining metal is a copper alloy (Table 1). The evenly distributed inclusions observed under SEM, SE-mode, are either light-grey or white (Fig. 5). The oval shape of the light-grey inclusions is due to deformation, probably by hot rolling (a common technique in the 18th century). Under polarised light they look red (Fig. 7) and their analysis reveals a composition similar to cuprite/Cu₂O (Table 2). The white inclusions are rich in Pb and are remnants of the refining process (Table 2). The etched copper shows a structure of polygonal and twinned grains (Fig. 6). The grain size is variable. The average hardness of the metal is about HV1 70.

Table 2: Chemical composition (mass %) of the inclusions in the metal (from Fig. 5). Method of analysis: SEM/EDS, Laboratory of Analytical Chemistry, Empa.

Fig. 5: SEM image, SE-mode, of the metal sample from Fig. 3 (detail). Light-grey and white inclusions are distributed evenly,

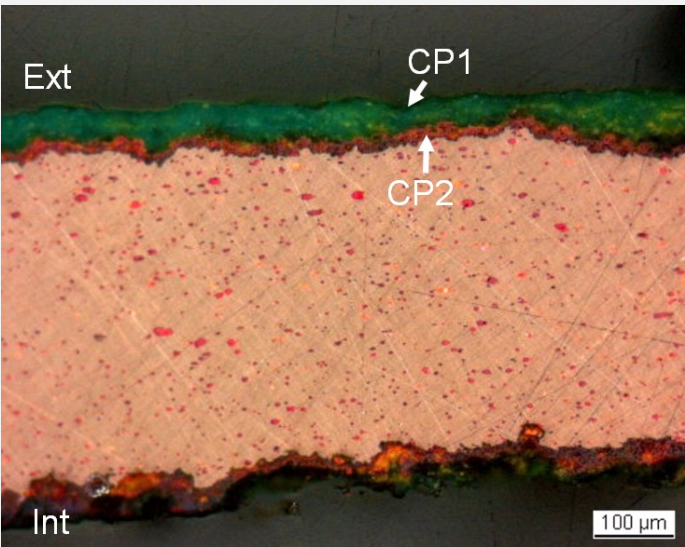
The corrosion crusts of the external and internal sides are distinctively different (Fig. 7). On the internal side an irregular red-orange corrosion layer has developed, and pitting corrosion has occurred. The more uniform corrosion layers on the external side are composed of a red-orange layer, followed by a thicker green outer layer. In some areas, dark-red corrosion products can be observed between the green and red-orange sub-layers. The same dark-red sub-layer can be seen in areas on the internal side covering the red-orange corrosion products. The red-orange corrosion layer on both sides (CP2) has a chemical composition similar to cuprite/ Cu_2O , while the green layer on the external side (CP1) contains Cu, S and O and is enriched on its upper surface with Si (Table 3 and Fig. 8). XRD analysis of the corrosion products on the external side of another shingle fragment from the same roof identified brochantite/ $\text{Cu}_4\text{SO}_4(\text{OH})_6$ and cuprite as corrosion products (Rapport d'analyse no. MAH 98-257). These results are confirmed by Raman spectroscopy of the external side of this sample where the same compounds were clearly identified (Figs. 9 and 10).

Fig. 7: Micrograph of the metal sample from Fig. 3 and corresponding to the stratigraphy of Fig. 4, polarised light. External side: the regular corrosion crust with outer green, inner red-orange corrosion products and intermediate dark-red corrosion products. Internal side: the irregular corrosion crust with inner red-orange and outer dark-red corrosion products,

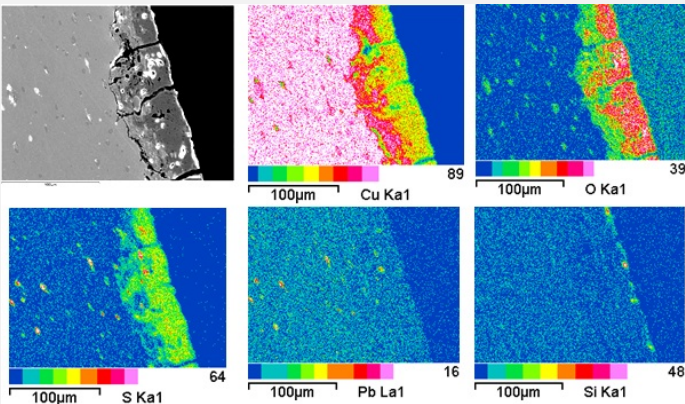
Fig. 8: SEM image, SE-mode, and elemental chemical distribution of the selected area of Fig. 3 (rotated image, detail). Method of examination: SEM/EDS, Laboratory of Analytical Chemistry, Empa,

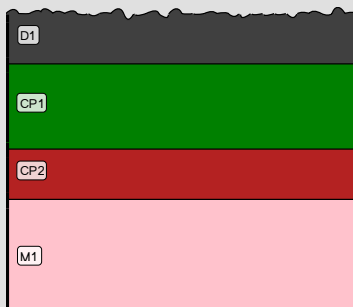
Fig. 4: Stratigraphic representation of the object in cross-section using the MiCorr application. This representation can be compared to Fig. 7, Credit HE-Arc CR.
