SHINGLE OF A ROOF – CU ALLOY – MODERN TIMES – SWITZERLAND

Artefact name	Shingle of a roof
Authors	Marianne. Senn (EMPA, Dübendorf, Zurich, Switzerland) & Christian. Degriany (HE-Arc CR, Neuchâtel, Neuchâtel, Switzerland)
Url	/artefacts/370/

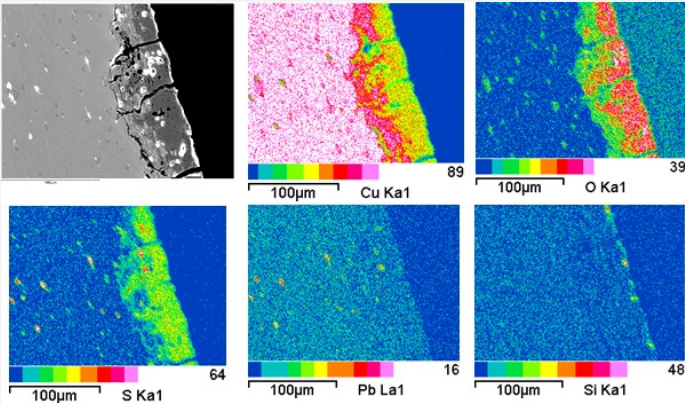
Fig. 8: SEM image, SE-mode, and elemental chemical distribution of the selected area of Fig. 3 (rotated image, detail). Method of examination: SEM/EDS, Laboratory of Analytical Chemistry, Empa,

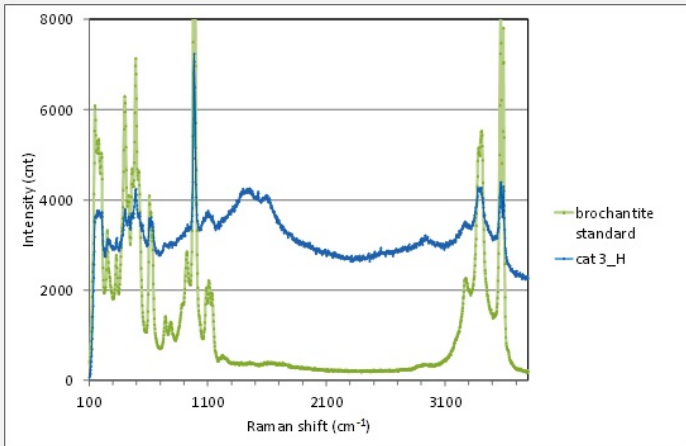
Fig. 10: Raman spectrum of the green outer corrosion layer (CP1) of the external side (cat3_H) compared to a brochantite standard spectrum. Settings: laser wavelength 532nm, acquisition time 100s, one accumulation, filter D2 (0.75-0.8 mW), hole 500, slit 80, grating 600. The peak indicated with an arrow on the cat3_H spectrum is due to fluorescence. Method of analysis: Raman spectroscopy, Lab Swiss National Museum, Affoltern a. Albis ZH,

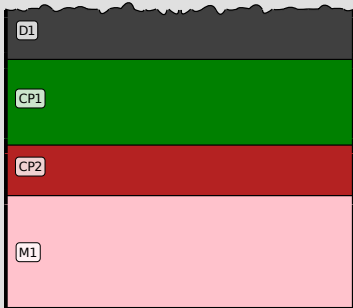
Fig. 4: Stratigraphic representation of the object in cross-section using the MiCorr application. This representation can be compared to Fig. 7, Credit HE-Arc CR.
