FITTING ON BACK PANEL OF A MILITARY CARRIAGE - THOMAS STEEL - MODERN TIMES - SWITZERLAND

Artefact name Fitting on back panel of a military carriage

Authors Marianne. Senn (EMPA, Dübendorf, Zurich, Switzerland) & Christian. Degrigny (HE-Arc CR, Neuchâtel, Neuchâtel, Switzerland)

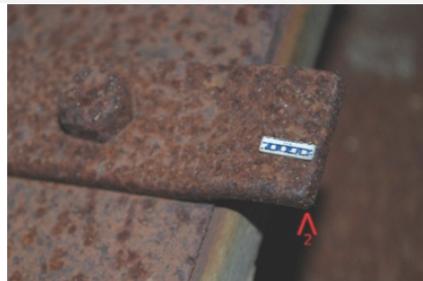
Fig. 1: Steel fitting on back panel of a military carriage (©Tarchini),

Description of the artefact	Fitting on back panel, first exposed outdoors, later indoors (Fig. 1). Uniform corrosion and pitting corrosion are visible.
Type of artefact	Military carriage
Origin	Swiss Army, Thun, Bern, Switzerland
Recovering date	Built by Konstruktions-Werkstätte, 1918
Chronology category	Modern Times
chronology tpp	1918 <input type="button" value="A.D. ▾"/>
chronology taq	<input type="button" value="---- ▾"/>
Chronology comment	1918
Burial conditions / environment	Outdoor to indoor atmosphere
Artefact location	Historical Swiss Army Material Foundation, Burgdorf, Bern
Owner	Historical Swiss Army Material Foundation, Burgdorf, Bern
Inv. number	n.a.
Recorded conservation data	Not conserved

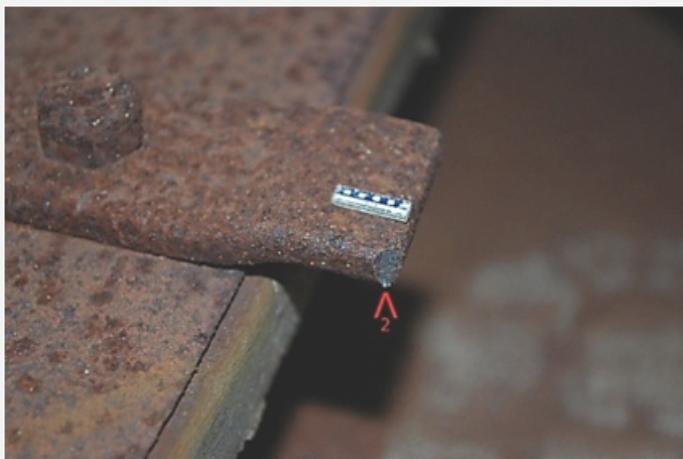
Fig. 2: Location of sampling area,

Description of sample	This sample is a cut from the corner of one of the two fittings on the back panel (Fig. 2). The metal is covered by a thin corrosion layer (Fig. 3).
Alloy	Thomas steel
Technology	Piled from several strips, hot rolled and annealed
Lab number of sample	POINT-Fe2
Sample location	Empa (Marianne Senn)
Responsible institution	Historical Swiss Army Material Foundation, Burgdorf, Bern
Date and aim of sampling	05/2009 metallography

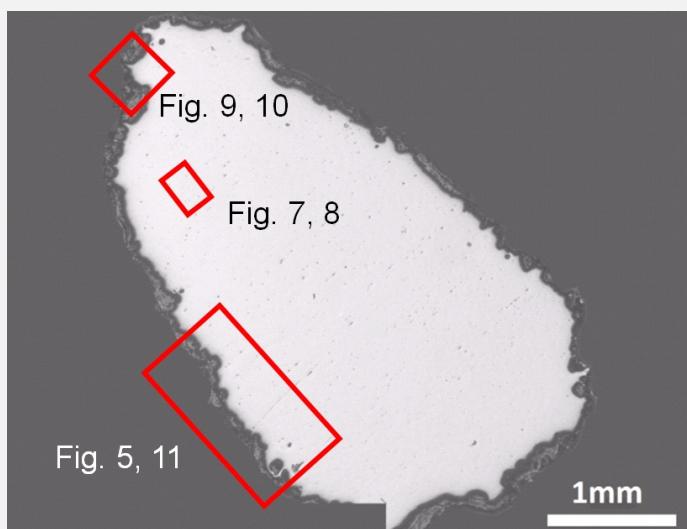
Fig. 3: Micrograph of the cross-section showing the location of Figs. 5 and 7 to 11,

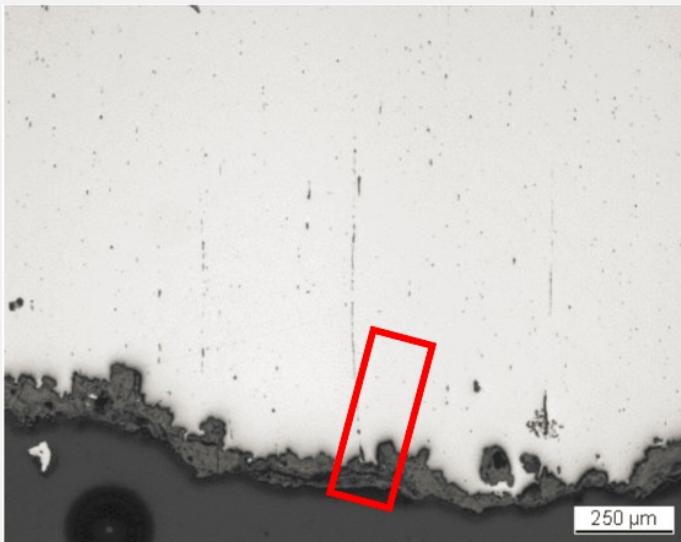
The remaining metal is a Mn-rich soft steel (C content around 0.1 mass%) containing manganese sulphide inclusions with a varying Fe content (Tables 1 and 2). The numerous inclusions form parallel rows (Fig. 5). This orientation is typical for hot rolled metal. After etching with Oberhoffer's reagent, three main welding seams (P-rich) become visible (Fig. 6). Near the surface they are also outlined by corrosion (Figs. 5 and 11). After nital etching, the metal shows a ferritic structure with tertiary cementite and lamellar pearlite at the grain boundaries (Figs. 7 and 8). The grains are small with an ASTM grain size of 10 and are recrystallized due to annealing after hot rolling. The average hardness of the metal is HV1 165. The hardness is slightly high for such a structure and this is due to the Mn content of the metal. The chemical composition, especially the Mn content and the presence of carbo-nitrides (not analysed here), is typical for Thomas steel.

Fig. 5: Micrograph of the metal sample from Fig. 3 (rotated by 270°, detail), unetched, bright field. We observe the metal including welding seams outlined by corrosion products and MnS inclusions. The mapped area of Fig. 11 is marked by the rectangle,

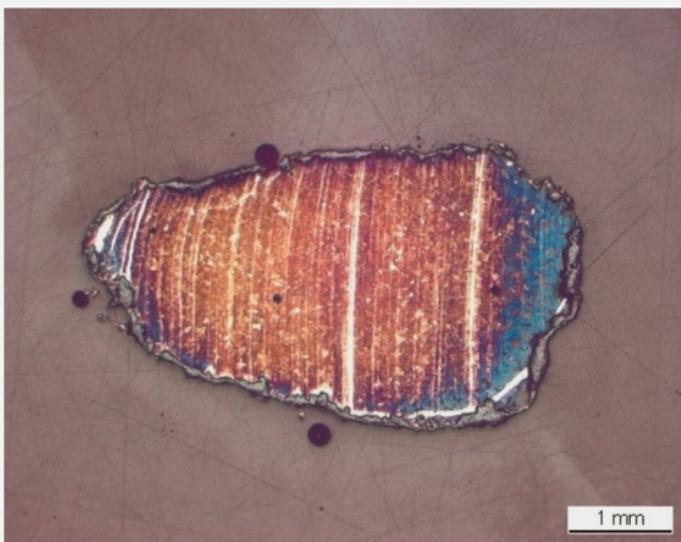
Fig. 6: Micrograph of the metal sample from Fig. 3, etched with Oberhoffer's reagent, bright field. We observe three P-rich welding seams in white,

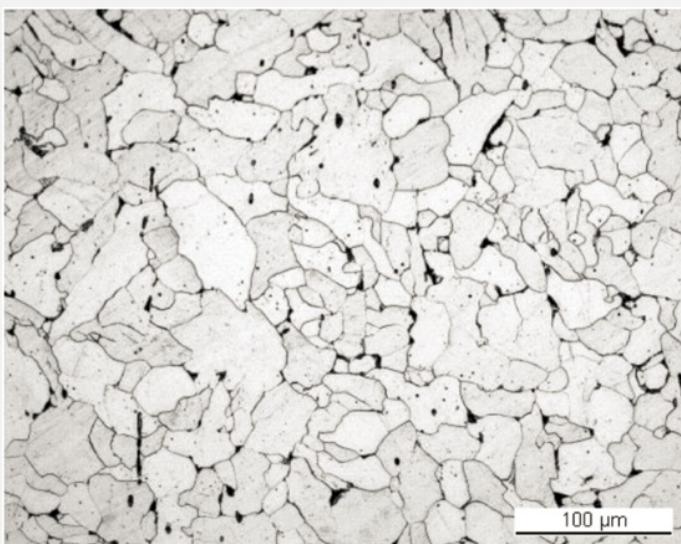
Fig. 7: Micrograph of the metal sample, nital etched, bright field. We observe tertiary cementite (black) on the grain boundaries,

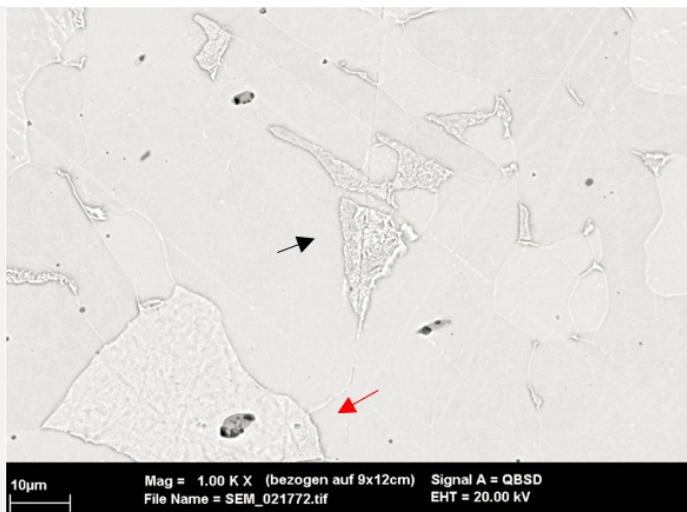
Fig. 8: SEM image of the metal sample from Fig. 3 (detail), BSE-mode, nital etched, bright field. The white ferrite grains contain lamellar pearlite (black arrow) and lenticular grey MnS inclusions (red arrow) in between the grain boundaries.

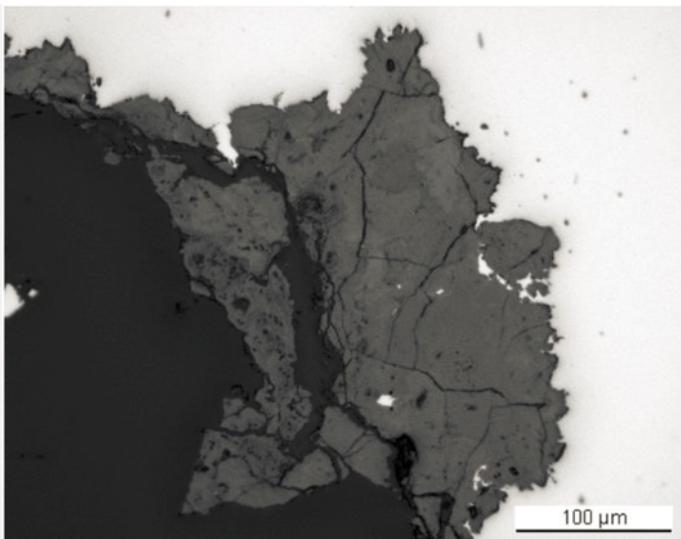
The average thickness of the corrosion products is about 80µm (Figs. 5 and 9). In bright field they appear grey, marbled and heavily cracked (Fig. 9). Under polarised light, the corrosion products appear orange to dark-brown (Fig. 10). At the metal - corrosion products interface they are dark-brown (CP3). The middle part (CP2) is red-orange and the outer part is bright orange (CP1). The elemental mapping of the corrosion layers shows no distinctive stratification, but areas near the metal - corrosion crust interface (CP3) as well as the top surface of the corrosion layer (CP1) seem to have a lower O content (Fig. 11). The O content indicates the presence of iron hydroxides (Table 3). Soil materials (such as rock fragments and dust) are found in the welding seams near the surface.

Fig. 9: Micrograph showing the metal - corrosion crust interface from Fig. 3 (rotated by 270°, detail), unetched, bright field. We observe in white the metal, in grey the corrosion products and in black the resin,

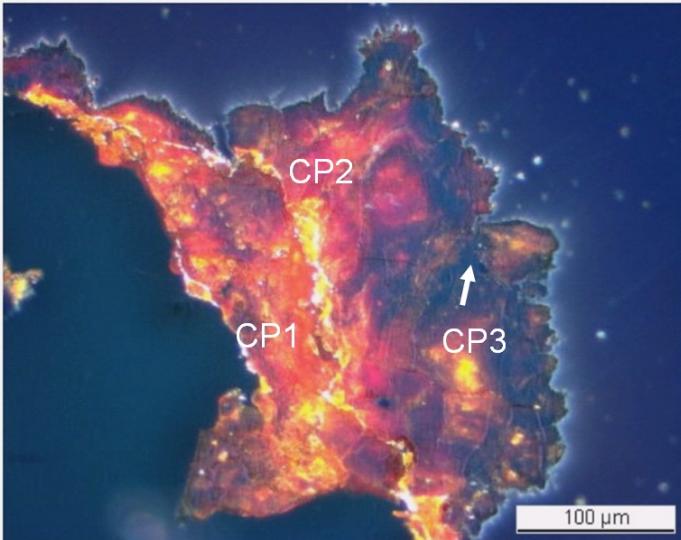
Fig. 10: Micrograph (same as Fig. 9) and corresponding to the stratigraphy of Fig. 4, unetched, polarised light. The corrosion products are dark-brown at the metal - corrosion crust interface and red-orange on the outside,

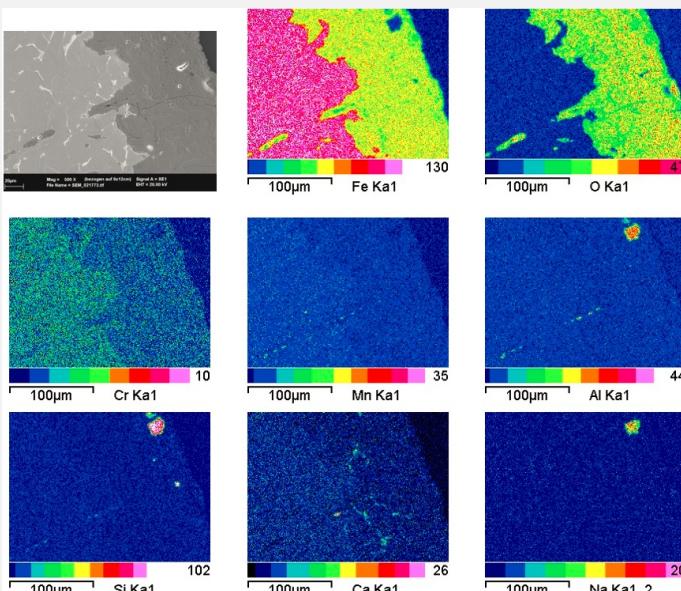
Table 3: Chemical composition (mass %) of the corrosion layer (from Fig. 11). Method of analysis: SEM/EDS, Laboratory of Analytical Chemistry, Empa.

Fig. 11: SEM image, BSE-mode, and elemental chemical distribution of the selected area from Fig. 5 (rotated by 270°, detail). Method of examination: SEM/EDS, Laboratory of Analytical Chemistry, Empa.

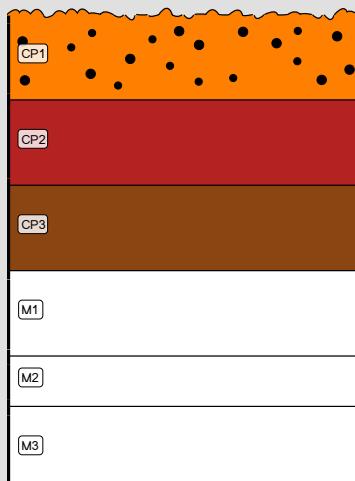
Fig. 4: Stratigraphic representation of the object in cross-section using the MiCorr application. This representation showing for the metal part a welding seam (M2) can be compared to Fig. 10, Credit HE-Arc CR.
