FITTING ON BACK PANEL OF A MILITARY CARRIAGE – THOMAS STEEL – MODERN TIMES – SWITZERLAND

Artefact name Fitting on back panel of a military carriage

Authors Marianne. Senn (EMPA, Dübendorf, Zurich, Switzerland) & Christian. Degriigny (HE-Arc CR, Neuchâtel, Neuchâtel, Switzerland)

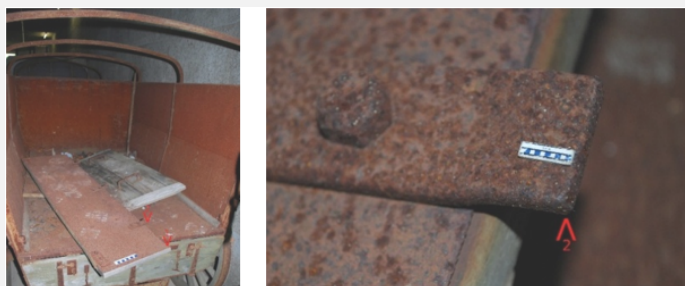
Fig. 1: Steel fitting on back panel of a military carriage (©Tarchini),

Description of the artefact	Fitting on back panel, first exposed outdoors, later indoors (Fig. 1). Uniform corrosion and pitting corrosion are visible.
Type of artefact	Military carriage
Origin	Swiss Army, Thun, Bern, Switzerland
Recovering date	Built by Konstruktions-Werkstätte, 1918
Chronology category	Modern Times
chronology tpq	<input type="text" value="1918"/> A.D. ▾
chronology taq	<input type="text" value=""/> ---- ▾
Chronology comment	1918
Burial conditions / environment	Outdoor to indoor atmosphere
Artefact location	Historical Swiss Army Material Foundation, Burgdorf, Bern
Owner	Historical Swiss Army Material Foundation, Burgdorf, Bern
Inv. number	n.a.
Recorded conservation data	Not conserved

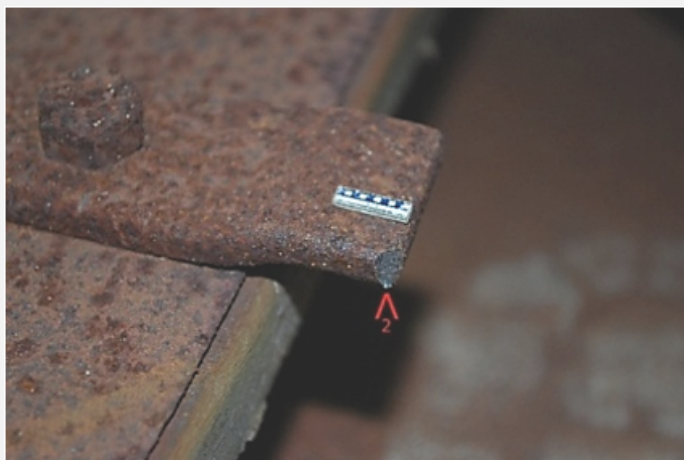
Fig. 2: Location of sampling area,

This sample is a cut from the corner of one of the two fittings on the back panel (Fig. 2). The metal is covered by a thin corrosion layer (Fig. 3).

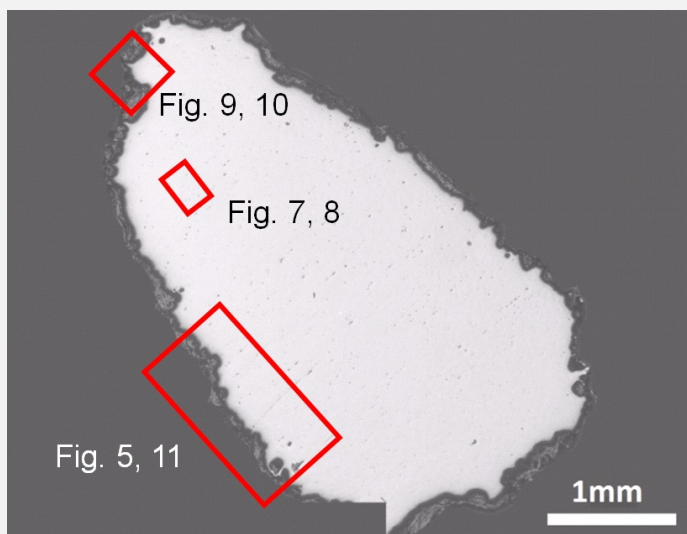
Fig. 3: Micrograph of the cross-section showing the location of Figs. 5 and 7 to 11,

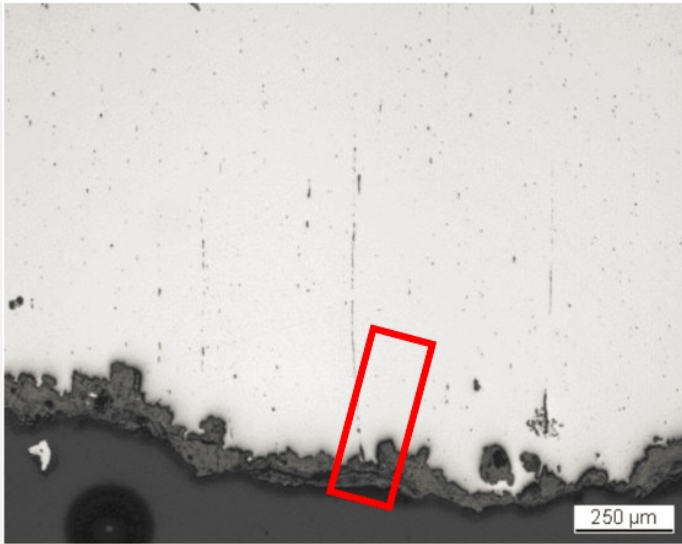
The remaining metal is a Mn-rich soft steel (C content around 0.1 mass%) containing manganese sulphide inclusions with a varying Fe content (Tables 1 and 2). The numerous inclusions form parallel rows (Fig. 5). This orientation is typical for hot rolled metal. After etching with Oberhoffer's reagent, three main welding seams (P-rich) become visible (Fig. 6). Near the surface they are also outlined by corrosion (Figs. 5 and 11). After nital etching, the metal shows a ferritic structure with tertiary cementite and lamellar pearlite at the grain boundaries (Figs. 7 and 8). The grains are small with an ASTM grain size of 10 and are recrystallized due to annealing after hot rolling. The average hardness of the metal is HV1 165. The hardness is slightly high for such a structure and this is due to the Mn content of the metal. The chemical composition, especially the Mn content and the presence of carbo-nitrides (not analysed here), is typical for Thomas steel.

Fig. 5: Micrograph of the metal sample from Fig. 3 (rotated by 270°, detail), unetched, bright field. We observe the metal including welding seams outlined by corrosion products and MnS inclusions. The mapped area of Fig. 11 is marked by the rectangle,

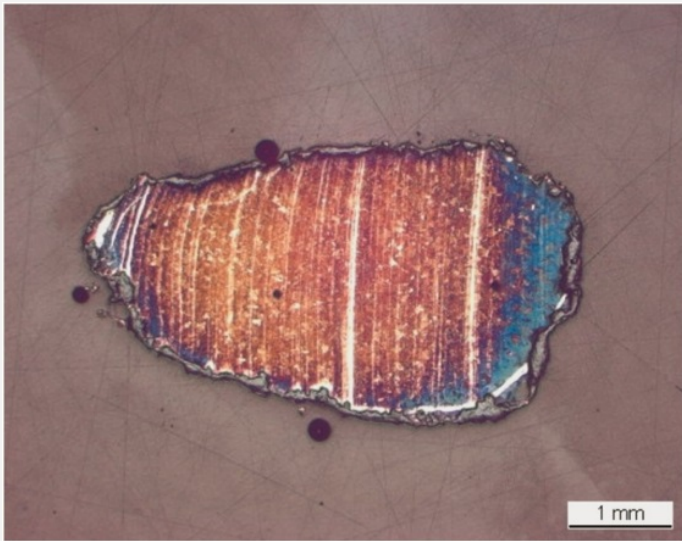
Fig. 6: Micrograph of the metal sample from Fig. 3, etched with Oberhoffer's reagent, bright field. We observe three P-rich welding seams in white,

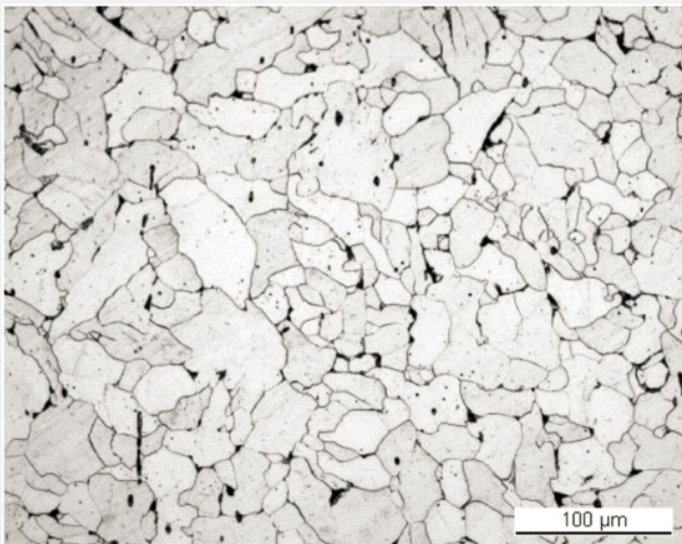
Fig. 7: Micrograph of the metal sample, nital etched, bright field. We observe tertiary cementite (black) on the grain boundaries,

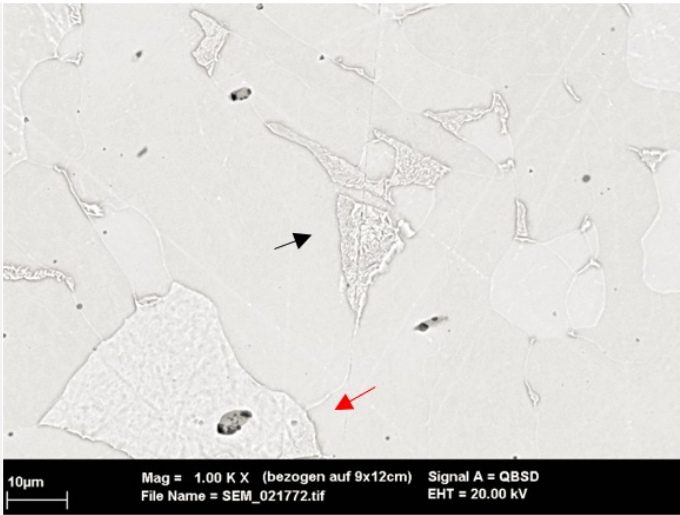
Fig. 8: SEM image of the metal sample from Fig. 3 (detail), BSE-mode, nital etched, bright field. The white ferrite grains contain lamellar pearlite (black arrow) and lenticular grey MnS inclusions (red arrow) in between the grain boundaries,

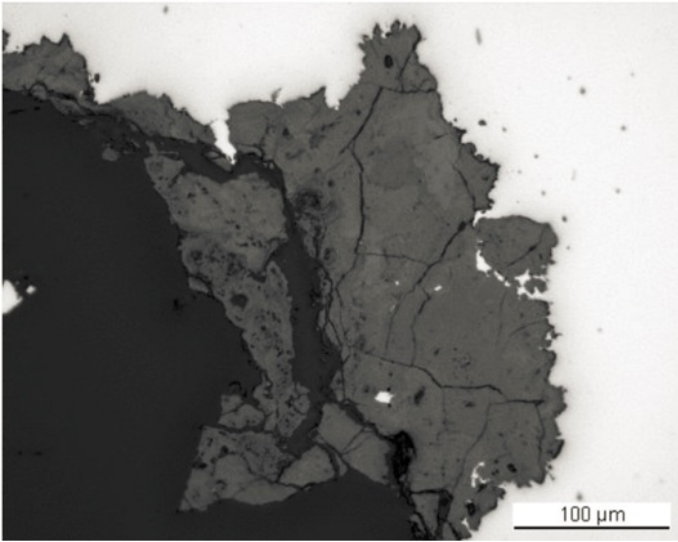
The average thickness of the corrosion products is about 80µm (Figs. 5 and 9). In bright field they appear grey, marbled and heavily cracked (Fig. 9). Under polarised light, the corrosion products appear orange to dark-brown (Fig. 10). At the metal - corrosion products interface they are dark-brown (CP3). The middle part (CP2) is red-orange and the outer part is bright orange (CP1). The elemental mapping of the corrosion layers shows no distinctive stratification, but areas near the metal - corrosion crust interface (CP3) as well as the top surface of the corrosion layer (CP1) seem to have a lower O content (Fig. 11). The O content indicates the presence of iron hydroxides (Table 3). Soil materials (such as rock fragments and dust) are found in the welding seams near the surface.

Fig. 9: Micrograph showing the metal - corrosion crust interface from Fig. 3 (rotated by 270°, detail), unetched, bright field. We observe in white the metal, in grey the corrosion products and in black the resin,

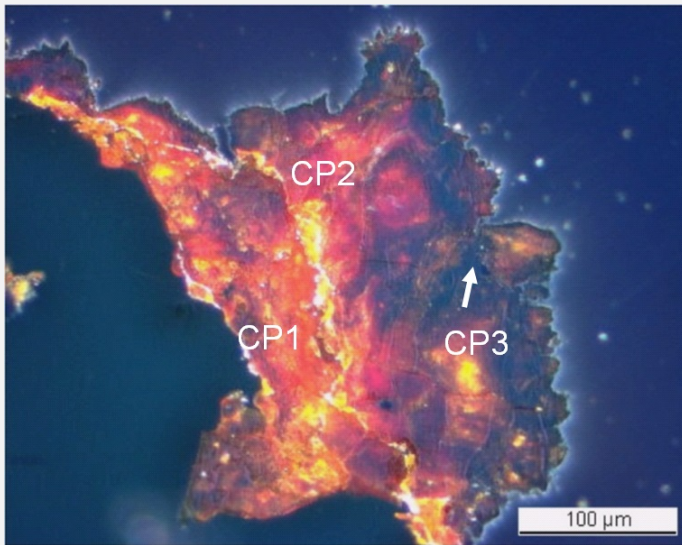
Fig. 10: Micrograph (same as Fig. 9) and corresponding to the stratigraphy of Fig. 4, unetched, polarised light. The corrosion products are dark-brown at the metal - corrosion crust interface and red-orange on the outside,

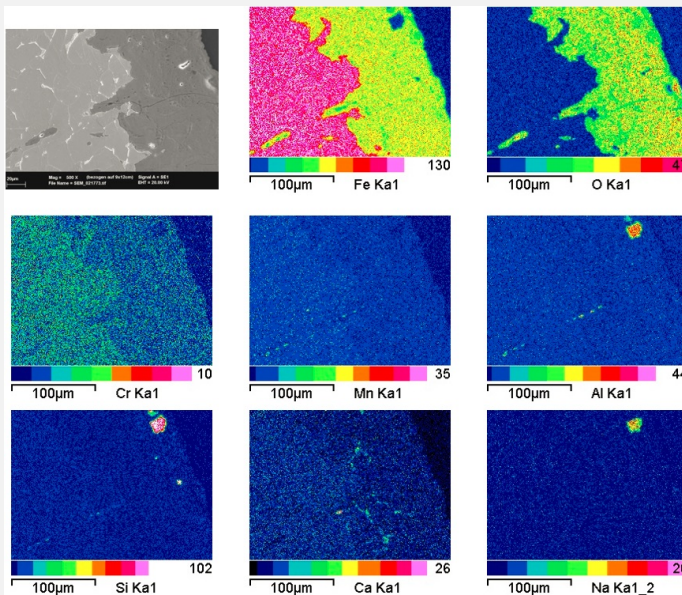
Table 3: Chemical composition (mass %) of the corrosion layer (from Fig. 11). Method of analysis: SEM/EDS, Laboratory of Analytical Chemistry, Empa.

Fig. 11: SEM image, BSE-mode, and elemental chemical distribution of the selected area from Fig. 5 (rotated by 270°, detail). Method of examination: SEM/EDS, Laboratory of Analytical Chemistry, Empa.

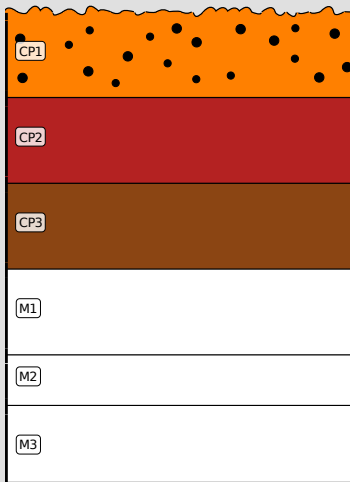
Fig. 4: Stratigraphic representation of the object in cross-section using the MiCorr application. This representation showing for the metal part a welding seam (M2) can be compared to Fig. 10, Credit HE-Arc CR.
