Artefact name Corroded metal sheet FN 655.13.01

Authors Marianne. Senn (EMPA, Dübendorf, Zurich, Switzerland) & Christian. Degrigny (HE-Arc CR, Neuchâtel, Neuchâtel, Switzerland)

Description of the artefact Iron sheet with middle rib. The shape is no longer discernible (Fig. 1). The metal is covered by a thick corrosion crust. Dimensions: L = 4.5cm; WT = 35g.

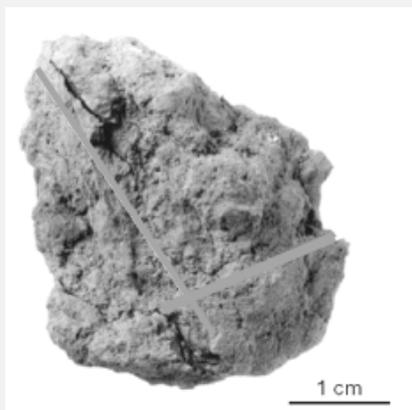
Fig. 1: Iron (and steel) sheet (after Senn Bischofberger 2005, 137),

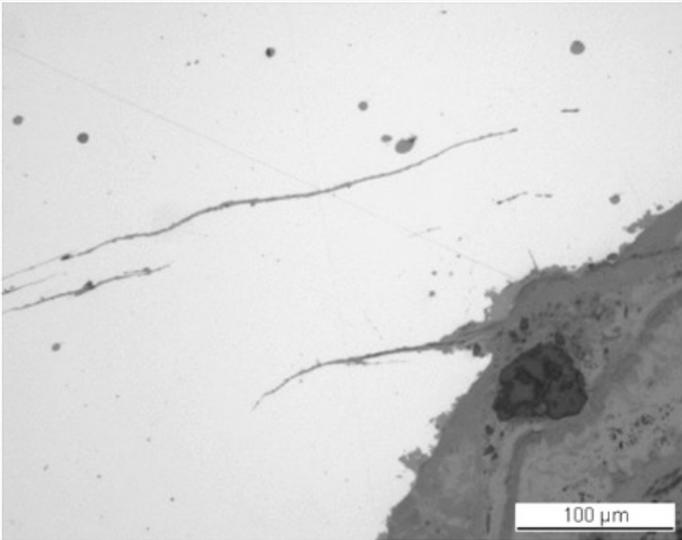
The remaining metal is an iron containing elevated (more than 1g/kg) concentrations of Co and Ni (Table 1), small round slag inclusions and cracks resulting from corrosion and deformation (Fig. 5). The composition of the round, elongated slag inclusions is similar to wüstite-FeO (Table 2). Iron reduced in the direct smelting process never contains such pure compounds and only FeO inclusions. In modern steels FeO occurs in low carbon alloys and Armco-iron (Schumann 1991, 474). After etching, the cross-section shows a heavily deformed ferritic microstructure from cold working (Fig. 6). The cracks have the same orientation as the deformation. The average hardness of the metal is HV1 195.

Fig. 5: Micrograph of metal sample from Fig. 3 (inverted picture, detail), unetched, bright field. In white the metal with round slag inclusions as well as cracks filled with corrosion products,

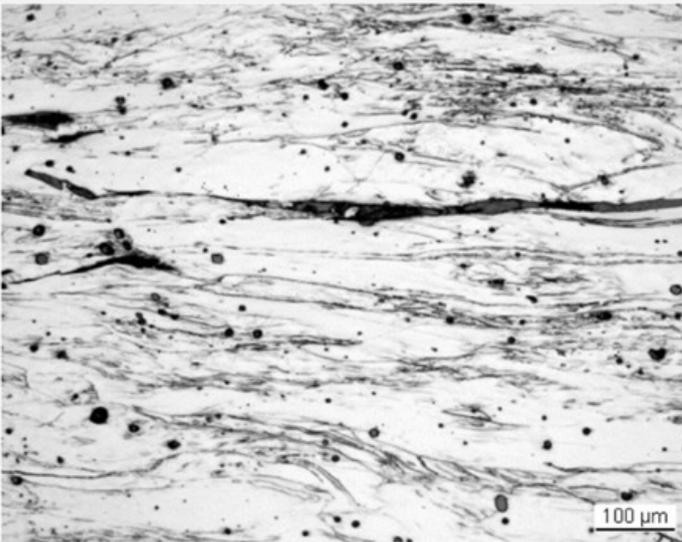
Fig. 6: Micrograph of metal sample from Fig. 3 (detail), etched, bright field. The heavily cold worked metal shows elongated grains with nearly invisible grain boundaries and cracks parallel to the grains,

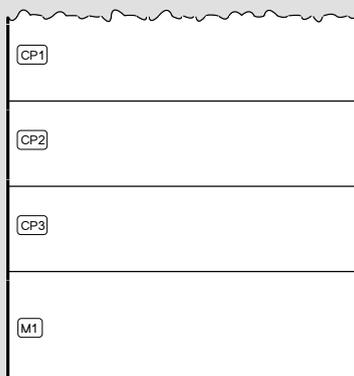
Fig. 4: Stratigraphic representation of the object in cross-section using the MiCorr application. This representation can be compared to Figs. 7 and 8, Credit HE-Arc CR.

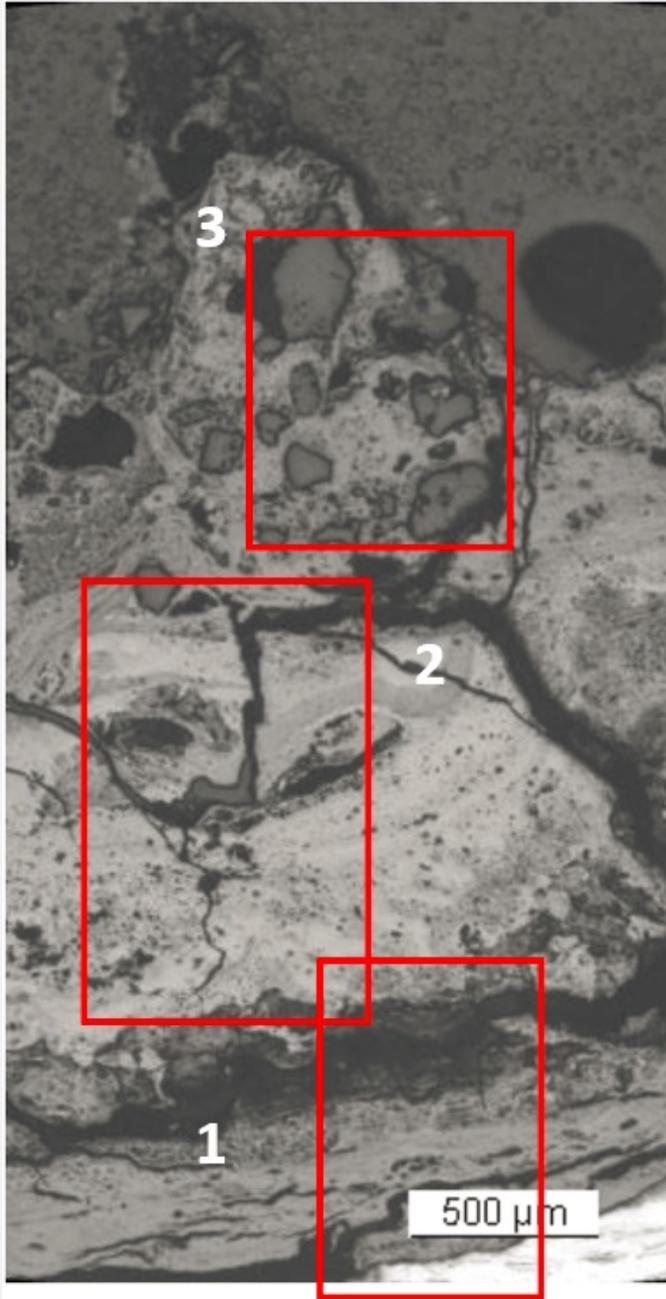
(the rest having been lost during the cutting process). It does not show well defined layers. Despite this, three areas can be distinguished (Figs. 7 and 8). Adhering to the metal (area 1), we find an orange-red-brown layer enriched in Cl (CP3 in Fig. 4, Fig. 9 and Table 3). The dark or violet middle area 2 is richer in Fe (CP2 in Fig. 4). The outer area 3 is red-brown (CP1 in Fig. 4) and strongly contaminated by soil material (rock fragment inclusion and elements like Si, Al, P etc.). This layer is enriched in O (Fig. 9).

Fig. 7: Micrograph of the corrosion layer from Fig. 3 showing the metal - corrosion crust interface (detail, rotated by 45°) and corresponding to the stratigraphy of Fig. 4, unetched, bright field. Areas 1 (inner layer, CP3) to 3 (outer layer, CP1) are indicated,
