CORRODED METAL SHEET FN 655.13.01 - FE ALLOY - MODERN TIMES - SWITZERLAND

Artefact name Corroded metal sheet FN 655.13.01

Authors Marianne. Senn (EMPA, Dübendorf, Zurich, Switzerland) & Christian. Degrigny (HE-Arc CR, Neuchâtel, Neuchâtel,

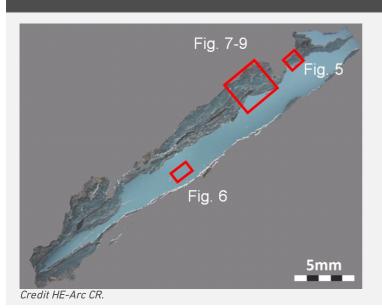
Fig. 3: Micrograph of the cross-section showing the location of Figs. 5 to 9.

Description of sampleA longitudinal cut has been made through the sheet (Fig. 2). Large parts of the corrosion crust fell off

during sampling (Fig. 3).

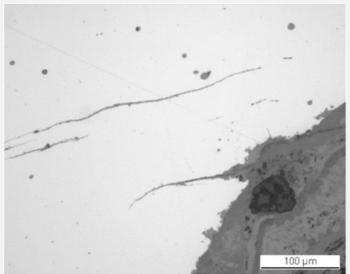
The remaining metal is an iron containing elevated (more than 1g/kg) concentrations of Co and Ni (Table 1), small round slag inclusions and cracks resulting from corrosion and deformation (Fig. 5). The composition of the round, elongated slag inclusions is similar to wüstite-FeO (Table 2). Iron reduced in the direct smelting process never contains such pure compounds and only FeO inclusions. In modern steels FeO occurs in low carbon alloys and Armco-iron (Schumann 1991, 474). After etching, the cross-section shows a heavily deformed ferritic microstructure from cold working (Fig. 6). The cracks have the same orientation as the deformation. The average hardness of the metal is HV1 195.

Fig. 5: Micrograph of metal sample from Fig. 3 (inverted picture, detail), unetched, bright field. In white the metal with round slag inclusions as well as cracks filled with corrosion products,

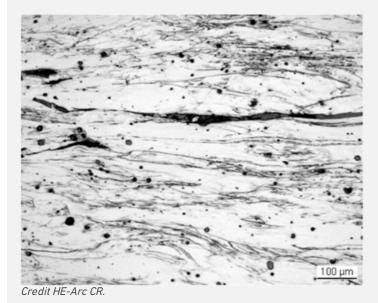
Fig. 6: Micrograph of metal sample from Fig. 3 (detail), etched, bright field. The heavily cold worked metal shows elongated grains with nearly invisible grain boundaries and cracks parallel to the grains,

Microstructure Heavily deformed ferritic microstructure

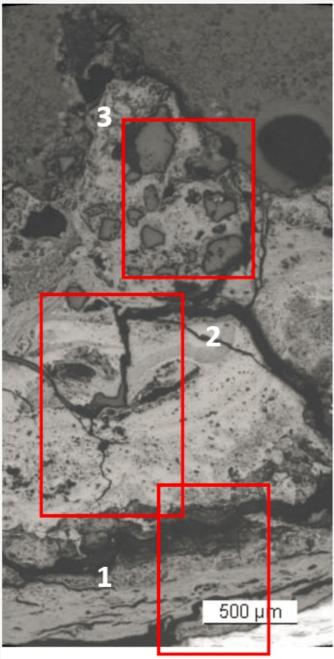
The corrosion is massive and large parts of the outer corrosion layers have been lost during the sample preparation. The heavily cracked corrosion crust represents about one third of the thickness of the sample (Fig. 3) and is located on one side of the metal (the rest having been lost during the cutting process). It does not show well defined layers. Despite this, three areas can be distinguished (Figs. 7 and 8). Adhering to the metal (area 1), we find an orange-red-brown layer enriched in Cl (CP3 in Fig. 4, Fig. 9 and Table 3). The dark or violet middle area 2 is richer in Fe (CP2 in Fig. 4). The outer area 3 is red-brown (CP1 in Fig. 4) and strongly contaminated by soil material (rock fragment inclusion and elements like Si, Al, P etc.). This layer is enriched in O (Fig. 9).

Fig. 7: Micrograph of the corrosion layer from Fig. 3 showing the metal - corrosion crust interface (detail, rotated by 45°) and corresponding to the stratigraphy of Fig. 4, unetched, bright field. Areas 1 (inner layer, CP3) to 3 (outer layer, CP1) are indicated,

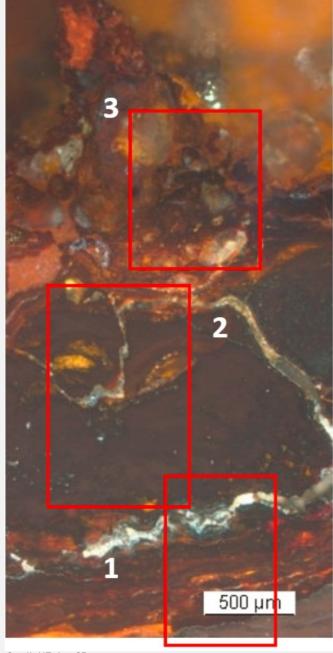
Fig. 8: Micrograph (same as Fig.7) and corresponding to the stratigraphy of Fig. 4, polarised light. The inner layer (CP3) is redbrown, area 2 is brown-violet (CP2) and the outer pale brown area contains rock fragment inclusions (CP1),

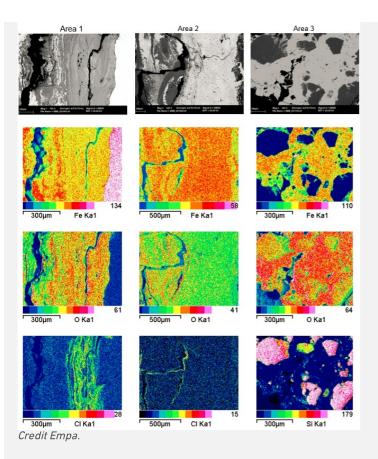
Fig. 9: SEM images, BSE-mode, and elemental chemical distribution of the selected areas from Fig. 8 (reversed picture rotated by 270°, details). First column: mapping on area 1 (CP3) where an inner layer enriched in Cl appears near the metal surface. 2nd column: area 2 (CP2) where iron oxides prevail. 3rd column: area 3 (CP1) where the outer 0-rich layer includes rock fragments rich in Si. Method of examination: SEM/EDS, Lab. Anal. Chem. Empa,

This iron sheet is entirely cold worked and hard compared to an annealed metal. The corrosion is massive and masks the shape of the object. The presence of Cl adjacent to the metal surface indicates that the corrosion front is potentially active. The very thick top corrosion layers may have slowed down the corrosion. The object was mentioned as being Roman in Senn Bischofberger 2005, however the chemical composition of the slag inclusions shows that it is a product of the 20th century AD which has been accidentally introduced into a Roman layer.
