CORRODED METAL SHEET FN 655.13.01 – FE ALLOY – MODERN TIMES – SWITZERLAND

Artefact name Corroded metal sheet FN 655.13.01

Authors Marianne. Senn (EMPA, Dübendorf, Zurich, Switzerland) & Christian. Degriigny (HE-Arc CR, Neuchâtel, Neuchâtel, Switzerland)

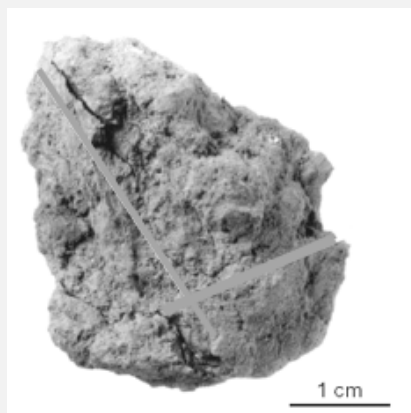
Fig. 1: Iron (and steel) sheet (after Senn Bischofberger 2005, 137),

| Description of the artefact | Iron sheet with middle rib. The shape is no longer discernible (Fig. 1). The metal is covered by a thick corrosion crust. Dimensions: L = 4.5cm; WT = 35g. |

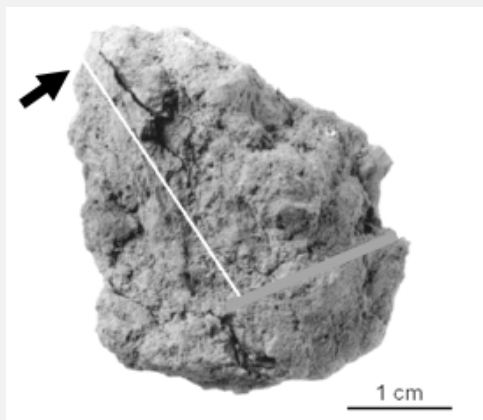
Fig. 2: Location of sampling area,

| Description of sample | A longitudinal cut has been made through the sheet (Fig. 2). Large parts of the corrosion crust fell off during sampling (Fig. 3). |

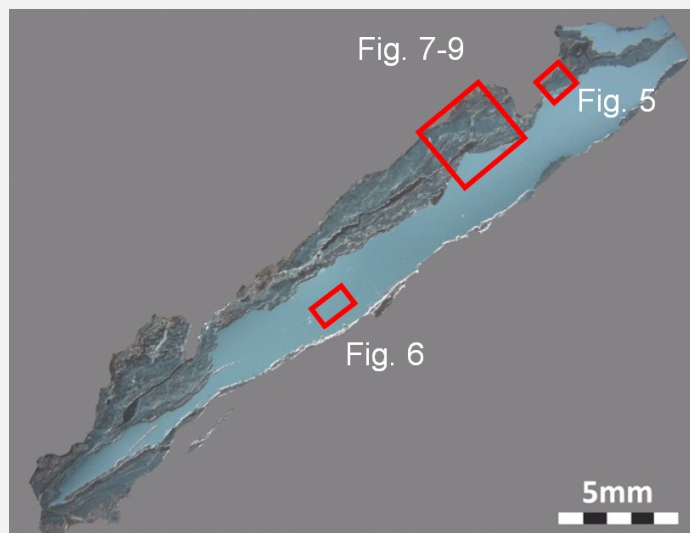
Fig. 3: Micrograph of the cross-section showing the location of Figs. 5 to 9,

The corrosion is massive and large parts of the outer corrosion layers have been lost during the sample preparation. The heavily cracked corrosion crust represents about one third of the thickness of the sample (Fig. 3) and is located on one side of the metal

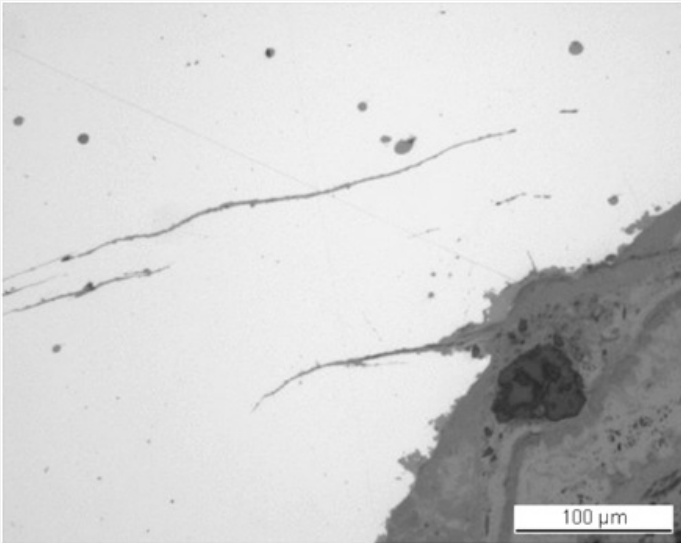
The remaining metal is an iron containing elevated (more than 1g/kg) concentrations of Co and Ni (Table 1), small round slag inclusions and cracks resulting from corrosion and deformation (Fig. 5). The composition of the round, elongated slag inclusions is similar to wüstite-FeO (Table 2). Iron reduced in the direct smelting process never contains such pure compounds and only FeO inclusions. In modern steels FeO occurs in low carbon alloys and Armco-iron (Schumann 1991, 474). After etching, the cross-section shows a heavily deformed ferritic microstructure from cold working (Fig. 6). The cracks have the same orientation as the deformation. The average hardness of the metal is HV1 195.

Fig. 5: Micrograph of metal sample from Fig. 3 (inverted picture, detail), unetched, bright field. In white the metal with round slag inclusions as well as cracks filled with corrosion products,

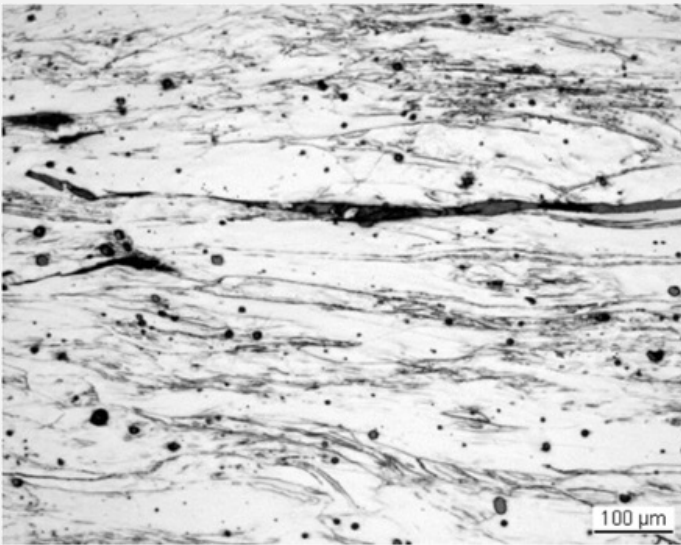
Fig. 6: Micrograph of metal sample from Fig. 3 (detail), etched, bright field. The heavily cold worked metal shows elongated grains with nearly invisible grain boundaries and cracks parallel to the grains,

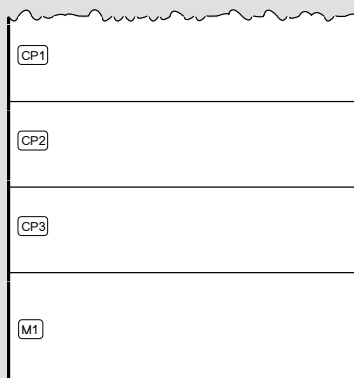
Fig. 4: Stratigraphic representation of the object in cross-section using the MiCorr application. This representation can be compared to Figs. 7 and 8, Credit HE-Arc CR.

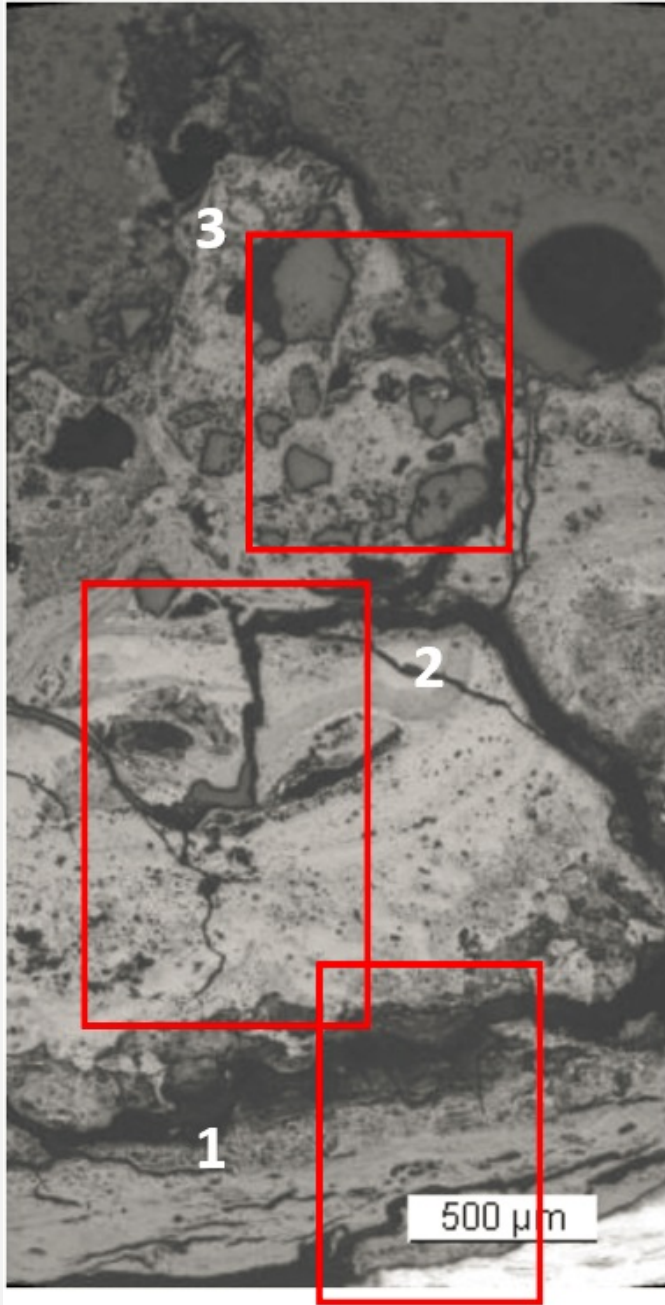
(the rest having been lost during the cutting process). It does not show well defined layers. Despite this, three areas can be distinguished (Figs. 7 and 8). Adhering to the metal (area 1), we find an orange-red-brown layer enriched in Cl (CP3 in Fig. 4, Fig. 9 and Table 3). The dark or violet middle area 2 is richer in Fe (CP2 in Fig. 4). The outer area 3 is red-brown (CP1 in Fig. 4) and strongly contaminated by soil material (rock fragment inclusion and elements like Si, Al, P etc.). This layer is enriched in O (Fig. 9).

Fig. 7: Micrograph of the corrosion layer from Fig. 3 showing the metal - corrosion crust interface (detail, rotated by 45°) and corresponding to the stratigraphy of Fig. 4, unetched, bright field. Areas 1 (inner layer, CP3) to 3 (outer layer, CP1) are indicated,

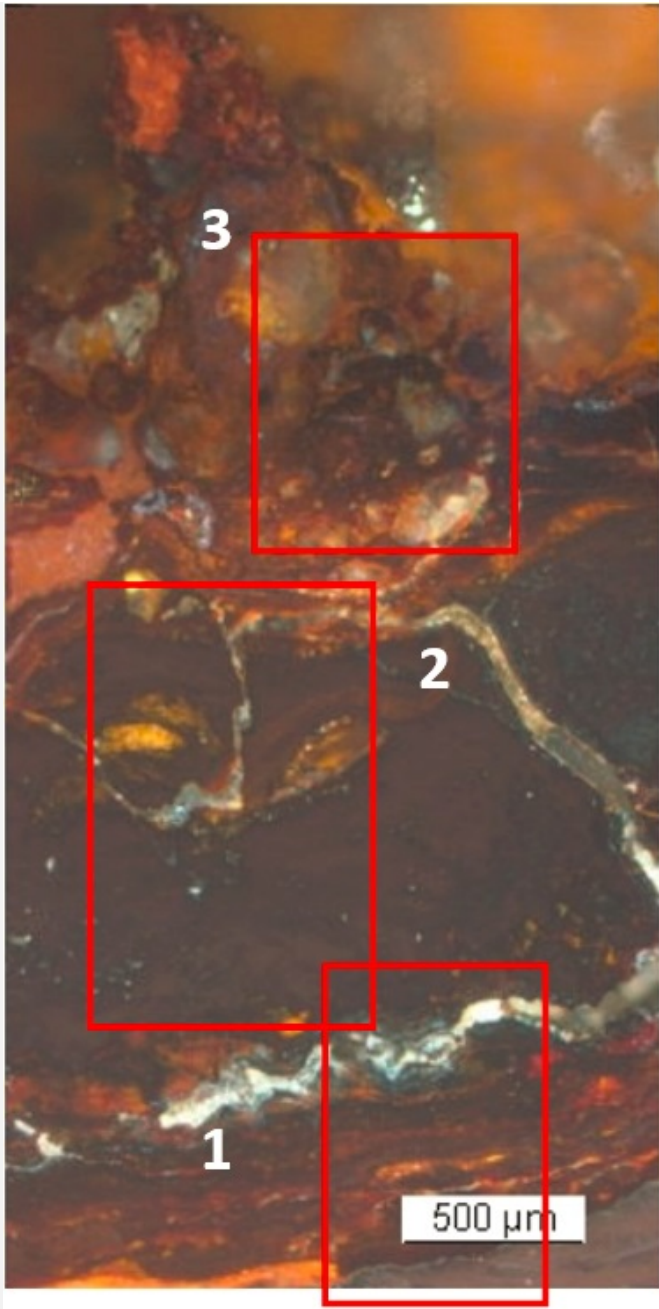
Fig. 8: Micrograph (same as Fig.7) and corresponding to the stratigraphy of Fig. 4, polarised light. The inner layer (CP3) is red-brown, area 2 is brown-violet (CP2) and the outer pale brown area contains rock fragment inclusions (CP1),

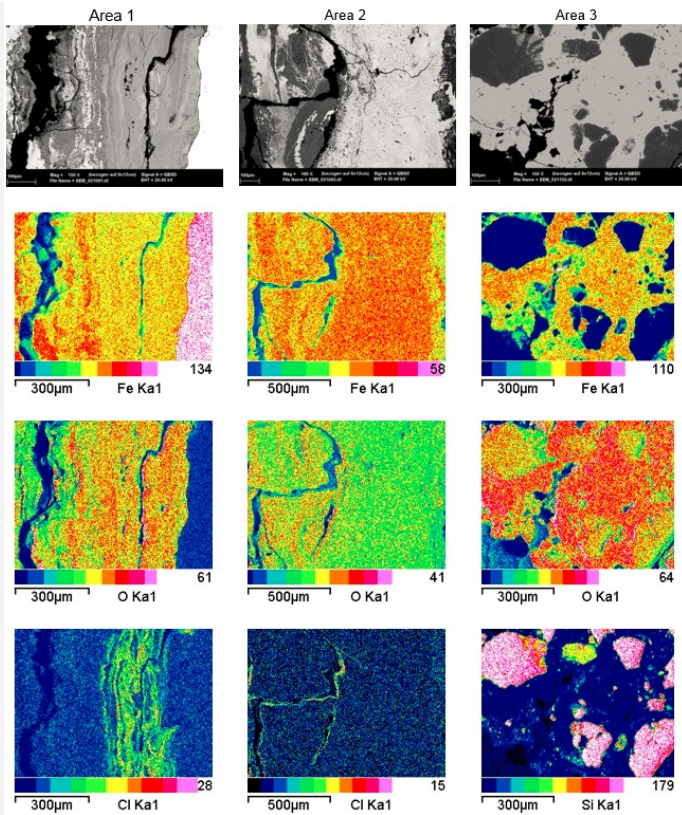
Fig. 9: SEM images, BSE-mode, and elemental chemical distribution of the selected areas from Fig. 8 (reversed picture rotated by 270°, details). First column: mapping on area 1 (CP3) where an inner layer enriched in Cl appears near the metal surface. 2nd column: area 2 (CP2) where iron oxides prevail. 3rd column: area 3 (CP1) where the outer O-rich layer includes rock fragments rich in Si. Method of examination: SEM/EDS, Lab. Anal. Chem. Empa,
