# CORRODED METAL SHEET FN 655.13.01 – FE ALLOY – MODERN TIMES – SWITZERLAND

Artefact name	Corroded metal sheet FN 655.13.01
Authors	Marianne. Senn (EMPA, Dübendorf, Zurich, Switzerland) & Christian. Degriigny (HE-Arc CR, Neuchâtel, Neuchâtel, Switzerland)
Url	/artefacts/375/

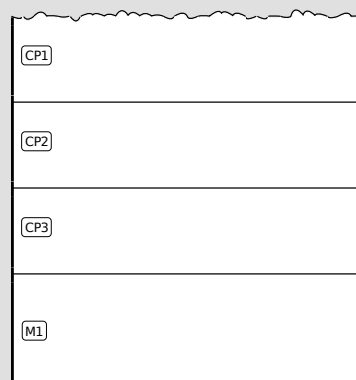
Fig. 4: Stratigraphic representation of the object in cross-section using the MiCorr application. This representation can be compared to Figs. 7 and 8, Credit HE-Arc CR.
