TANG FRAGMENT OF A KNIFE HR-6567 - LEADED BRONZE - LATE BRONZE AGE - SWITZERLAND

Artefact name Tang fragment of a knife HR-6567

Authors Marianne. Senn (EMPA, Dübendorf, Zurich, Switzerland) & Christian. Degrigny (HE-Arc CR, Neuchâtel, Neuchâtel,

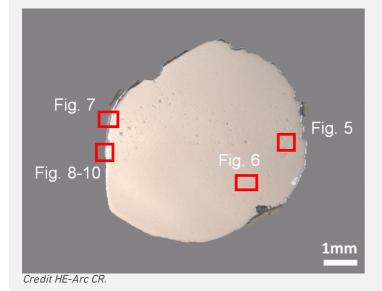
Fig. 3: Micrograph of the cross-section showing the location of Figs. 5 to 10, $\,$

This cross-section shows a lateral cut through the tang (Fig. 2). Most of the corrosion crust is absent (Fig. 3).

The metal has lost most of its original corrosion crust, the remainder having an average thickness between 60 and 190 μ m (Fig. 3). In some areas up to three corrosion layers are visible (Fig. 8). In polarised light (Fig. 9), the corrosion stratigraphy appears more clearly: it is composed of a dense black inner layer, an intermediate thick brown layer with bright spots (indicating porosity) and an outer red layer with white particles. The elemental chemical distribution of the SEM image reveals that the black inner layer (CP3) is Sn-rich, but contains Cu, O, Fe, Si, P, Pb, Ni, As, Ca and S (Table 3, Fig. 10). The brown layer (CP2) contains S, Fe and Cu and has a composition similar to chalcopyrite/CuFeS $_2$ (Table 3, Fig. 10). This was confirmed by past XRD analyses carried out by Schweizer (1994, museum report (1987)). The red layer (CP1) is an iron oxide (main elements Fe and 0) and is contaminated with calcite/CaCO $_3$ particles (Table 3, Fig. 10).

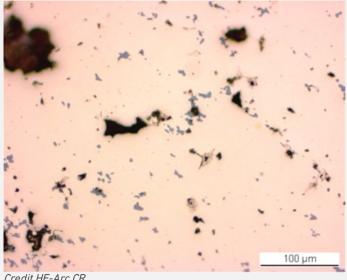
The remaining metal is a leaded bronze (Table 1) containing numerous copper sulphide and tiny Pb inclusions (Figs. 5-7, 10 and Table 2). The porosity within the metal is high, particularly along a band through the middle of the sample (Figs. 3 and 5). The etched structure of the leaded bronze shows small, regular polygonal grains, some with twinning (Fig. 6). Strain lines appear in grains close to the metal surface (Fig. 7). The average hardness of the metal is HV1 120.

Fig. 5: Micrograph of the metal sample from Fig. 3 (detail), unetched, bright field. In pink the metal, in black the porosity and in dark-grey copper sulphide inclusions,

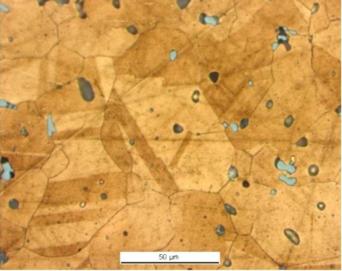
Fig. 6: Micrograph of the metal sample from Fig. 3 (detail), etched, bright field. Angular and twinned grains are revealed as well as copper sulphide inclusions in grey,

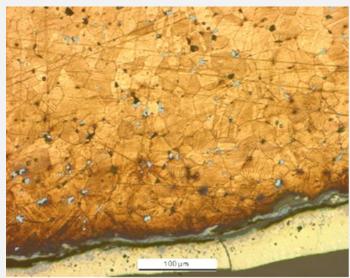
Fig. 7: Micrograph of the metal sample from Fig. 3, etched, bright field (rotated by 270° , detail). Angular grains with strain lines can be seen as well as copper sulphide inclusions in grey,

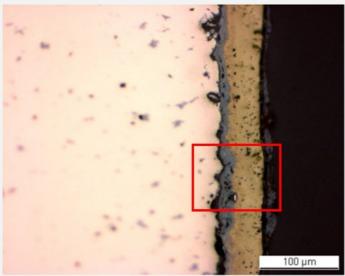
Fig. 8: Micrograph of the metal sample from Fig. 3 (reversed picture, detail), unetched, bright field. From left to right: metal (in pink), inner light-grey layer, intermediate brown layer and top dark-grey layer. The mapped area of Fig. 10 is marked by a square,

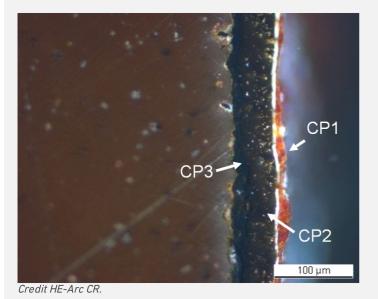
Fig. 9: Micrograph of the same area as Fig. 8 and corresponding to the stratigraphy of Fig. 4, polarized light. From left to right: metal (in brown) covered with a corrosion crust consisting of a black layer, an intermediate brown layer with bright spots, a crack (white line) and a red layer with white particles,

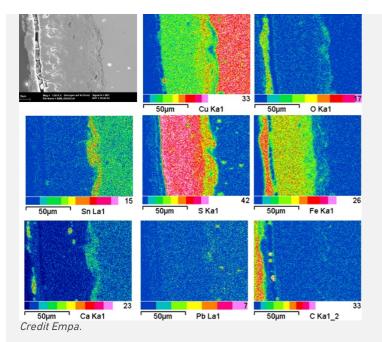
Fig. 10: SEM image, SE-mode, and elemental chemical distribution of the selected area of Fig. 7 (reversed picture). Method of examination: SEM/EDS, Laboratory of Analytical Chemistry, Empa,
