SITULA EMT09-554.665 – TIN BRONZE – IRON AGE – SWITZERLAND

Artefact name	Situla EMT09-554.665
Authors	Christian. Degriigny (HE-Arc CR, Neuchâtel, Neuchâtel, Switzerland) & Marie-Jeanne. Scholl (HE-Arc CR, Neuchâtel, Neuchâtel, Switzerland) & Valentin. Boissonnas (HE-Arc CR, Neuchâtel, Neuchâtel, Switzerland)
Url	/artefacts/382/

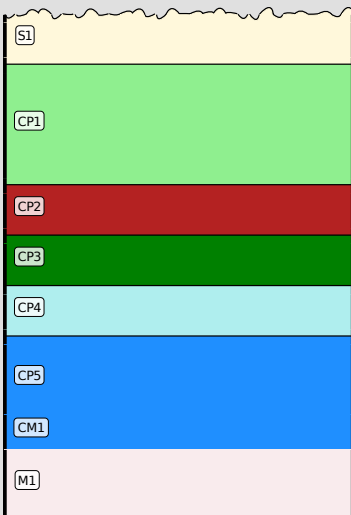
Fig. 6: Stratigraphic representation of the object in cross-section using the MiCorr application. This representation shows the interior face and can be compared to Fig. 10 (top square), Credit HE-Arc CR, M-J.Scholl.

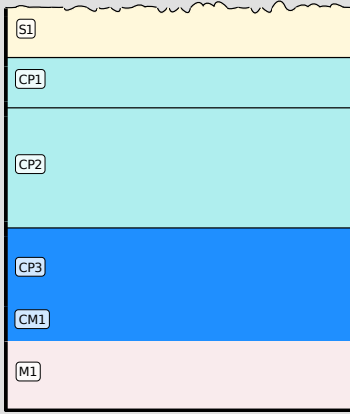
Fig. 5: Stratigraphic representation of the object in cross-section using the MiCorr application. This representation shows the exterior face and can be compared to Fig. 10 (bottom square), Credit HE-Arc CR, M-J.Scholl.
