SITULA EMT09-554.665 – TIN BRONZE – IRON AGE – SWITZERLAND

Artefact name	Situla EMT09-554.665
Authors	Christian. Degrigny (HE-Arc CR, Neuchâtel, Neuchâtel, Switzerland) & Marie-Jeanne. Scholl (HE-Arc CR, Neuchâtel, Neuchâtel, Switzerland) & Valentin. Boissonnas (HE-Arc CR, Neuchâtel, Neuchâtel, Switzerland)
Url	/artefacts/382/

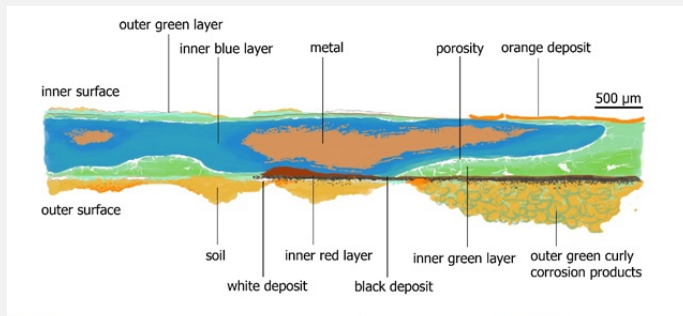
Fig. 16: Improved stratigraphic representation of the situla from visual observations and analyses,

Strata	Composition
Soil (S)	Ca, Si, Al, Fe
Black deposit (D1)	C
Orange deposit (D2)	Ferrous oxides
White deposit (D3)	Ca
Outer green curly corrosion product (CP1e)	Copper carbonates (curly malachite)
Inner red (CP2i)	Copper oxide (cuprite ?)
Outer green layer (CP3i)	Copper carbonates (malachite)
Inner green layer (CP4i)	Copper carbonates (?) + Sn
Inner blue layer (CP5i)	Copper carbonates (?) + Sn
Remnant metal phase (M)	Bronze (90%Cu, 10% Sn)
