SITULA EMT09-554.665 – TIN BRONZE – IRON AGE – SWITZERLAND

Artefact name	Situla EMT09-554.665
Authors	Christian. Degriigny (HE-Arc CR, Neuchâtel, Neuchâtel, Switzerland) & Marie-Jeanne. Scholl (HE-Arc CR, Neuchâtel, Neuchâtel, Switzerland) & Valentin. Boissonnas (HE-Arc CR, Neuchâtel, Neuchâtel, Switzerland)
Url	/artefacts/382/

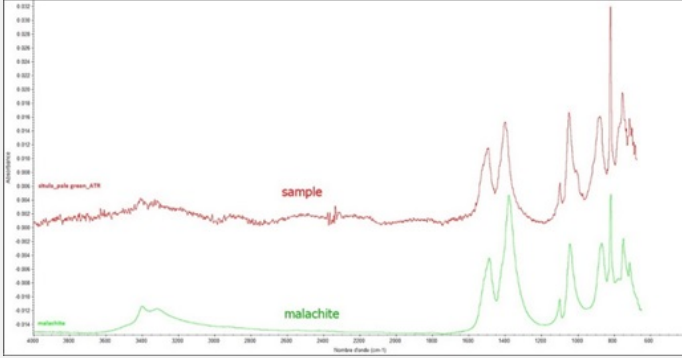
Fig. 15: FTIR spectrum (ATR mode) of the outer green layer compared to the malachite standard spectrum. Method of analysis: FTIR spectroscopy, HE-Arc CR.,

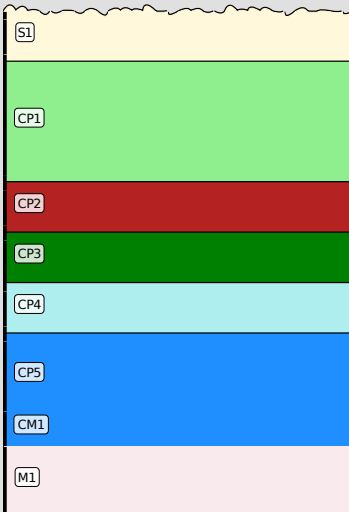
Fig. 6: Stratigraphic representation of the object in cross-section using the MiCorr application. This representation shows the interior face and can be compared to Fig. 10 (top square), Credit HE-Arc CR, M-J.Scholl.

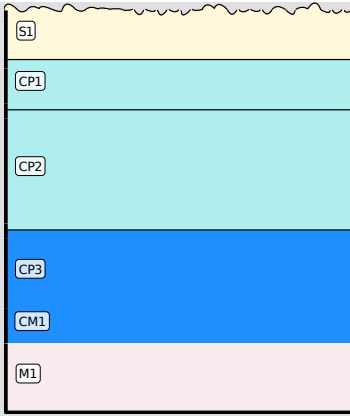
Fig. 5: Stratigraphic representation of the object in cross-section using the MiCorr application. This representation shows the exterior face and can be compared to Fig. 10 (bottom square), Credit HE-Arc CR, M-J.Scholl.
