SHOE NAIL 2637 1370.B. – HYPOEUTECTOID STEEL – ROMAN TIMES – SWITZERLAND

Artefact name Shoe nail 2637 1370.B.

Authors Christian. Degrigny (HE-Arc CR, Neuchâtel, Neuchâtel, Switzerland) & Valentin. Boissonnas (HE-Arc CR, Neuchâtel, Neuchâtel, Switzerland) & Vincent Chappuis. (HE-Arc CR, Neuchâtel, Neuchâtel, Switzerland)

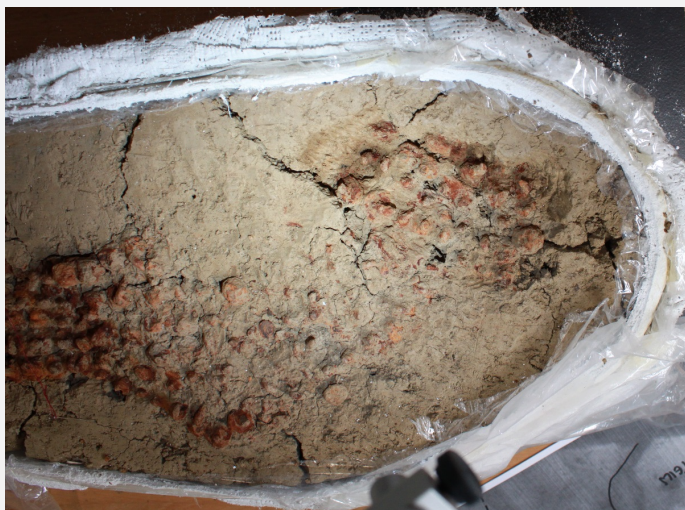
Fig. 1: The block-lifted object before conservation.

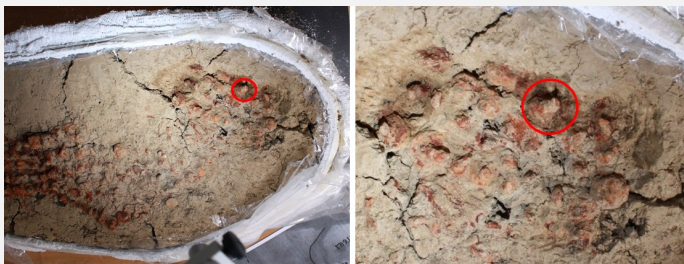
Fig. 2: Incomplete shoe from which the nail was sampled (in red circle),

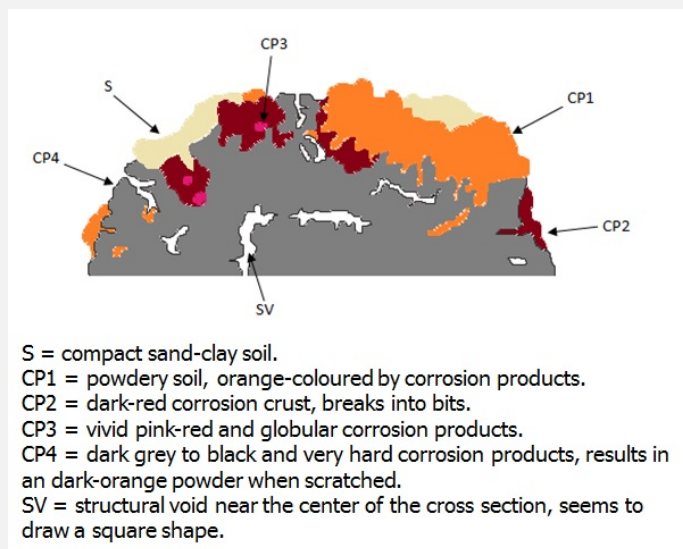
Fig. 3: Preliminary stratigraphy based on the observation of a broken nail,

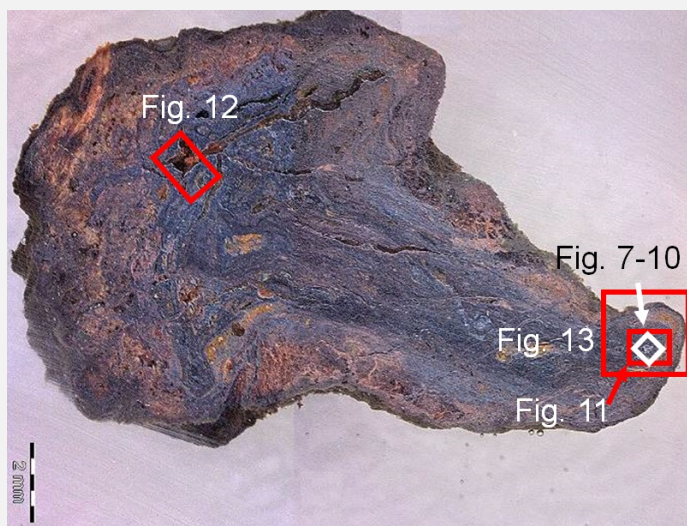
Fig. 4: Micrograph of the cross-section showing the location of figs. 7 to 13,

The metal is heavily corroded and the thickness of the corrosion crust is irregular, varying from 0.8 to 3.8mm, with an average of about 2mm. The corrosion has replaced most of the metal (Fig. 4). Between corrosion layers the limit of the original structure is visible. Some leather fibers seem to be preserved as pseudomorphic structures in voids of the metal core (POM1, Figs. 11 and 12). The carbon mapping (Fig.13) shows the presence of carbon in these areas. This can also be due to the penetration of the mounting resin in the cracks.

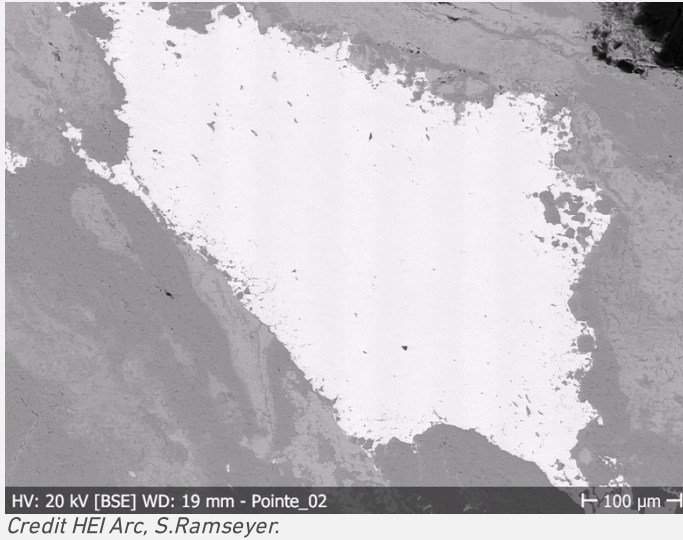
The remaining metal is an hypoeutectoid steel (Fig. 7 and 8), containing Fe, Si and O slags inclusions (possibly fayalite FeO, SiO_2), and consisting of less than 1% of the total volume of the highly mineralized nail. After Nital etching, it shows intergranular corrosion on one of its sides (Figs. 9 and 10).

Fig. 7: SEM, BSE-mode picture of remaining metal,

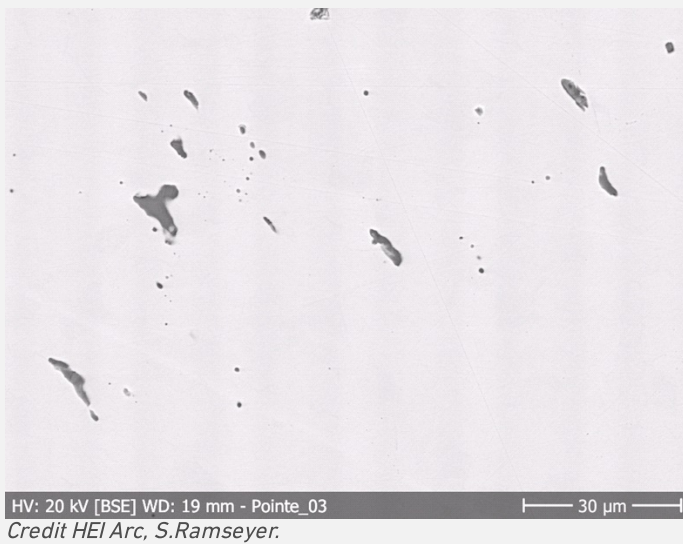
Fig. 8: SEM, BSE-mode picture of inclusions in remaining metal,

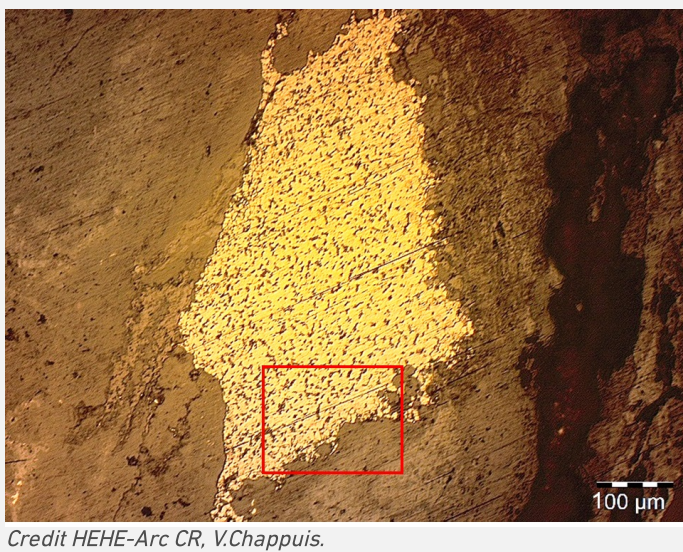
Fig. 9: Micrograph of the metal sample from Fig. 7 (detail, rotated 90°), Nital etched, bright field,

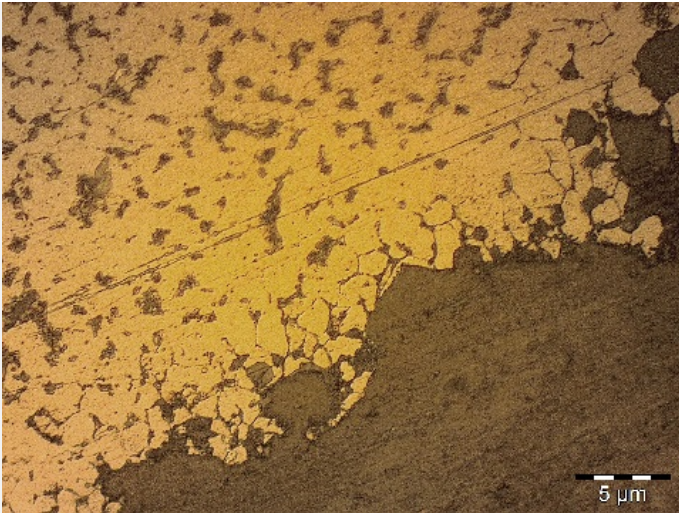
Fig. 10: Micrograph of the selected area of Fig. 9, Nital etched with no clear grain structure, bright field, Intergranular corrosion and grey phase (perlite?) are observed,

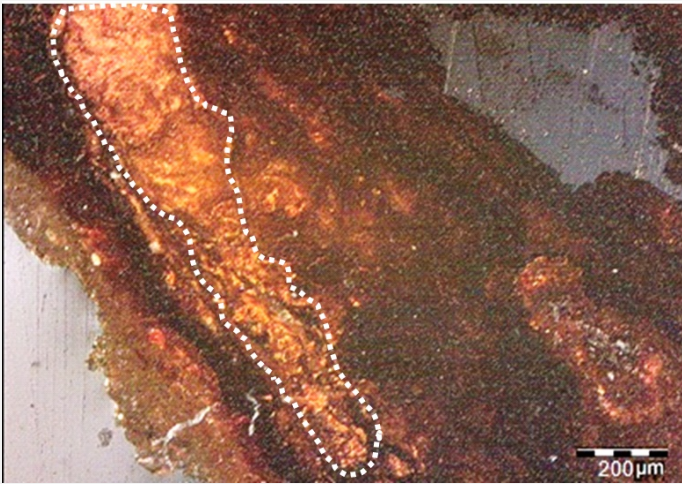
Fig. 11: Micrograph of the metal sample, bright field. The delimited zone shows what could be leather pseudomorphic fibers filling a void,

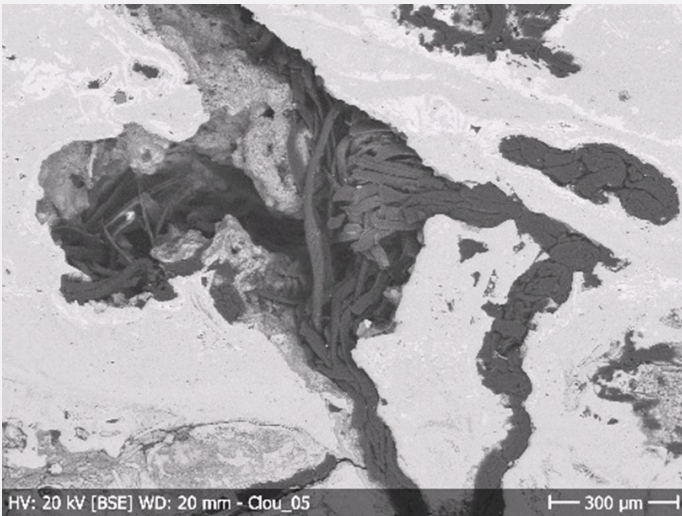
Fig. 12: Micrograph (SEM - BSE-mode) of another void filled with fibers in the head of the nail,

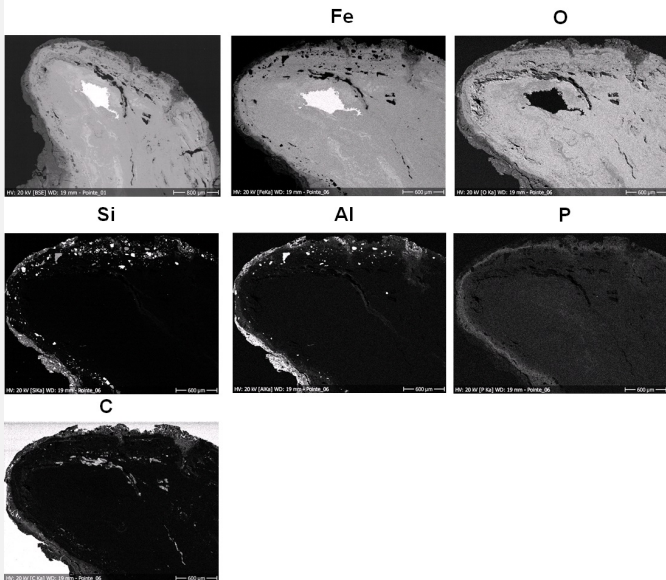
Si, Al, P and K can be considered external markers, helping to determine the limit of the original surface (Fig. 13 and Table 1). The outer layer of corrosion products (CP1-3) ranges from dark grey to orange in bright field and contains less O and Fe on its borders than the inner layer (CP4-5, Figs. 4 and 13, Table 1). The SEM pictures show a marbling appearance of the inner corrosion layer (CP5). Cl and S do not seem to be present in the sampled nail.

Fig. 13: Elemental chemical distribution of the selected area from Fig. 4 (90° counter-clockwise rotated). SEM-EDS,

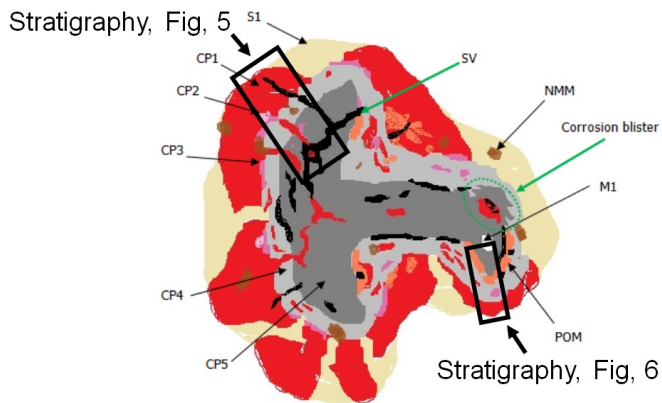
Based on the analyses carried out, the schematic representation of the [stratigraphy](#) of corrosion layers was corrected (Fig. 14). The following strata were identified:

Fig. 14: Improved stratigraphic representation of the nail from visual observations and analyses and visualization of the two stratigraphies of Figs, 5 and 6,
