SHOE NAIL 2637 1370.B. – HYPOEUTECTOID STEEL – ROMAN TIMES – SWITZERLAND

Artefact name Shoe nail 2637 1370.B.

Authors Christian. Degrigny (HE-Arc CR, Neuchâtel, Neuchâtel, Switzerland) & Valentin. Boissonnas (HE-Arc CR, Neuchâtel, Neuchâtel, Switzerland) & Vincent Chappuis. (HE-Arc CR, Neuchâtel, Neuchâtel, Switzerland)

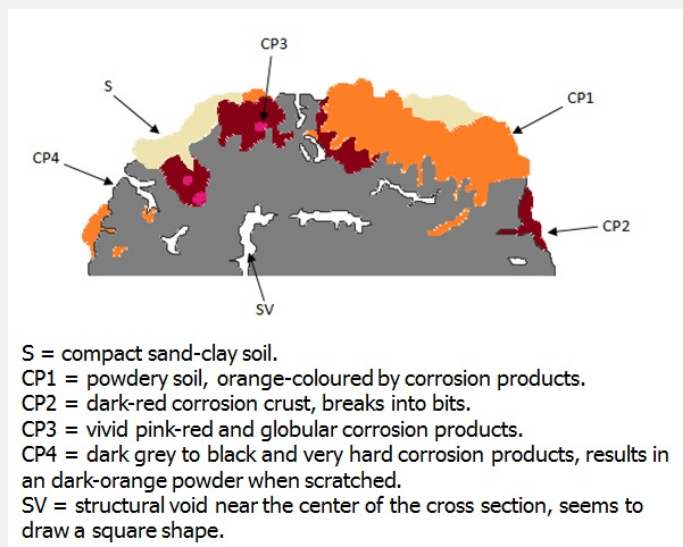
Fig. 3: Preliminary stratigraphy based on the observation of a broken nail,

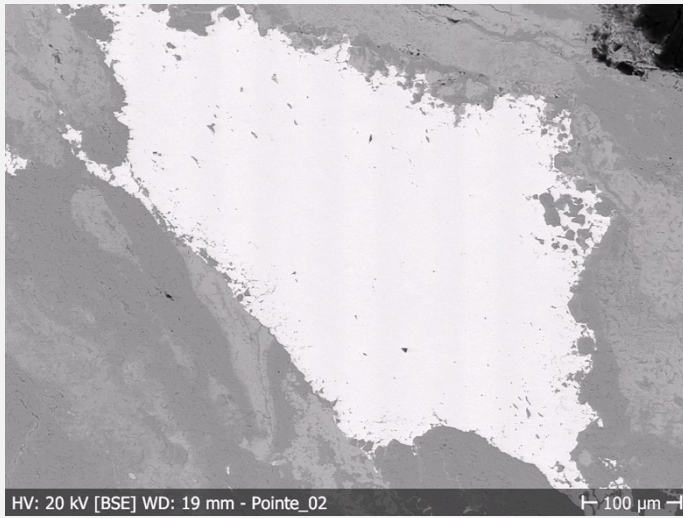
The remaining metal is an hypoeutectoid steel (Fig. 7 and 8), containing Fe, Si and O slags inclusions (possibly fayalite FeO, SiO_2), and consisting of less than 1% of the total volume of the highly mineralized nail. After Nital etching, it shows intergranular corrosion on one of its sides (Figs. 9 and 10).

Fig. 7: SEM, BSE-mode picture of remaining metal,

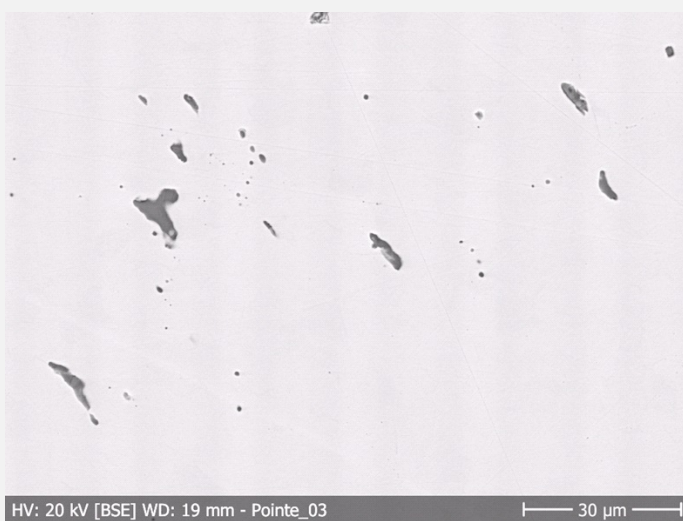
Fig. 8: SEM, BSE-mode picture of inclusions in remaining metal,

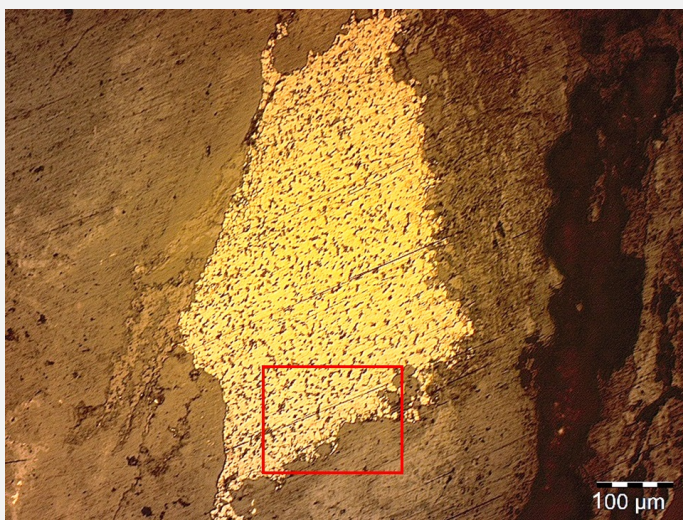
Fig. 9: Micrograph of the metal sample from Fig. 7 (detail, rotated 90°), Nital etched, bright field,

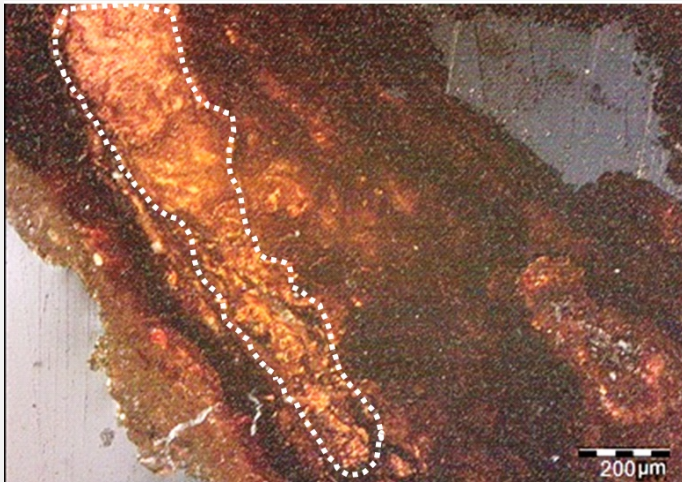
Fig. 11: Micrograph of the metal sample, bright field. The delimited zone shows what could be leather pseudomorphic fibers filling a void,

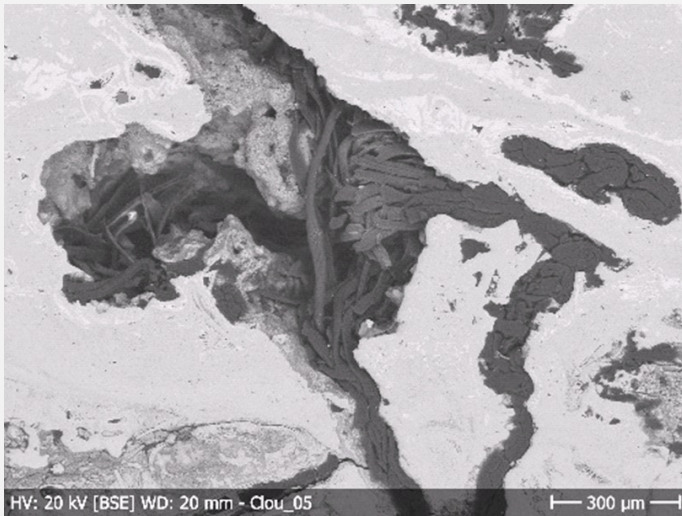
Fig. 12: Micrograph (SEM - BSE-mode) of another void filled with fibers in the head of the nail,

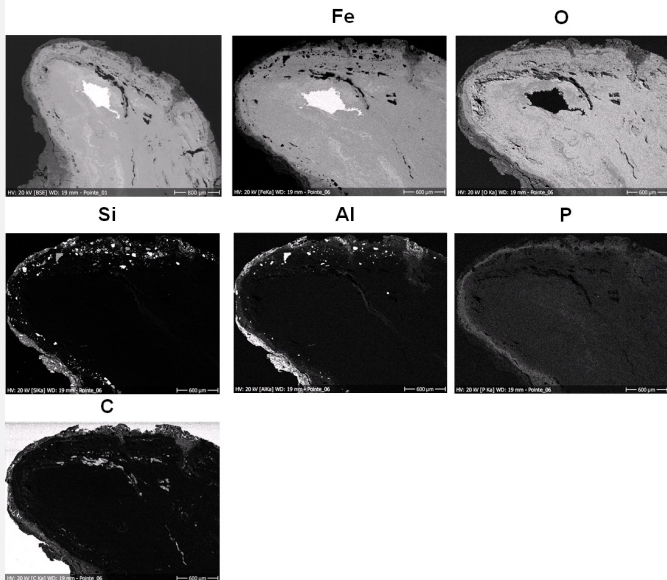
Si, Al, P and K can be considered external markers, helping to determine the limit of the original surface (Fig. 13 and Table 1). The outer layer of corrosion products (CP1-3) ranges from dark grey to orange in bright field and contains less O and Fe on its borders than the inner layer (CP4-5, Figs. 4 and 13, Table 1). The SEM pictures show a marbling appearance of the inner corrosion layer (CP5). Cl and S do not seem to be present in the sampled nail.

Fig. 13: Elemental chemical distribution of the selected area from Fig. 4 (90° counter-clockwise rotated). SEM-EDS,

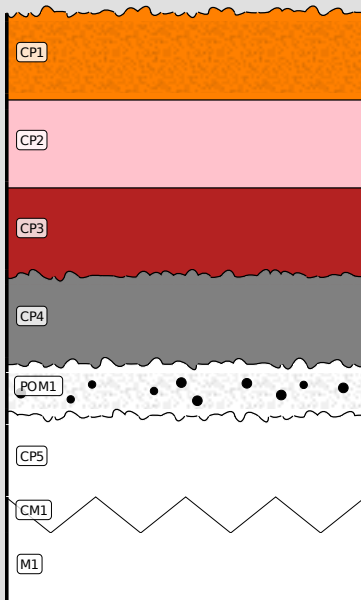
Fig. 6: Stratigraphic representation of the object in cross-section using the MiCorr application. This representation can be compared to Fig. 14, Credit HE-Arc CR, V.Chappuis.

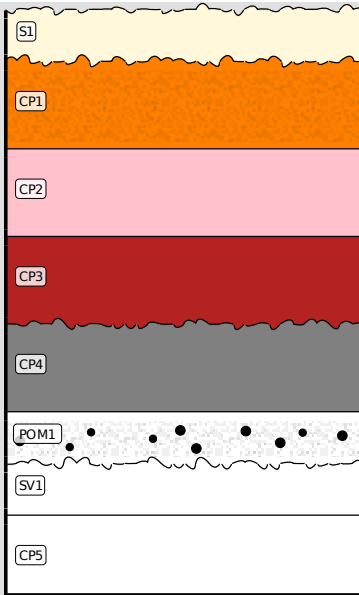
Fig. 5: Stratigraphic representation of the object in cross-section using the MiCorr application. This representation can be compared to Fig. 14, Credit HE-Arc CR, V.Chappuis.

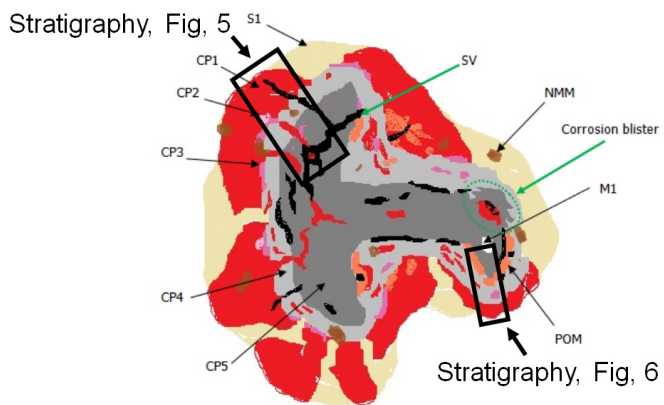
Based on the analyses carried out, the schematic representation of the [stratigraphy](#) of corrosion layers was corrected (Fig. 14). The following strata were identified:

Fig. 14: Improved stratigraphic representation of the nail from visual observations and analyses and visualization of the two stratigraphies of Figs, 5 and 6,
