# ARMATURE FROM A CLOCK MOVEMENT MIH IV-212 – ZN AL SN CU ALLOY – MODERN TIMES

<b>Artefact name</b>	Armature from a clock movement MIH IV-212
<b>Authors</b>	Marianne. Senn (EMPA, Dübendorf, Zurich, Switzerland) & Christian. Degrigny (HE-Arc CR, Neuchâtel, Neuchâtel, Switzerland)
<b>Url</b>	/artefacts/388/

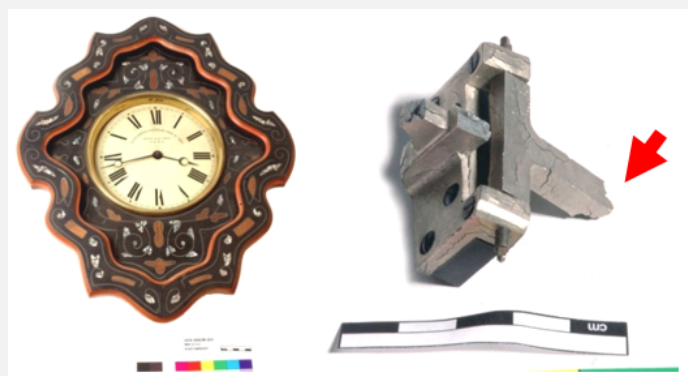
Fig. 1: Wooden wall clock, zinc alloy armature from the clock movement (after Seematter 2009),

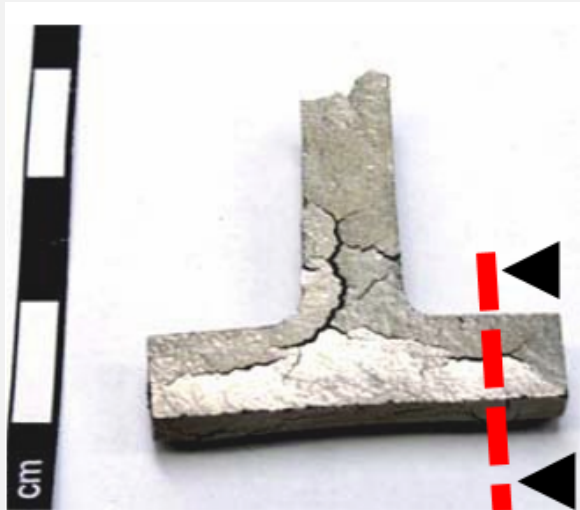
Fig. 2: Location of sampling area.

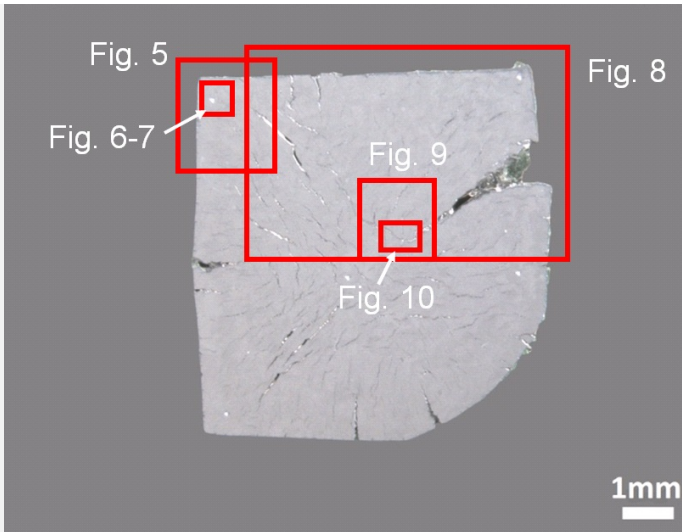
Fig. 3: Micrograph of the cross-section showing the location of Figs. 5 to 10,

<b>Description of sample</b>	This sample is the complete cross-section from an element of the armature (Fig. 2). The metal has huge cracks radiating from the centre to the outside which have deformed the armature (Fig. 3). The metal is covered with a Ni coating.
<b>Alloy</b>	Zn Al Sn Cu Alloy
<b>Technology</b>	As-cast
<b>Lab number of sample</b>	MIH-VI-212
<b>Sample location</b>	HE-Arc CR, Neuchâtel, Neuchâtel
<b>Responsible institution</b>	International museum of horology (IMH), La Chaux-de-Fonds, Neuchâtel
<b>Date and aim of sampling</b>	2009, metal analysis

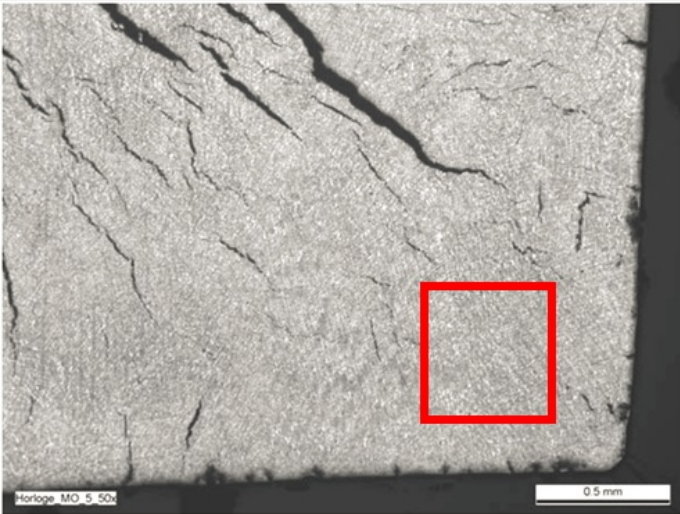
The metal is a Zn-Al-Sn-Cu alloy (Table 1) with an average hardness of HV1 105. A fine dendritic structure is observed (Fig. 5) which consists of clearly separated Zn, Al-Cu and Sn-rich phases (Figs. 6 and 7). Pb is associated with Sn but also forms tiny nodules.

Fig. 5: Micrograph of the metal sample from Fig. 3 (inverted picture, rotated by 270°, detail), unetched, bright field. A dendritic structure is visible. The micrograph of Fig. 6 is marked by a square,

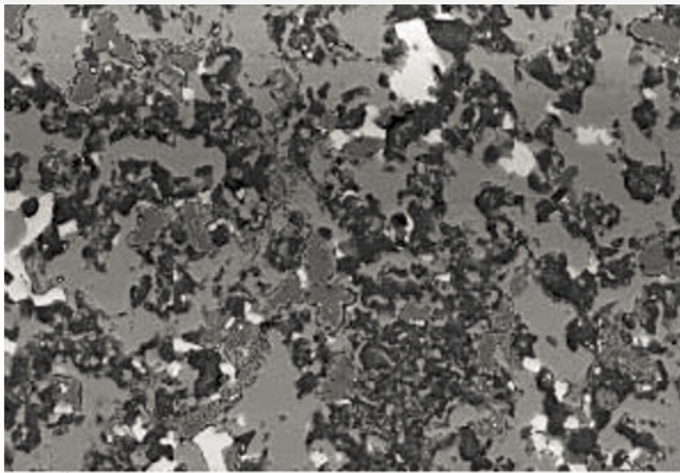
Fig. 6: SEM image, BSE-mode, detail from Fig. 5 (detail), unetched, bright field. Three phases appear: in light-grey the Zn-rich phase, in dark-grey the Al and Cu-rich phase and in white the Sn-rich phase,

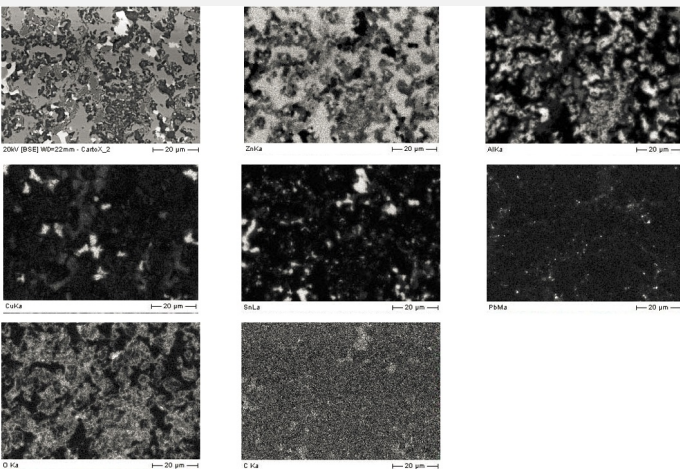
Fig. 7: SEM image, BSE-mode, and elemental chemical distribution of the selected area from Fig. 6. Method of examination: SEM/EDS, Lab of Electronic Microscopy and microanalysis, IMA (Néode), HEI Arc,

The Zn-rich phase is heavily oxidised internally (Fig. 7). The corrosion has developed throughout the entire metal body, generating cracks (Figs. 8 and 9). The cracks are Zn, O and C-rich (Fig. 10) and could be composed of zinc carbonate.

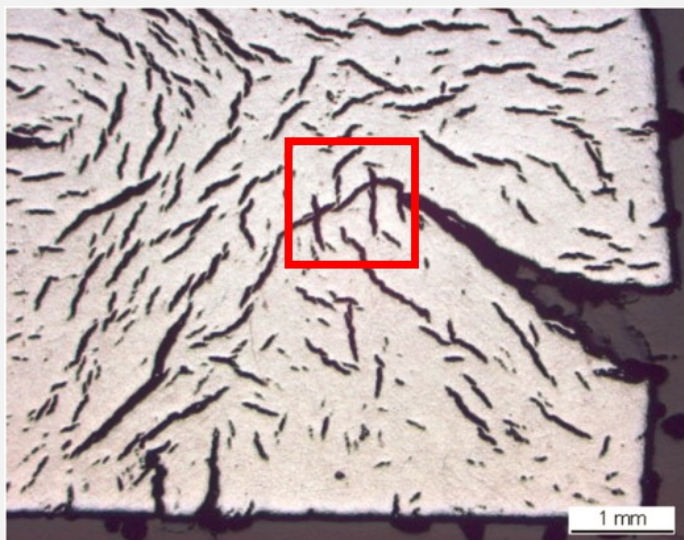
Fig. 8: Micrograph showing the metal - "corrosion products" interface from Fig. 3 (reversed picture, detail), unetched, bright field. We observe in white the metal matrix and dark-grey the adhering material,

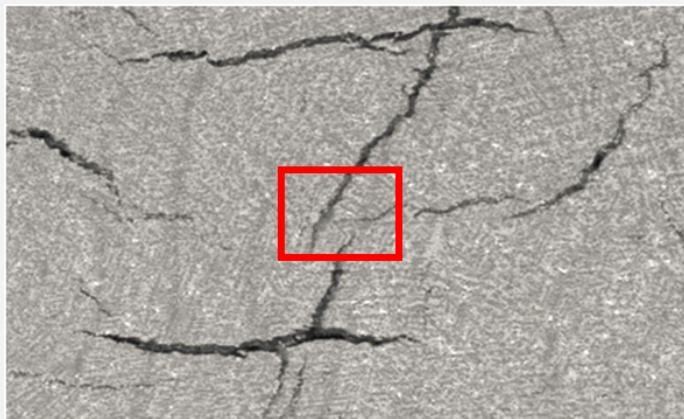
Fig. 9: Micrograph of the metal sample, detail from Fig. 8 (reversed and rotated by 90°), unetched, bright field. A dendritic structure is visible. The micrograph of Fig. 10 is marked by a rectangle,

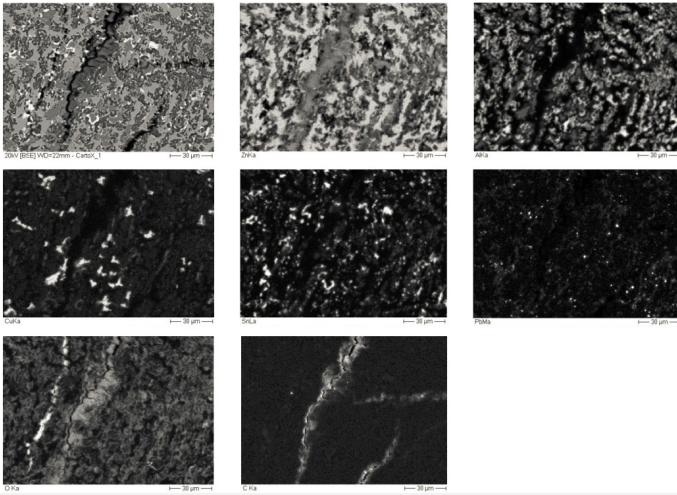
Fig. 10: SEM image, BSE-mode, and elemental chemical distribution of the selected area from Fig. 9 (detail). Method of examination: SEM/EDX, Lab of Electronic Microscopy and microanalysis, IMA (Néode), HEI Arc,

**Corrosion form** Uniform - transgranular  
**Corrosion type** zinc pest
