ARMATURE FROM A CLOCK MOVEMENT MIH IV-212 – ZN AL SN CU ALLOY – MODERN TIMES

Artefact name	Armature from a clock movement MIH IV-212
Authors	Marianne. Senn (EMPA, Dübendorf, Zurich, Switzerland) & Christian. Degrigny (HE-Arc CR, Neuchâtel, Neuchâtel, Switzerland)
Url	/artefacts/388/

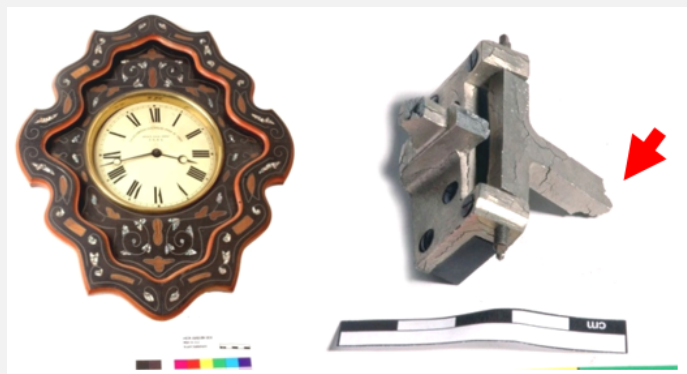
Fig. 1: Wooden wall clock, zinc alloy armature from the clock movement (after Seematter 2009),

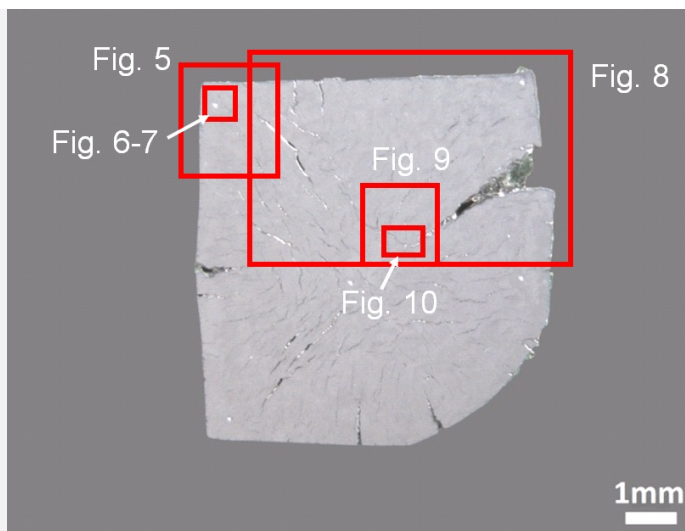
Fig. 3: Micrograph of the cross-section showing the location of Figs. 5 to 10,

This sample is the complete cross-section from an element of the armature (Fig. 2). The metal has huge cracks radiating from the centre to the outside which have deformed the armature (Fig. 3). The metal is covered with a Ni coating.

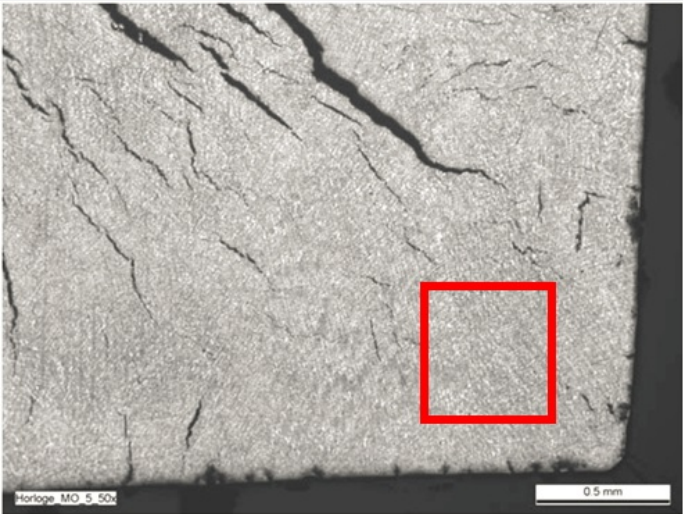
The metal is a Zn-Al-Sn-Cu alloy (Table 1) with an average hardness of HV1 105. A fine dendritic structure is observed (Fig. 5) which consists of clearly separated Zn, Al-Cu and Sn-rich phases (Figs. 6 and 7). Pb is associated with Sn but also forms tiny nodules.

Fig. 5: Micrograph of the metal sample from Fig. 3 (inverted picture, rotated by 270°, detail), unetched, bright field. A dendritic structure is visible. The micrograph of Fig. 6 is marked by a square,

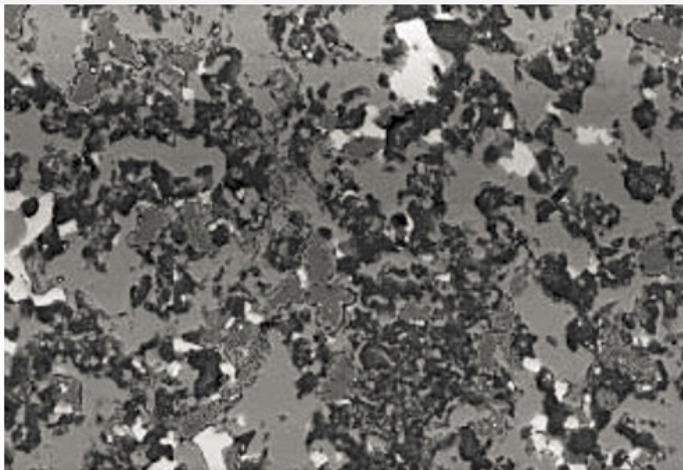
Fig. 6: SEM image, BSE-mode, detail from Fig. 5 (detail), unetched, bright field. Three phases appear: in light-grey the Zn-rich phase, in dark-grey the Al and Cu-rich phase and in white the Sn-rich phase,

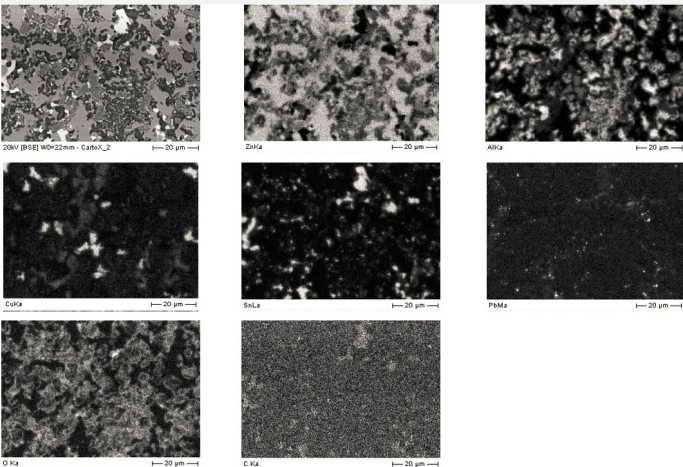
Fig. 7: SEM image, BSE-mode, and elemental chemical distribution of the selected area from Fig. 6. Method of examination: SEM/EDS, Lab of Electronic Microscopy and microanalysis, IMA (Néode), HEI Arc,

The Zn-rich phase is heavily oxidised internally (Fig. 7). The corrosion has developed throughout the entire metal body, generating cracks (Figs. 8 and 9). The cracks are Zn, O and C-rich (Fig. 10) and could be composed of zinc carbonate.

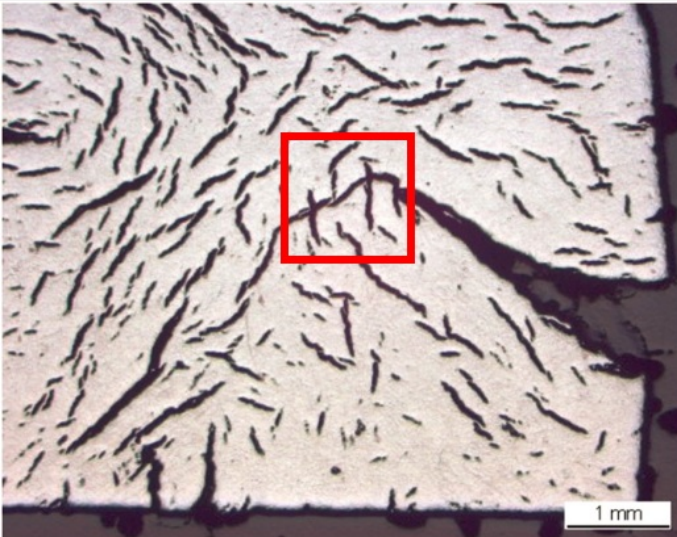
Fig. 8: Micrograph showing the metal - "corrosion products" interface from Fig. 3 (reversed picture, detail), unetched, bright field. We observe in white the metal matrix and dark-grey the adhering material,

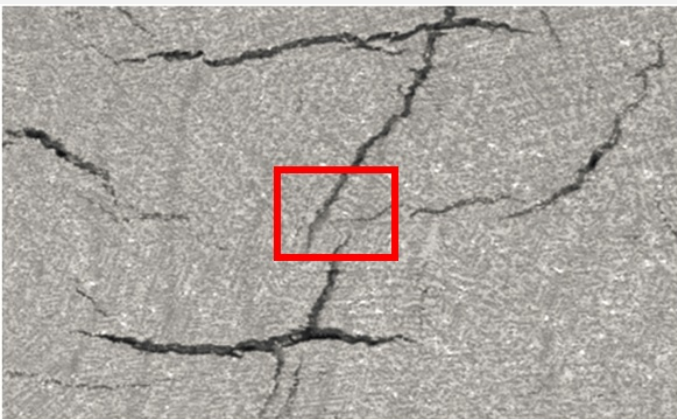
Fig. 9: Micrograph of the metal sample, detail from Fig. 8 (reversed and rotated by 90°), unetched, bright field. A dendritic structure is visible. The micrograph of Fig. 10 is marked by a rectangle,

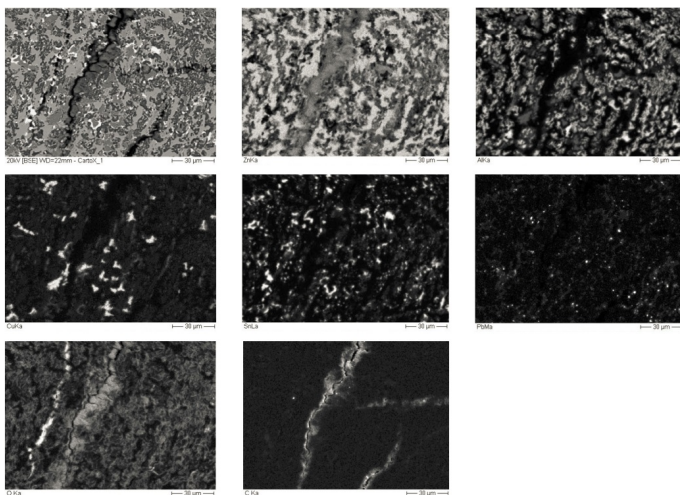
Fig. 10: SEM image, BSE-mode, and elemental chemical distribution of the selected area from Fig. 9 (detail). Method of examination: SEM/EDX, Lab of Electronic Microscopy and microanalysis, IMA (Néode), HEI Arc,
