ARMATURE FROM A CLOCK MOVEMENT MIH IV-212 – ZN AL SN CU ALLOY – MODERN TIMES

Artefact name	Armature from a clock movement MIH IV-212
Authors	Marianne. Senn (EMPA, Dübendorf, Zurich, Switzerland) & Christian. Degriigny (HE-Arc CR, Neuchâtel, Neuchâtel, Switzerland)
Url	/artefacts/388/

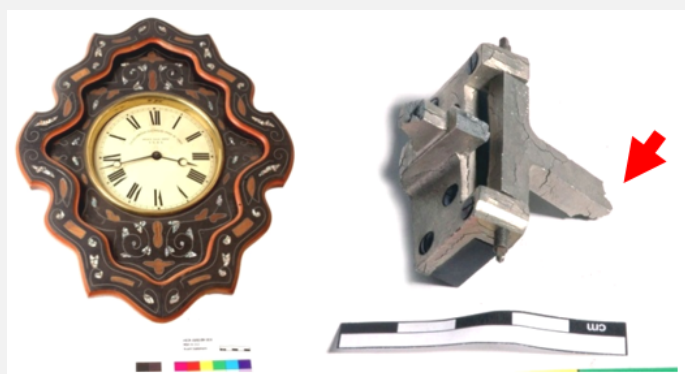
Fig. 1: Wooden wall clock, zinc alloy armature from the clock movement (after Seematter 2009),

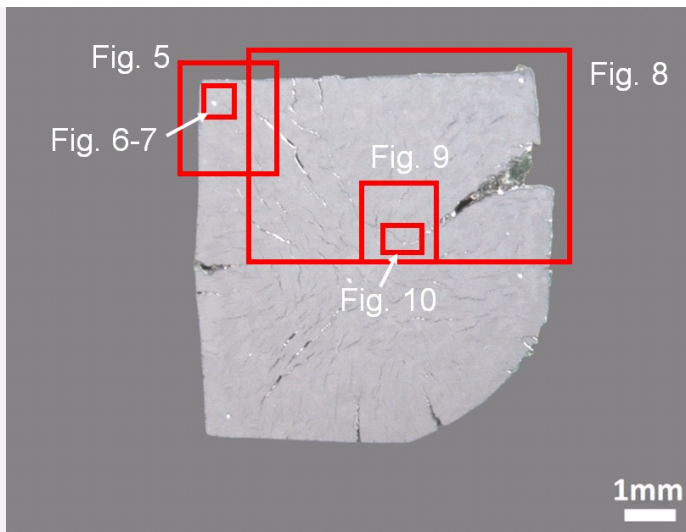
Fig. 3: Micrograph of the cross-section showing the location of Figs. 5 to 10,

This sample is the complete cross-section from an element of the armature (Fig. 2). The metal has huge cracks radiating from the centre to the outside which have deformed the armature (Fig. 3). The metal is covered with a Ni coating.

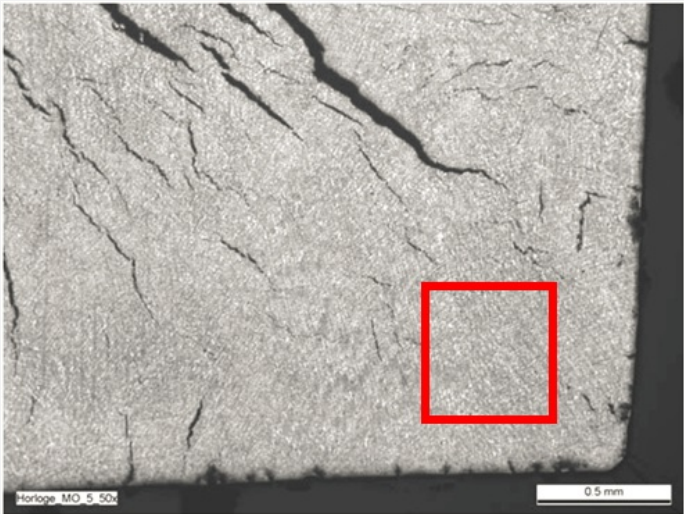
The metal is a Zn-Al-Sn-Cu alloy (Table 1) with an average hardness of HV1 105. A fine dendritic structure is observed (Fig. 5) which consists of clearly separated Zn, Al-Cu and Sn-rich phases (Figs. 6 and 7). Pb is associated with Sn but also forms tiny nodules.

Fig. 5: Micrograph of the metal sample from Fig. 3 (inverted picture, rotated by 270°, detail), unetched, bright field. A dendritic structure is visible. The micrograph of Fig. 6 is marked by a square,

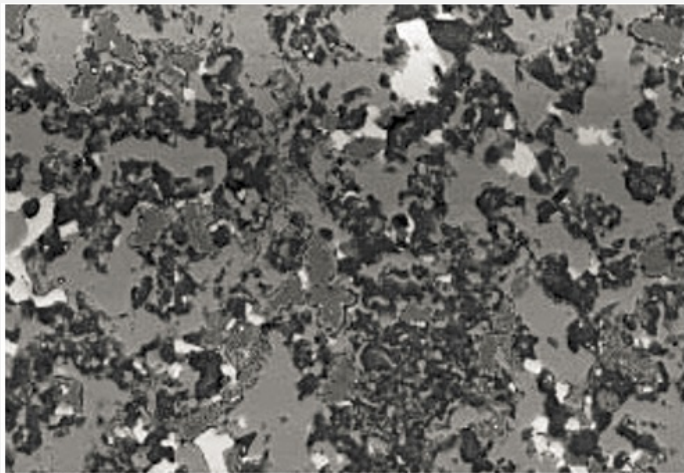
Fig. 6: SEM image, BSE-mode, detail from Fig. 5 (detail), unetched, bright field. Three phases appear: in light-grey the Zn-rich phase, in dark-grey the Al and Cu-rich phase and in white the Sn-rich phase,

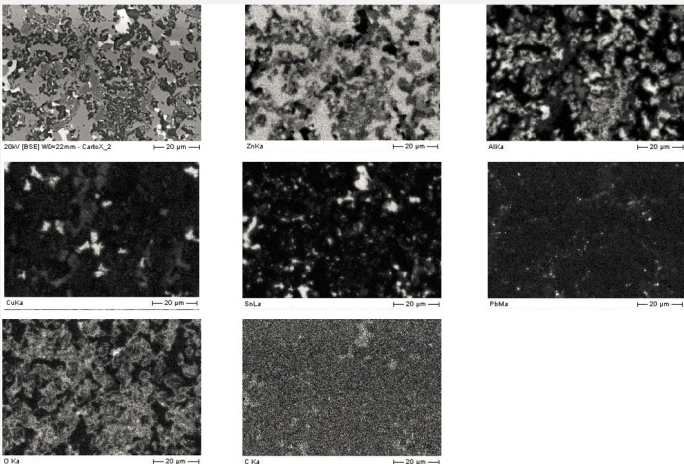
Fig. 7: SEM image, BSE-mode, and elemental chemical distribution of the selected area from Fig. 6. Method of examination: SEM/EDS, Lab of Electronic Microscopy and microanalysis, IMA (Néode), HEI Arc,

The Zn-rich phase is heavily oxidised internally (Fig. 7). The corrosion has developed throughout the entire metal body, generating cracks (Figs. 8 and 9). The cracks are Zn, O and C-rich (Fig. 10) and could be composed of zinc carbonate.

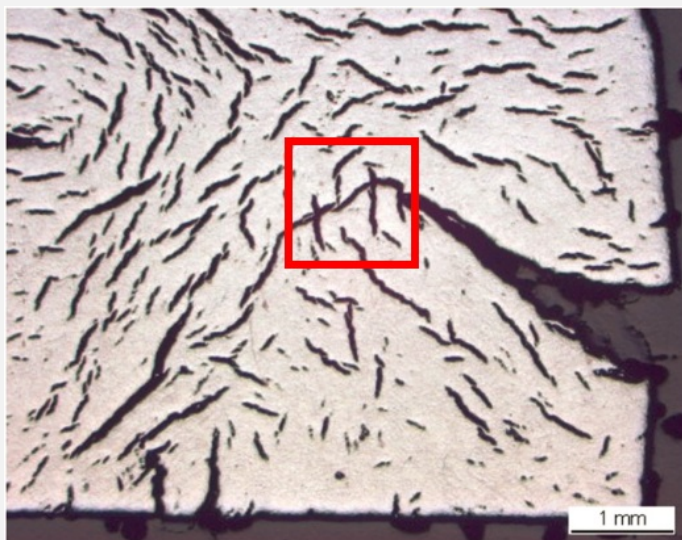
Fig. 8: Micrograph showing the metal - "corrosion products" interface from Fig. 3 (reversed picture, detail), unetched, bright field. We observe in white the metal matrix and dark-grey the adhering material,

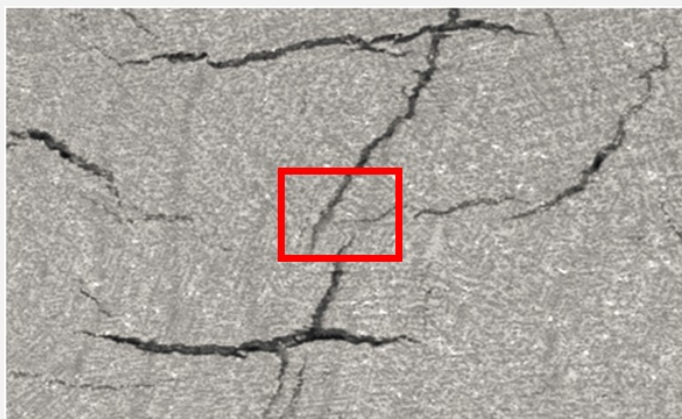
Fig. 9: Micrograph of the metal sample, detail from Fig. 8 (reversed and rotated by 90°), unetched, bright field. A dendritic structure is visible. The micrograph of Fig. 10 is marked by a rectangle,

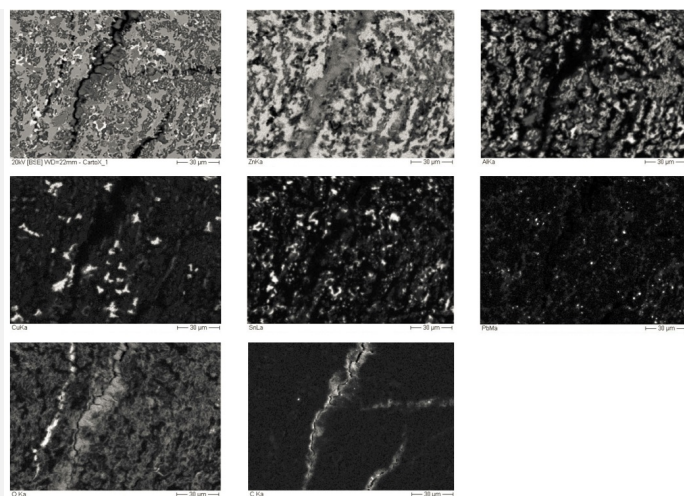
Fig. 10: SEM image, BSE-mode, and elemental chemical distribution of the selected area from Fig. 9 (detail). Method of examination: SEM/EDX, Lab of Electronic Microscopy and microanalysis, IMA (Néode), HEI Arc,
