ARMATURE FROM A CLOCK MOVEMENT MIH IV-212 - ZN AL SN CU ALLOY - MODERN TIMES

Artefact name Armature from a clock movement MIH IV-212

Authors Marianne. Senn (EMPA, Dübendorf, Zurich, Switzerland) & Christian. Degrigny (HE-Arc CR, Neuchâtel, Neuchâtel,

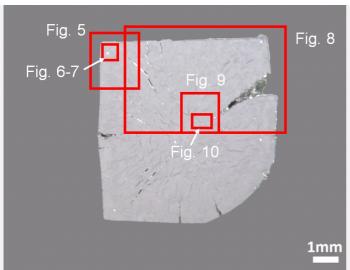
Fig. 3: Micrograph of the cross-section showing the location of Figs. 5 to 10,

Description of sampleThis sample is the complete cross-section from an element of the armature (Fig. 2). The metal has huge

cracks radiating from the centre to the outside which have deformed the armature (Fig. 3). The metal is

covered with a Ni coating.

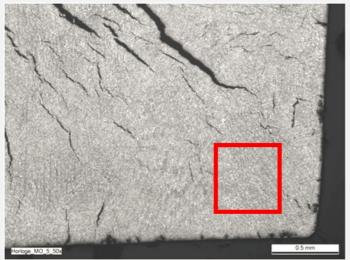
The metal is a Zn-Al-Sn-Cu alloy (Table 1) with an average hardness of HV1 105. A fine dendritic structure is observed (Fig. 5) which consists of clearly separated Zn, Al-Cu and Sn-rich phases (Figs. 6 and 7). Pb is associated with Sn but also forms tiny nodules.

Fig. 5: Micrograph of the metal sample from Fig. 3 (inverted picture, rotated by 270°, detail), unetched, bright field. A dendritic structure is visible. The micrograph of Fig. 6 is marked by a square,

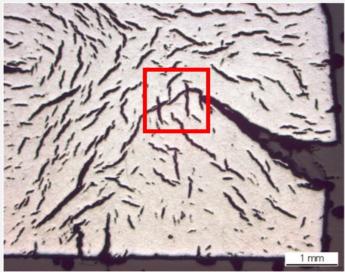
The Zn-rich phase is heavily oxidised internally (Fig. 7). The corrosion has developed throughout the entire metal body, generating cracks (Figs. 8 and 9). The cracks are Zn, O and C-rich (Fig. 10) and could be composed of zinc carbonate.

Fig. 8: Micrograph showing the metal - "corrosion products" interface from Fig. 3 (reversed picture, detail), unetched, bright field. We observe in white the metal matrix and dark-grey the adhering material,

The armature of the clock mechanism is constituted of a ZnAlSnCu alloy. The absence of cohesion between the different phases has led to the penetration of 0 during the manufacturing of the alloy. Small original cracks have developed further eventually causing the armature to break. This phenomenon, known since the 1920's, is called zinc pest. It develops mainly on cast objects, starting with localised modifications (blisters and pits, Cramer and Covino 2005).

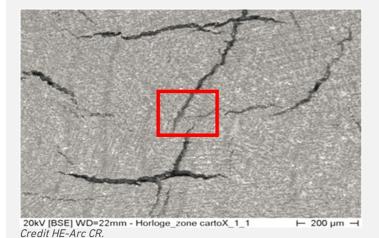
Fig. 9: Micrograph of the metal sample, detail from Fig. 8 (reversed and rotated by 90°), unetched, bright field. A dendritic structure is visible. The micrograph of Fig. 10 is marked by a rectangle,
