MILITARY ID TAG 5668-MXX-1008-1 - ZN PB ALLOY - MODERN TIMES - FRANCE

Artefact name	Military ID tag 5668-MXX-1008-1
Authors	Christian. Degryny (HE-Arc CR, Neuchâtel, Neuchâtel, Switzerland) & Marie-Jeanne. Scholl (HE-Arc CR, Neuchâtel, Neuchâtel, Switzerland) & Valentin. Boissonnas (HE-Arc CR, Neuchâtel, Neuchâtel, Switzerland)
Url	/artefacts/389/

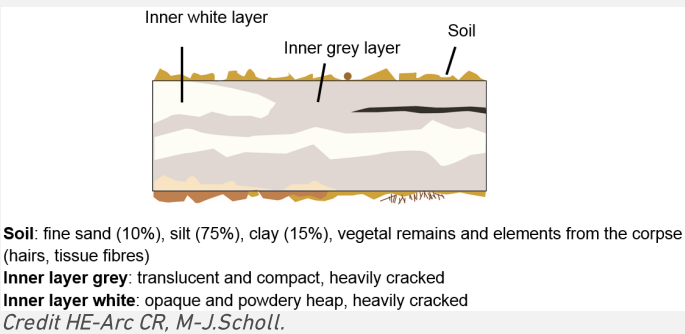
Fig. 3: Stratigraphic representation of the military tag in cross-section by macroscopic observation,

Soil: fine sand (10%), silt (75%), clay (15%), vegetal remains and elements from the corpse (hairs, tissue fibres)
Inner layer grey: translucent and compact, heavily cracked
Inner layer white: opaque and powdery heap, heavily cracked
Credit HE-Arc CR, M-J.Scholl.

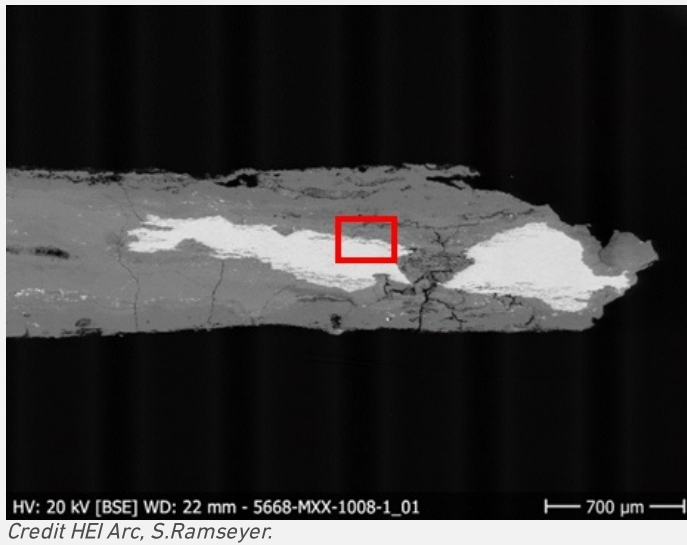
The remaining metal is an almost pure zinc alloy (Table 1) containing 1.8% in weight lead. Lead appears in the metal in the form of small flattened white Pb inclusions (Figs. 7 and 8), confirming the manufacturing technique, namely lamination. The etched metal does not show any specific microstructure (Fig. 9).

Fig. 7: SEM image of the cross-section, from Fig. 4 (detail), BSE-mode. Note the presence of Pb inclusions all through the thickness of the heavily cracked corrosion layers,

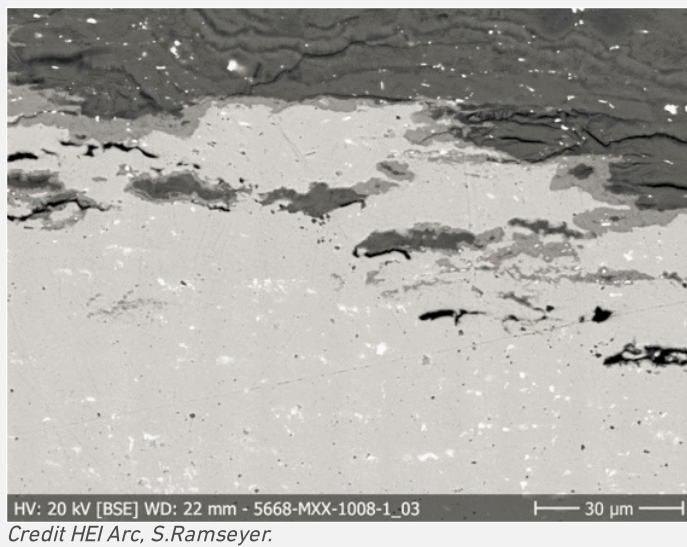
Fig. 8: SEM image of the cross-section, from Fig. 5 (detail), BSE-mode,

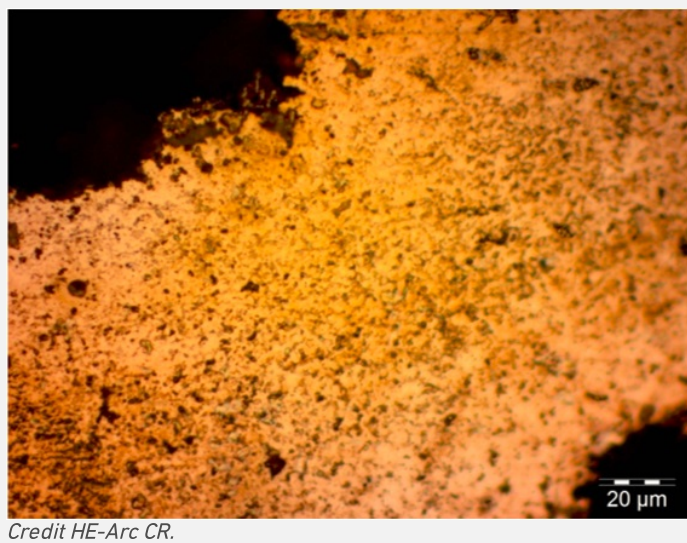
Fig. 9: Micrograph of the cross-section, etched, bright field, 500x,

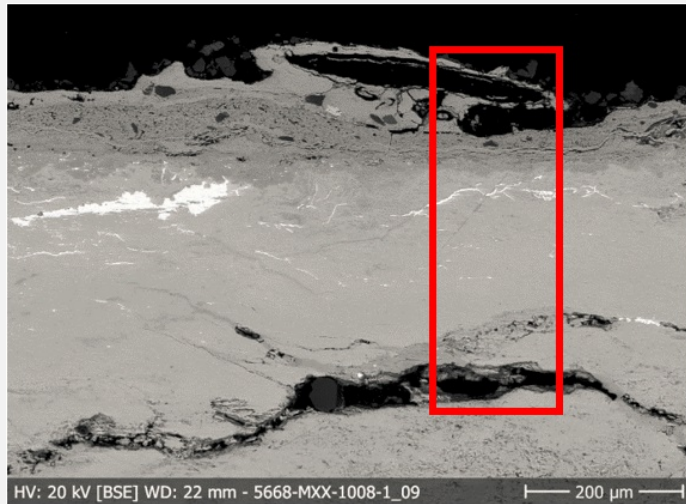
Fig. 11: SEM image of the cross-section from Fig. 10 (detail), BSE-mode. The mapped area (Fig. 12) is marked by a rectangle,

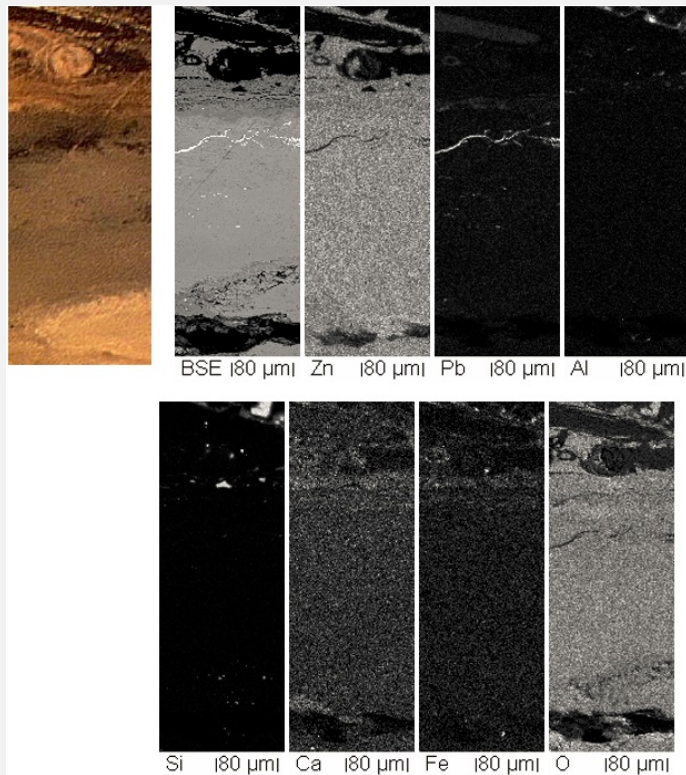
Fig. 12: SEM image of the cross-section from Fig. 11 (detail), SE-mode, and elemental chemical distribution. Method of examination: SEM/EDS, Lab of Electronic Microscopy and microanalysis, IMA (Néode), HEI Arc,

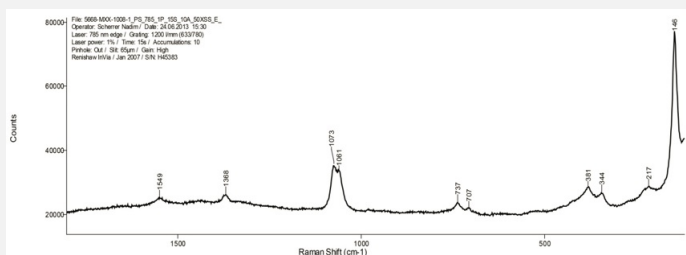
Fig. 15: Raman spectrum of the inner grey layer (CP1, ZnCO_3 – smithsonite?). Settings: laser wavelength 532nm, acquisition time 10s, one accumulation, filter D2 (0.75-0.8mW), hole 500, slit 80, grating 600. Method of analysis: Raman spectroscopy, Art Technological Laboratory, Departement Conservation HKB,

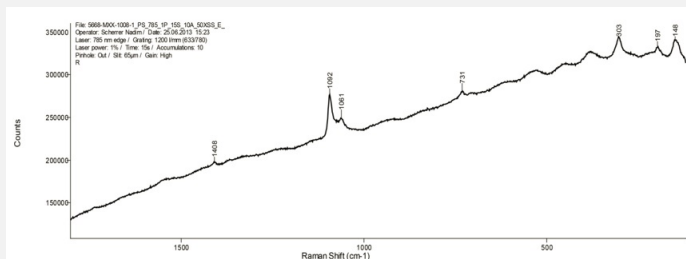
Fig. 16: Raman spectrum of the inner white layer (CP2, zinc hydroxycarbonate?). Settings: laser wavelength 532nm, acquisition time 10s, one accumulation, filter D2 (0.75-0.8mW), hole 500, slit 80, grating 600. Method of analysis: Raman spectroscopy, Art Technological Laboratory, Departement Conservation HKB,

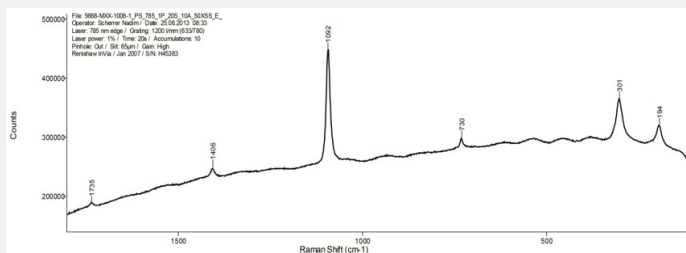
Fig. 17: Raman spectrum of the inner black layer (zinc carbonate?). Settings: laser wavelength 532nm, acquisition time 10s, one accumulation, filter D2 (0.75-0.8mW), hole 500, slit 80, grating 600. Method of analysis: Raman spectroscopy, Art Technological Laboratory, Departement Conservation HKB,

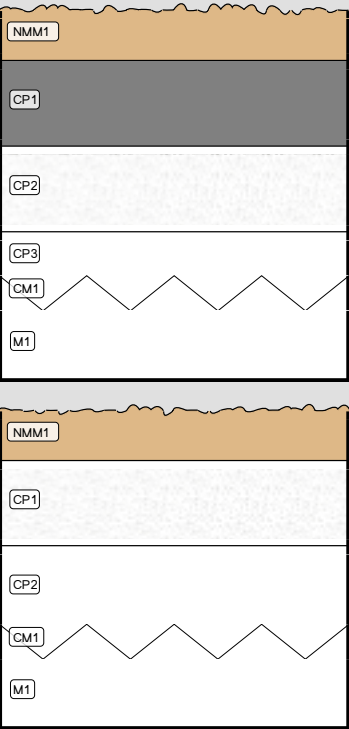
Fig. 5: Stratigraphic representation of the object in cross-section using the MiCorr application. This representation can be compared to Fig. 10, Credit HE-Arc CR, M-J.Scholl.

Fig. 6: Stratigraphic representation of the object in cross-section using the MiCorr application. This representation is different from Fig. 10 due to the inversion of CP1 and CP2. Furthermore, CP3 is not represented, Credit HE-Arc CR, M-J.Scholl.
