# AIRCRAFT FRONT FASTENING PLATE VHS-497 (2) - AL CU SN ZN SI ALLOY - MODERN TIMES

Artefact name	Aircraft front fastening plate VHS-497 (2)
Authors	Marianne. Senn (EMPA, Dübendorf, Zurich, Switzerland) & Christian. Degrigny (HE-Arc CR, Neuchâtel, Neuchâtel, Switzerland)
Url	/artefacts/390/

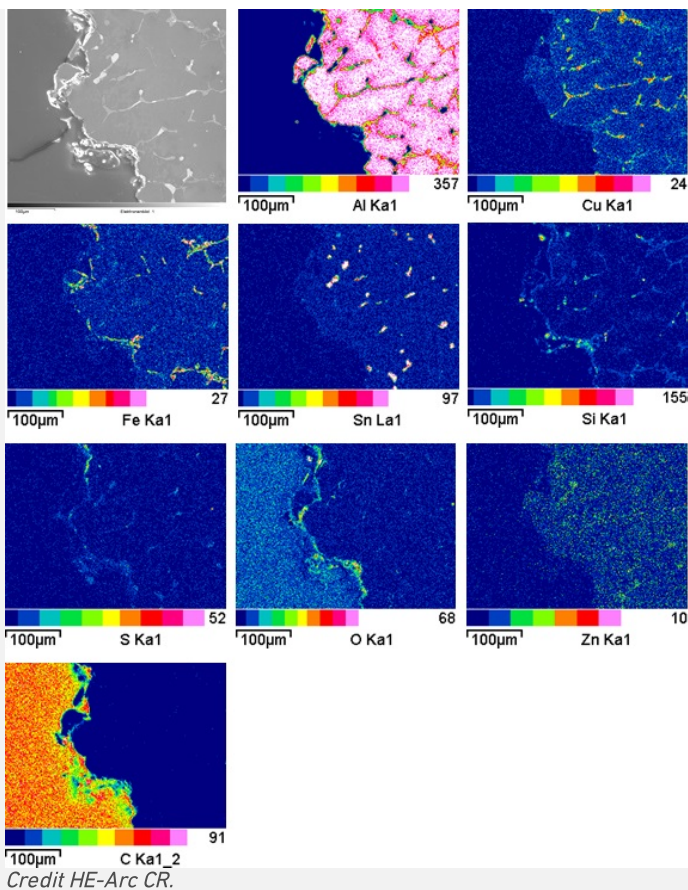
No corrosion layer can be seen on the metal surface (Figs. 3 and 7). Under polarized light small white and brown particles are visible on the broken edge (D1, Fig. 8). Their analysis reveals the presence of silica particles surrounded by dirt (Table 2 and Fig. 9). The metal surface is covered by a thin oxygen bearing skin (CP1, Fig. 9).

Fig. 9: SEM image, BSE-mode, and elemental chemical distribution of the selected area from Fig. 8 (reversed picture, detail). Method of examination: SEM/EDS, Laboratory of Analytical Chemistry, Empa,

Although not common at the beginning of the 20<sup>th</sup>, this Al-Cu-Sn-Zn-Si cast alloy was extensively used on the Dufaux IV plane. No corrosion layer has been found on the metal surface except adherent silica-rich particles and the thin oxidised skin typical of Al alloys. The presence of these materials might be explained by the regular maintenance of the metal using abrasive silicon carbide paper.
