AIRCRAFT REAR FASTENING PLATE VHS-497 - AL ALLOY - MODERN TIMES

Artefact name Aircraft rear fastening plate VHS-497

Authors Marianne. Senn (EMPA, Dübendorf, Zurich, Switzerland) & Christian. Degrigny (HE-Arc CR, Neuchâtel, Neuchâtel, Switzerland)

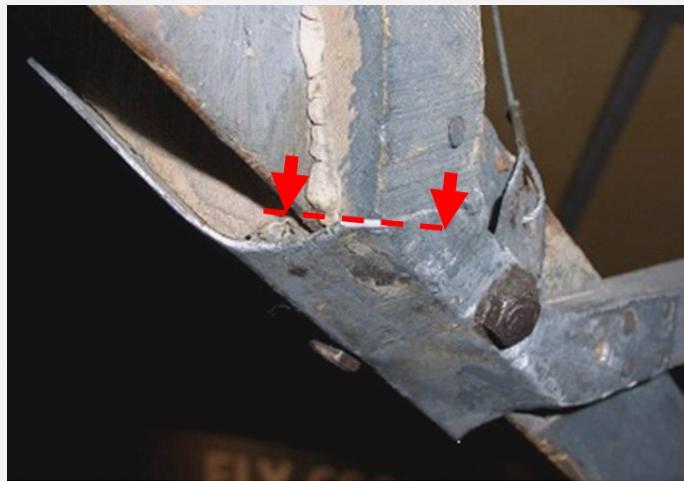
Fig. 2: Location of sampling area,

Sample cut from the corner of the fixation plate (Fig. 2). Dimensions: L = 4mm ; W = 1.2mm.

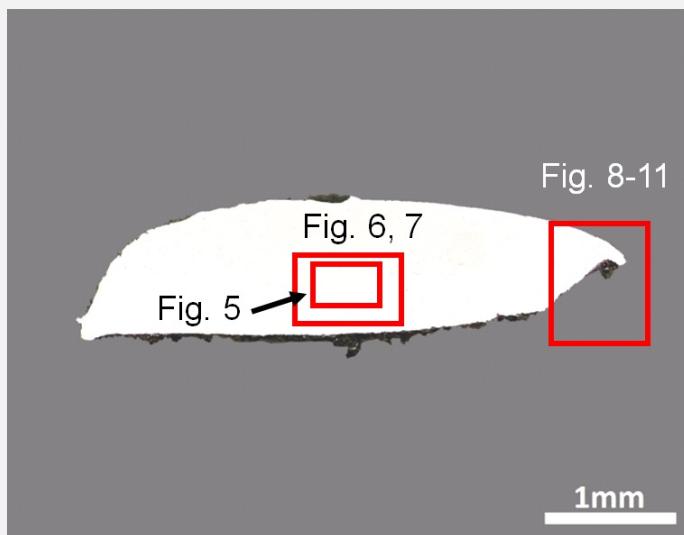
Fig. 3: Micrograph of the cross-section showing the location of Figs. 5 to 11,

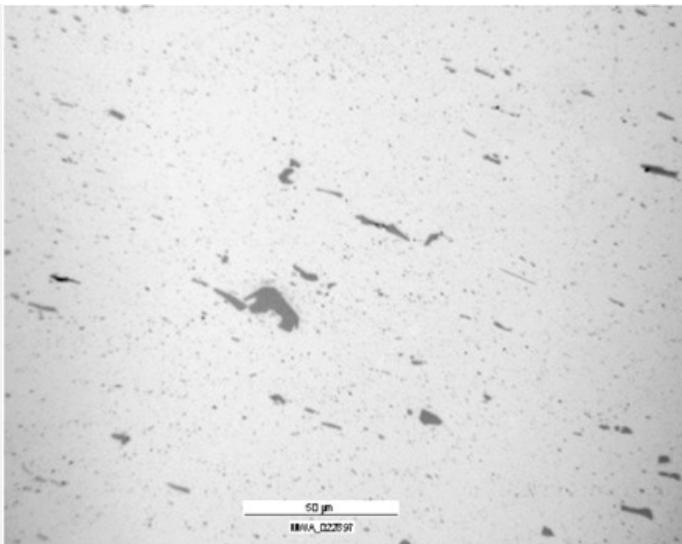
The metal is a relatively pure aluminium alloy with numerous inclusions (Table 1). From the chemical composition of the inclusions they can be interpreted as alpha-AlFeSi intermetallic compounds. In bright field we observe elongated inclusions indicating that the metal was rolled (Fig. 5). The alloy composition is similar to an unalloyed primary aluminium (Al content between 99 and 99.8 mass%). The O content reflects the immediate oxidation of the metal and is not part of the alloy. After etching the organisation of inclusions in rows is more easily seen (Fig. 6). The SEM image shows large grains formed after annealing (Fig. 7). The average hardness of the metal is HV1 40.

Table 1: Chemical composition (mass %) of the metal and inclusions (from Fig. 5). Method of analysis: SEM/EDS, Laboratory of Analytical Chemistry, Empa.

Fig. 5: Micrograph of the metal sample from Fig. 3 (detail), unetched, bright field. The metal matrix is in white, the elongated inclusions in grey,

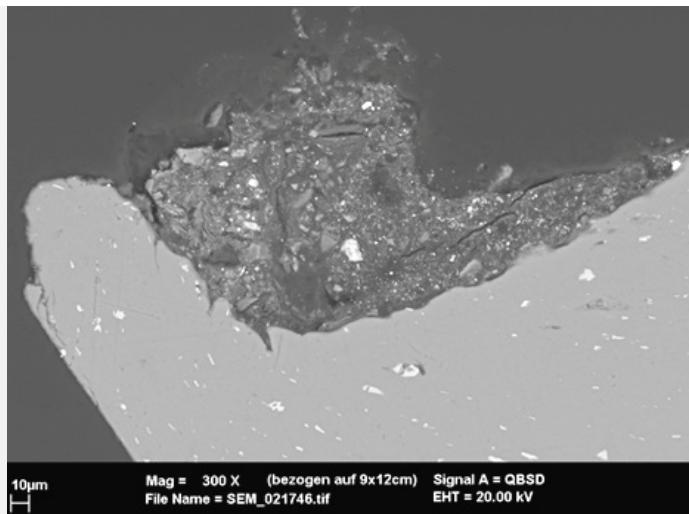
Fig. 10: SEM image (same as Fig. 8, inverted picture, detail), BSE-mode, unetched,
