AIRCRAFT REAR FASTENING PLATE VHS-497 – AL ALLOY – MODERN TIMES

Artefact name Aircraft rear fastening plate VHS-497

Authors Marianne. Senn (EMPA, Dübendorf, Zurich, Switzerland) & Christian. Degriy (HE-Arc CR, Neuchâtel, Neuchâtel, Switzerland)

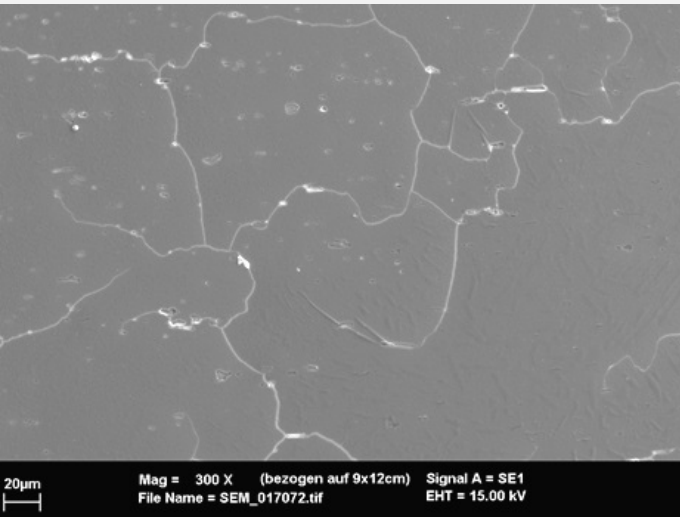
The metal is a relatively pure aluminium alloy with numerous inclusions (Table 1). From the chemical composition of the inclusions they can be interpreted as alpha-AlFeSi intermetallic compounds. In bright field we observe elongated inclusions indicating that the metal was rolled (Fig. 5). The alloy composition is similar to an unalloyed primary aluminium (Al content between 99 and 99.8 mass%). The O content reflects the immediate oxidation of the metal and is not part of the alloy. After etching the organisation of inclusions in rows is more easily seen (Fig. 6). The SEM image shows large grains formed after annealing (Fig. 7). The average hardness of the metal is HV1 40.

Fig. 7: SEM image of the metal sample from Fig. 3 (detail), SE-mode, etched. We observe the presence of large grains and numerous elongated inclusions,

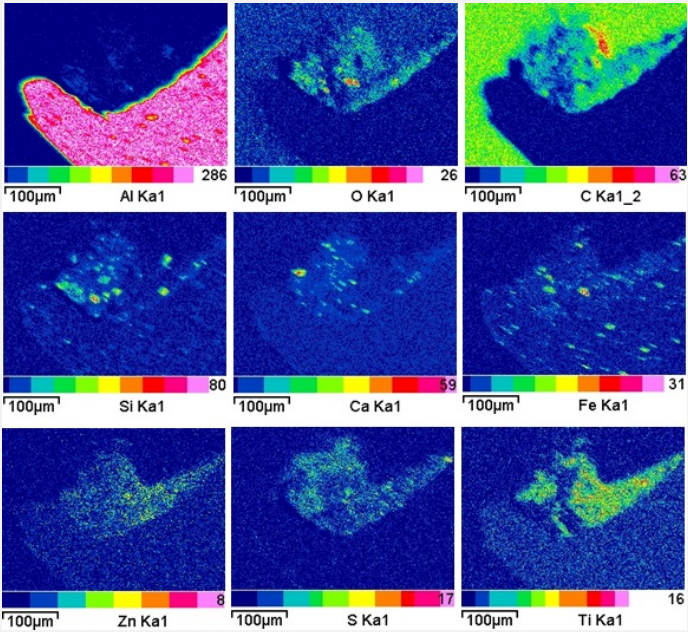
Fig. 11: Elemental chemical distribution of the selected area from Fig. 10. Method of examination: SEM/EDS, Laboratory of Analytical Chemistry, Empa,
