AIRCRAFT REAR FASTENING PLATE VHS-497 – AL ALLOY – MODERN TIMES

Artefact name Aircraft rear fastening plate VHS-497

Authors Marianne. Senn (EMPA, Dübendorf, Zurich, Switzerland) & Christian. Degrieny (HE-Arc CR, Neuchâtel, Neuchâtel, Switzerland)

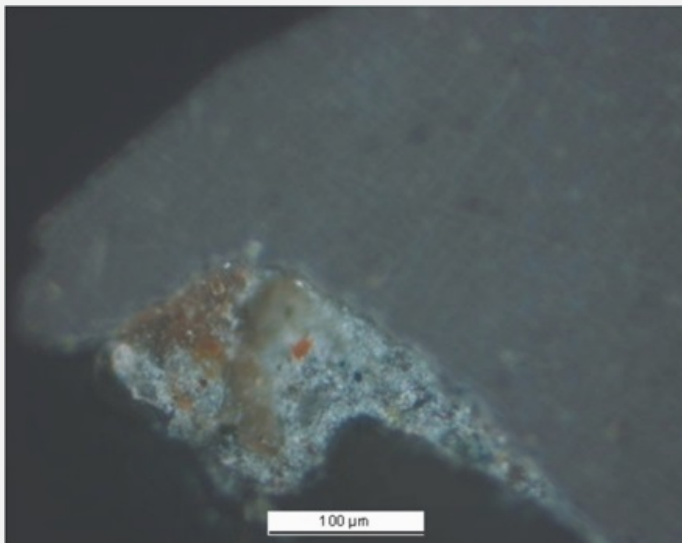
The metal is covered by a very thin corrosion layer (CP1). In addition to this, locally thicker "corrosion products" or adherent material can be observed (D1, appearing as dark-grey area in Fig. 8). Under polarized light, they appear blue-brown (Fig. 9). Analysis by SEM-EDS indicates that the metal is, as expected, covered by a very thin Al and O-rich layer whereas the particles in the adherent material contain C, O, Si, Ca, Fe, Zn, S and even Ti (Figs. 10 and 11). The location of the adherent material and the presence of both Zn and Ti suggest that it is a residue of a paint coating.

Fig. 9: Micrograph (same as Fig. 8) and corresponding to the stratigraphy of Fig. 4, unetched, polarised light. We observe in grey the metal matrix and blue-brown the adherent material,
