CHISEL POINT DEV 995 1069 PR – EUTECTOID TO HYPEREUTECTOID STEEL – EARLY MEDIEVAL TIMES – SWITZERLAND

Artefact name	Chisel point DEV 995 1069 PR
Authors	Marianne. Senn (EMPA, Dübendorf, Zurich, Switzerland) & Christian. Degryny (HE-Arc CR, Neuchâtel, Neuchâtel, Switzerland)
Url	/artefacts/393/

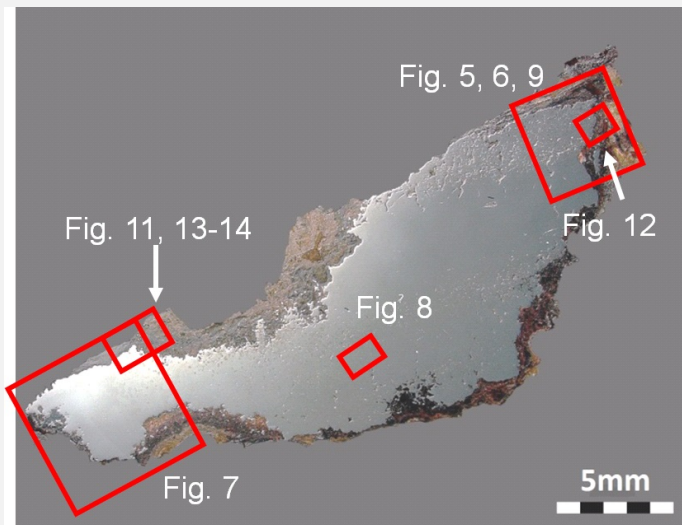
Fig. 3: Micrograph of the cross-section showing the location of Figs. 5 to 9 and 11 to 14,

A longitudinal cut from a chisel point (Figs. 2 and 3) undertaken after restoration. Dimensions: L = 30mm; W = 11mm (approximately).

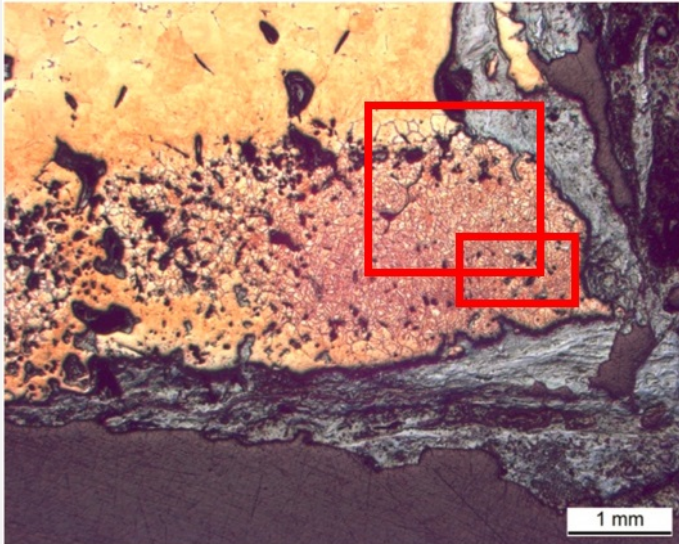
The remaining metal is a eutectoid to hypereutectoid steel (C 0.8-1 mass%) with cracks and porosity (Figs. 5 and 6). Its composition is given in Table 1 (except Fe). Of the trace elements, only Ni reaches a medium concentration (Ni 0.07 mass%). The composition and the high Ni/Co ratio are atypical for iron worked in smithies of the settlement at Develier-Courtételle JU, CH. The few slag inclusions and their chemical composition confirm this (Table 2). The slag is rich in CaO whereas the pisolithic or bean ore worked in the Central Jura smelting district is rich in Al₂O₃. The slag inclusions cannot be smithing slag because the artefact is formed from one piece of metal. The slag probably incorporated while refining the bloom or during the bloom smelting process. The ore from which this metal was smelted cannot yet be identified. Intergranular corrosion has developed, penetrating into the metal structure (Fig. 6). The etched metal shows a dominant martensitic structure, typical of quench hardened steel (Figs. 5, 7, 8 and 9). The characteristic forms of the martensite are non-organised needles (Fig. 8). In restricted areas bainite nodules occur (Figs. 7 and 8). In the centre of the point, hypereutectoid steel is composed of cementite in the grain boundaries and in needle like shapes within the grains (Fig. 10). Hypereutectoid regions also occur in the centre of the shaft and on its left surface (Fig. 5). Here the hypereutectoid steel is composed of martensite and cementite in the grain boundaries and in needle form within the grains (Figs. 6 and 9). Nevertheless, most of the chisel is dominated by eutectoid steel. The average hardness of the quench hardened eutectoid steel is about HV1 690. In the bainite nodules the average hardness drops to about HV1 350, the martensite has an average hardness of HV1 750.

Fig. 5: Micrograph of the metal sample from Fig. 3 (inverted picture, detail), etched, bright field. The metal contains porosity and cracks (in black). The micrographs of Figs. 6 and 9 are marked by the top and bottom rectangles respectively,

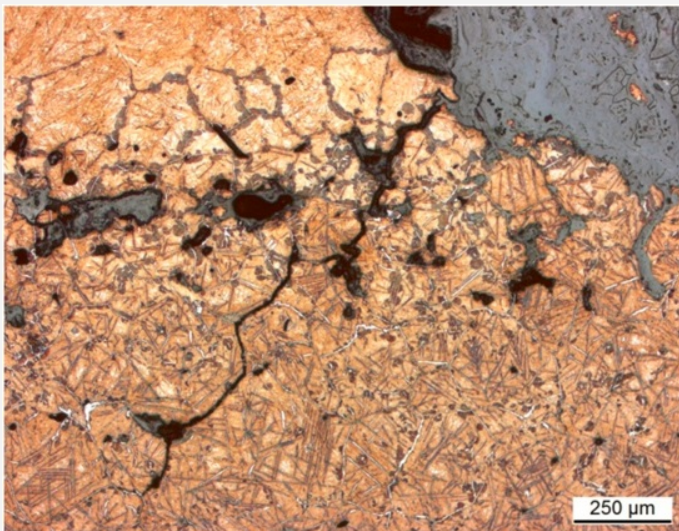
Fig. 6: Micrograph of the metal sample, detail from Fig. 5, etched, bright field. We observe martensite (in orange), cementite (in grey), porosity and intergranular cracks (in black) and corrosion,

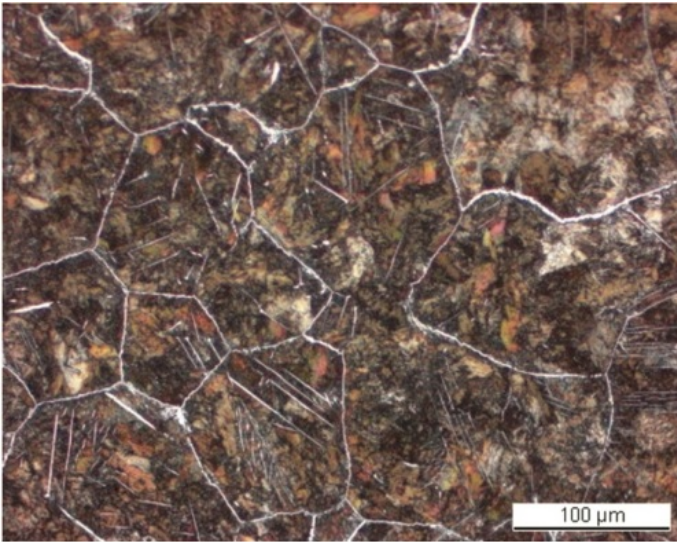
Fig. 10: Micrograph of the metal sample, detail from Fig. 7, etched, bright field. Hypereutectoid steel with a structure of cementite in white in the grain boundaries and in needle form combined with bainite (dark),

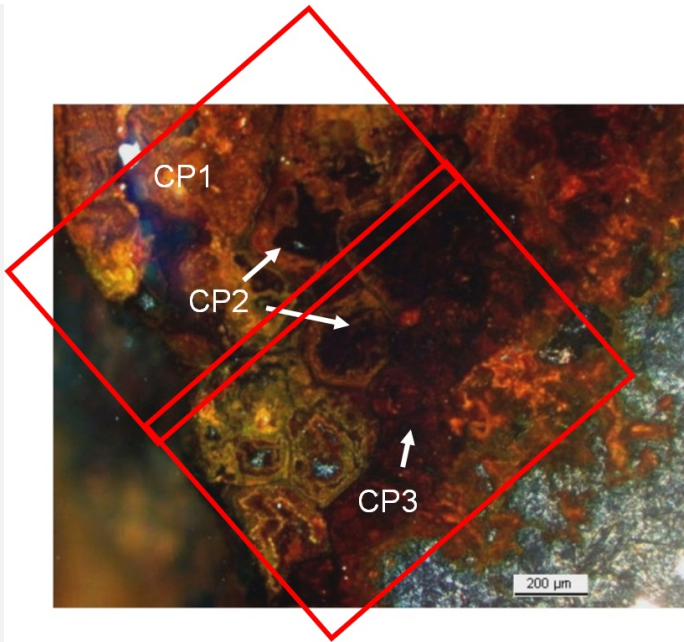
The metal is heavily corroded and the thickness of the corrosion crust is irregular, but averages about 0.5mm. The corrosion products enclose different ghost structures: the corrosion crust has preserved the shape of polygonal grains (Figs. 11 and 13) and cementite needles (Fig. 12). Under polarised light, the corrosion products at the metal - corrosion crust interface are dark-red and form an inner S-rich layer (CP3, Figs. 11 and 13). Cl occurs locally (CP3) and C is present in layers CP2 and CP3 (Fig. 13). The outer layer of the corrosion products (CP1) is orange and contains more O than the inner layer CP3 (Figs. 11 and 14).

Fig. 11: Micrograph showing the metal - corrosion crust interface from Fig. 3 (rotated by 270°, detail) and corresponding to the stratigraphy of Fig. 4, unetched, polarised light. Polygonal grains are visible as ghost structure in the corrosion crust. The mapped areas (Figs. 13 and 14) are marked by two rectangles (bottom: Fig. 13 and top: Fig. 14),

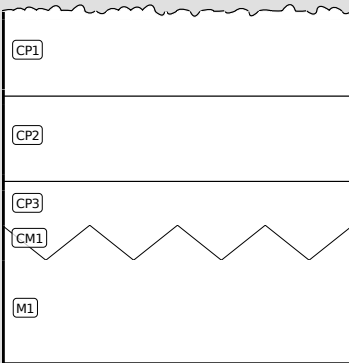
Fig. 4: Stratigraphic representation of the object in cross-section using the MiCorr application. This representation can be compared to Fig. 11, Credit HE-Arc CR.
