# CHISEL POINT DEV 995 1069 PR – EUTECTOID TO HYPEREUTECTOID STEEL – EARLY MEDIEVAL TIMES – SWITZERLAND

Artefact name	Chisel point DEV 995 1069 PR
Authors	Marianne. Senn (EMPA, Dübendorf, Zurich, Switzerland) & Christian. Degrieny (HE-Arc CR, Neuchâtel, Neuchâtel, Switzerland)
Url	/artefacts/393/

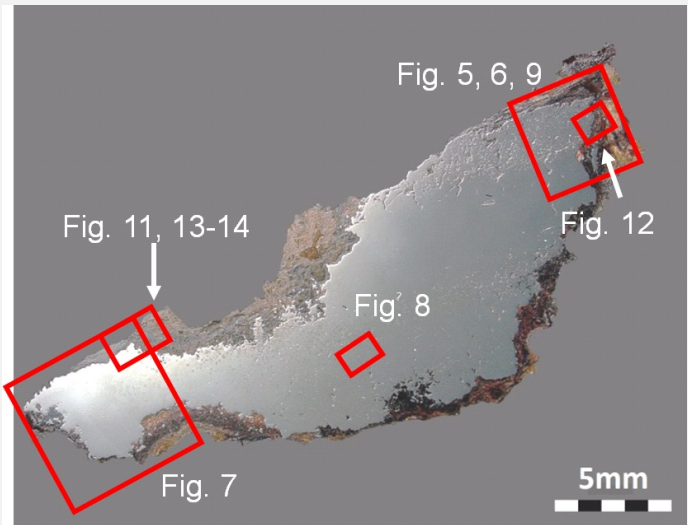
Fig. 3: Micrograph of the cross-section showing the location of Figs. 5 to 9 and 11 to 14,

A longitudinal cut from a chisel point (Figs. 2 and 3) undertaken after restoration. Dimensions: L = 30mm; W = 11mm (approximately).

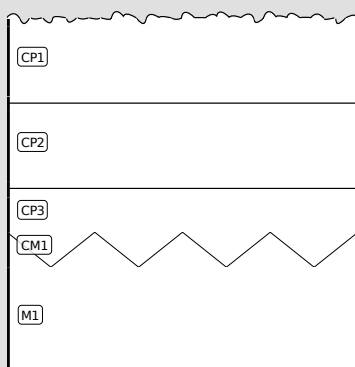
Fig. 4: Stratigraphic representation of the object in cross-section using the MiCorr application. This representation can be compared to Fig. 11, Credit HE-Arc CR.
