# CHISEL POINT DEV 995/1069 PR – EUTECTOID TO HYPEREUTECTOID STEEL – EARLY MEDIEVAL TIMES – SWITZERLAND

Artefact name	Chisel point DEV 995/1069 PR
Authors	Marianne. Senn (EMPA, Dübendorf, Zurich, Switzerland) & Christian. Degriigny (HE-Arc CR, Neuchâtel, Neuchâtel, Switzerland)
Url	/artefacts/393/

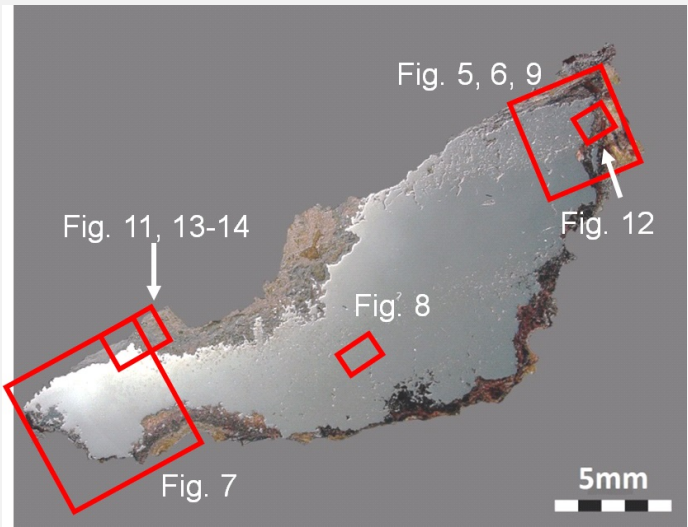
Fig. 3: Micrograph of the cross-section showing the location of Figs. 5 to 9 and 11 to 14,

A longitudinal cut from a chisel point (Figs. 2 and 3) undertaken after restoration. Dimensions: L = 30mm; W = 11mm (approximately).

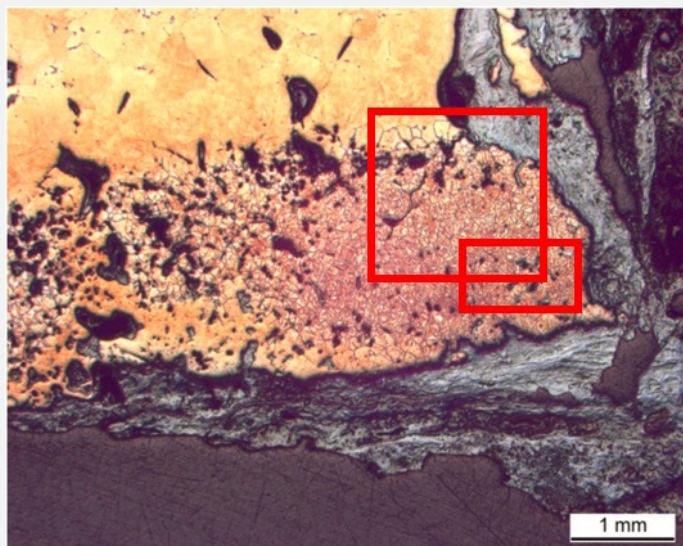
The remaining metal is a eutectoid to hypereutectoid steel (C 0.8-1 mass%) with cracks and porosity (Figs. 5 and 6). Its composition is given in Table 1 (except Fe). Of the trace elements, only Ni reaches a medium concentration (Ni 0.07 mass%). The composition and the high Ni/Co ratio are atypical for iron worked in smithies of the settlement at Develier-Courtételle JU, CH. The few slag inclusions and their chemical composition confirm this (Table 2). The slag is rich in CaO whereas the pisolithic or bean ore worked in the Central Jura smelting district is rich in  $Al_2O_3$ . The slag inclusions cannot be smithing slag because the artefact is formed from one piece of metal. The slag probably incorporated while refining the bloom or during the bloom smelting process. The ore from which this metal was smelted cannot yet be identified. Intergranular corrosion has developed, penetrating into the metal structure (Fig. 6). The etched metal shows a dominant martensitic structure, typical of quench hardened steel (Figs. 5, 7, 8 and 9). The characteristic forms of the martensite are non-organised needles (Fig. 8). In restricted areas bainite nodules occur (Figs. 7 and 8). In the centre of the point, hypereutectoid steel is composed of cementite in the grain boundaries and in needle like shapes within the grains (Fig. 10). Hypereutectoid regions also occur in the centre of the shaft and on its left surface (Fig. 5). Here the hypereutectoid steel is composed of martensite and cementite in the grain boundaries and in needle form within the grains (Figs. 6 and 9). Nevertheless, most of the chisel is dominated by eutectoid steel. The average hardness of the quench hardened eutectoid steel is about HV1 690. In the bainite nodules the average hardness drops to about HV1 350, the martensite has an average hardness of HV1 750.

Fig. 5: Micrograph of the metal sample from Fig. 3 (inverted picture, detail), etched, bright field. The metal contains porosity and cracks (in black). The micrographs of Figs. 6 and 9 are marked by the top and bottom rectangles respectively,

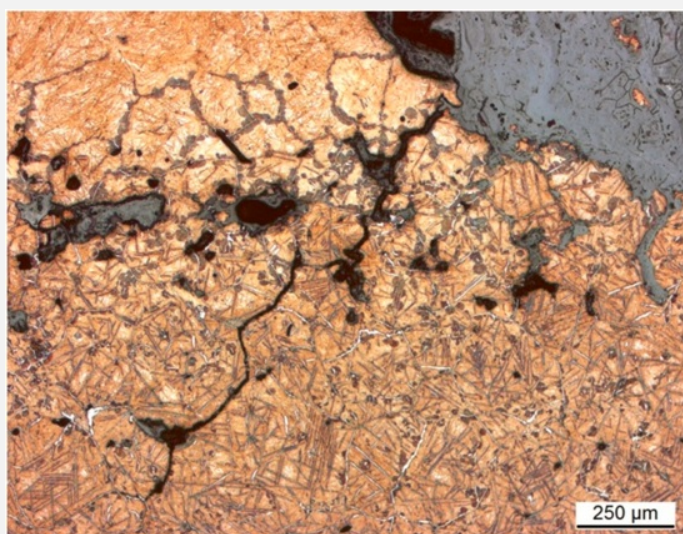
Fig. 6: Micrograph of the metal sample, detail from Fig. 5, etched, bright field. We observe martensite (in orange), cementite (in grey), porosity and intergranular cracks (in black) and corrosion,

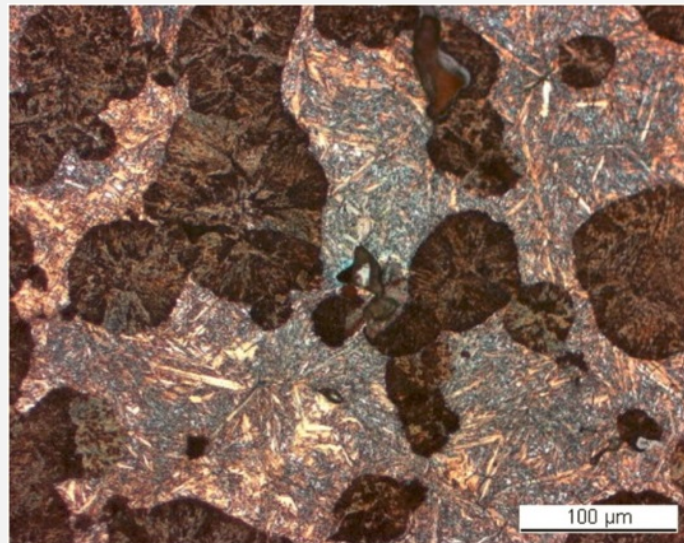
Fig. 8: Micrograph of the metal sample from Fig. 3 (detail), etched, bright field. We observe dark bainite nodules combined with martensite needles,

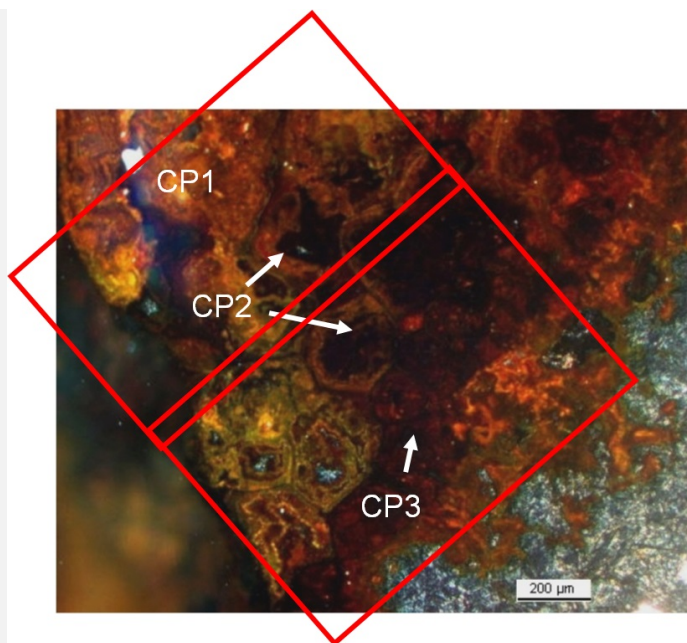
The metal is heavily corroded and the thickness of the corrosion crust is irregular, but averages about 0.5mm. The corrosion products enclose different ghost structures: the corrosion crust has preserved the shape of polygonal grains (Figs. 11 and 13) and cementite needles (Fig. 12). Under polarised light, the corrosion products at the metal - corrosion crust interface are dark-red and form an inner S-rich layer (CP3, Figs. 11 and 13). Cl occurs locally (CP3) and C is present in layers CP2 and CP3 (Fig. 13). The outer layer of the corrosion products (CP1) is orange and contains more O than the inner layer CP3 (Figs. 11 and 14).

Fig. 11: Micrograph showing the metal - corrosion crust interface from Fig. 3 (rotated by 270°, detail) and corresponding to the stratigraphy of Fig. 4, unetched, polarised light. Polygonal grains are visible as ghost structure in the corrosion crust. The mapped areas (Figs. 13 and 14) are marked by two rectangles (bottom: Fig. 13 and top: Fig. 14),

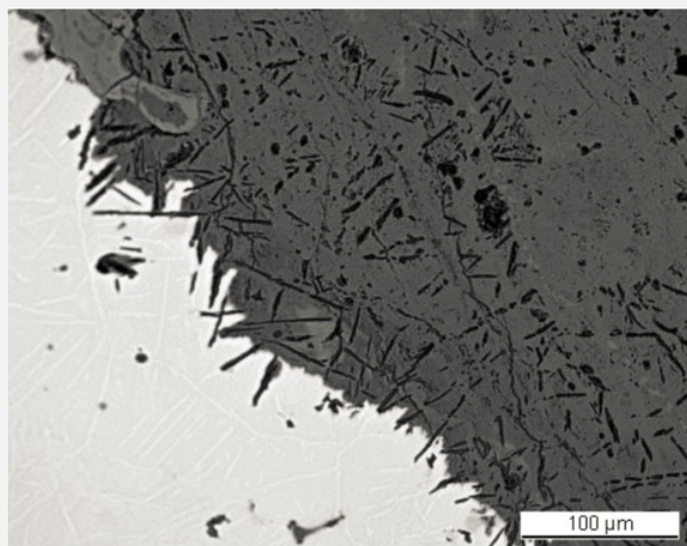
Fig. 12: Micrograph showing the metal - corrosion crust interface from Fig. 3 (detail), unetched, bright field. The cementite is visible as white needles in the metal and its ghost structure as black needles in the corrosion crust,

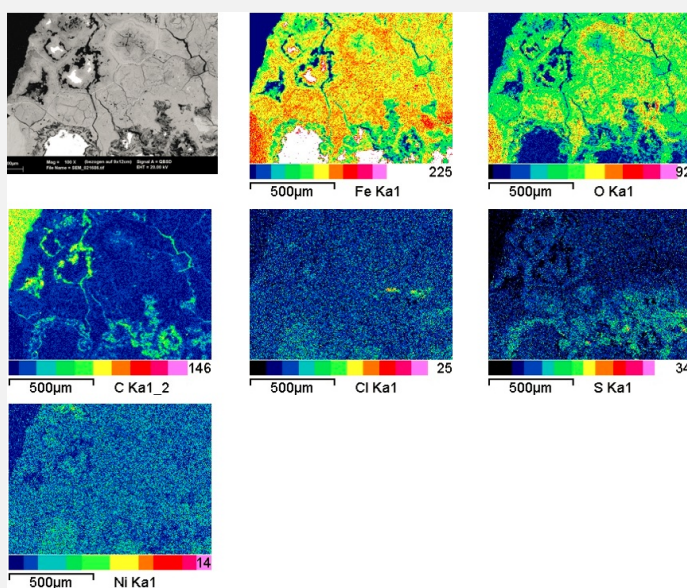
Fig. 13: SEM image, BSE-mode, and elemental chemical distribution of the selected area from Fig. 11 (rotated by 45°). Method of examination: SEM/EDS, Laboratory of Analytical Chemistry, Empa,

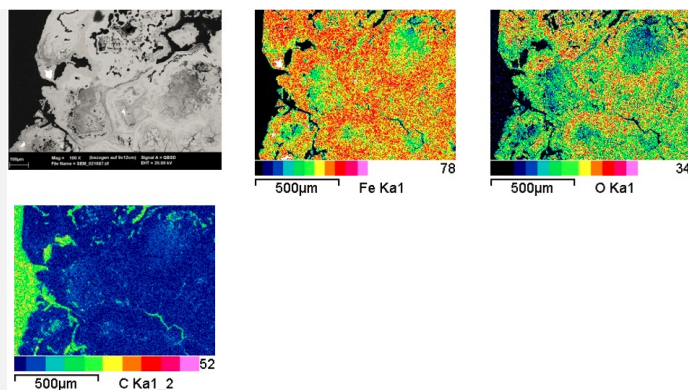
Fig. 14: SEM image, BSE-mode, and elemental chemical distribution of the selected area from Fig. 11 (rotated by 45°). Method of examination: SEM/EDS, Laboratory of Analytical Chemistry, Empa,

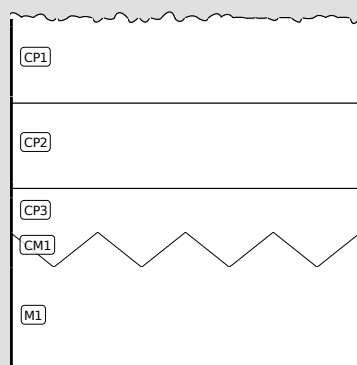
Fig. 4: Stratigraphic representation of the object in cross-section using the MiCorr application. This representation can be compared to Fig. 11, Credit HE-Arc CR.
