# CHISEL POINT DEV 995 1069 PR – EUTECTOID TO HYPEREUTECTOID STEEL – EARLY MEDIEVAL TIMES – SWITZERLAND

**Artefact name** Chisel point DEV 995 1069 PR

**Authors** Marianne. Senn (EMPA, Dübendorf, Zurich, Switzerland) & Christian. Degryny (HE-Arc CR, Neuchâtel, Neuchâtel, Switzerland)

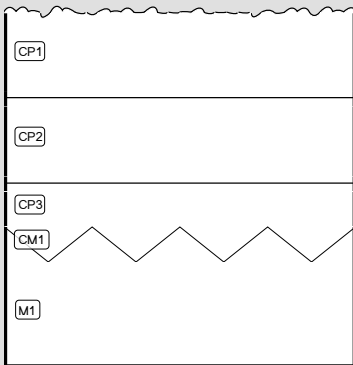
Fig. 4: Stratigraphic representation of the object in cross-section using the MiCorr application. This representation can be compared to Fig. 11, Credit HE-Arc CR.
