# HEADREST OR HORSE BIT VFIG 2003.7 - LEADED BRONZE - MODERN TIMES

**Artefact name** Headrest or horse bit VFig 2003.7

**Authors** Christian. Degriigny (HE-Arc CR, Neuchâtel, Neuchâtel, Switzerland) & Valentin. Boissonnas (HE-Arc CR, Neuchâtel, Neuchâtel, Switzerland)

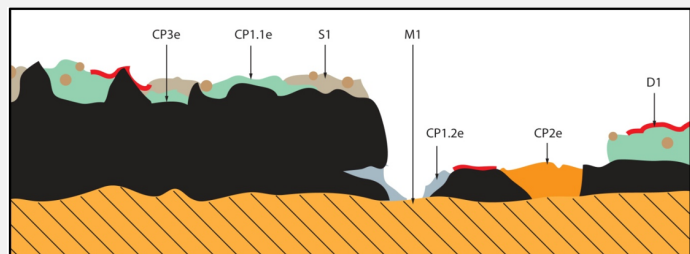
**S1:** soil (sand and limestone)  
**D1:** red deposit  
**CP1.1e:** outer light green-blue corrosion layer  
**CP1.2e:** outer white-blue-grey corrosion layer  
**CP2e:** outer orange corrosion layer  
**CP3e/i:** outer/inner black brown corrosion layer  
**M1:** metal

Fig. 3: Stratigraphic representation of the artefact in cross-section by macroscopic observation,

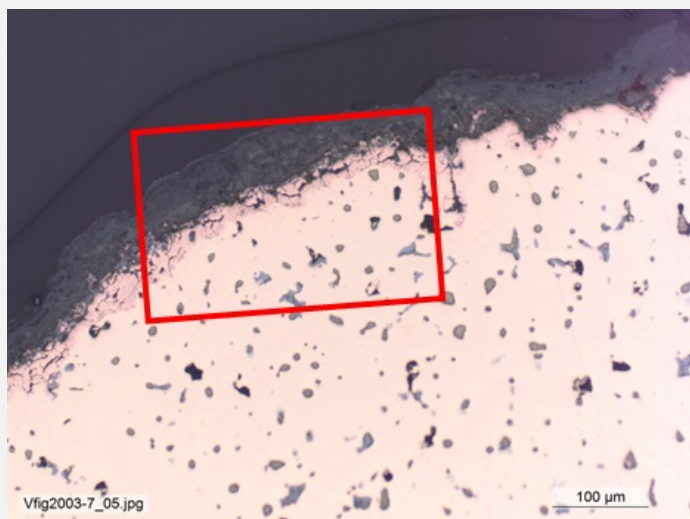
The remaining metal is a leaded bronze (Table 1) containing numerous copper sulphide and lead (Pb) inclusions (Figs. 6 and 7). The porosity is difficult to distinguish since the pores seem to have similar dimensions as the inclusions that could have been removed during the polishing of the sample (Fig. 6). After etching, the structure of the metal appears to be made up mostly of dendrites, but a grain structure seems to have developed on the right side of the sample, with occasional twin lines (Figs. 8 and 9). The twinned grain

Fig. 6: Micrograph of the cross-section of Fig. 4 (detail), unetched, bright field. Light grey copper sulphide and tiny round Pb inclusions as well as "porosities" can be observed. Area of Fig. 10 is marked by a rectangle,

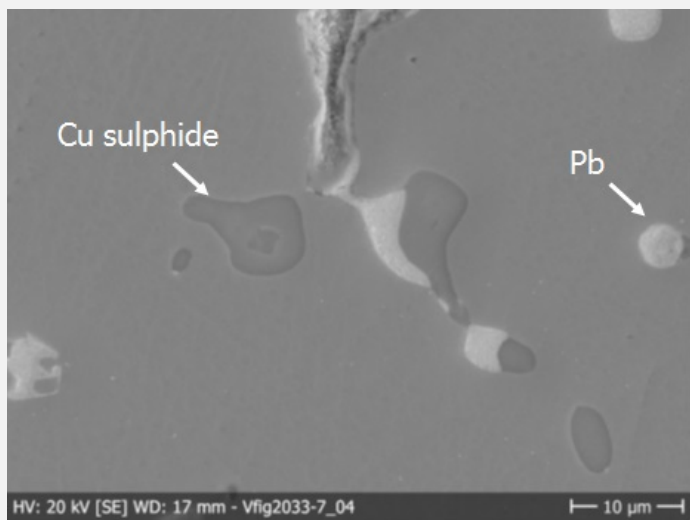
Fig. 7: SEM image, SE-mode, showing copper sulphide and lead inclusions,

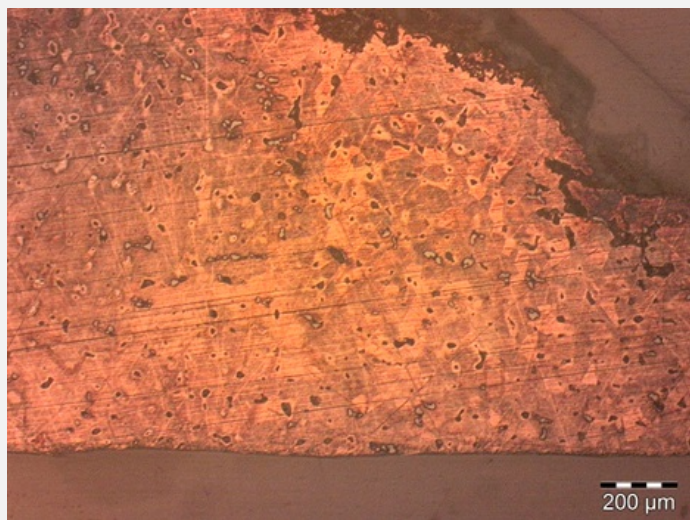
structure could be the result of cold work and annealing after casting, possibly through the application of an artificial patina under heat.

Fig. 8: Micrograph of the metal sample from Fig. 4 showing a dendritic structure and grains,

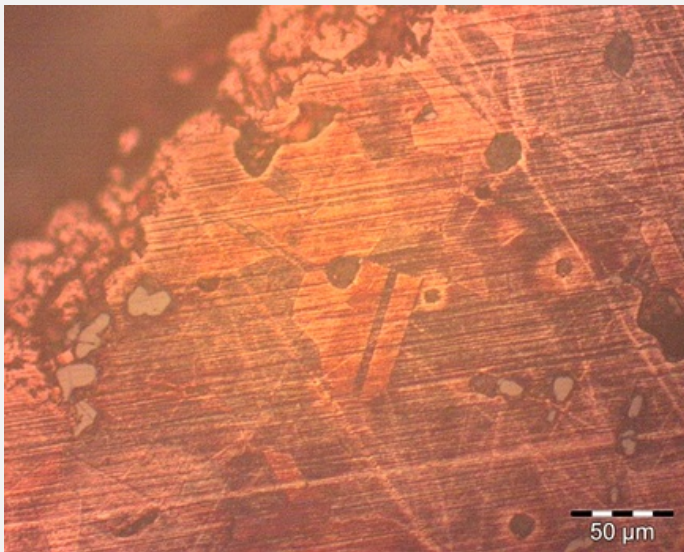
Fig. 9: Micrograph of a selected area showing grains and twin lines,

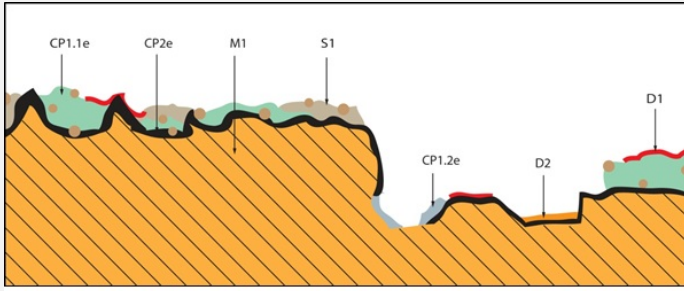
Based on the analyses carried out, the schematic representation of the stratigraphy of corrosion layers has been corrected: a thin, black sulphur-rich layer covers the metal surface. A thick green layer has developed on top and seems to be constituted mainly of atacamite enriched in lead with sediments on top.

Fig. 16: Improved stratigraphic representation of the artefact from visual observations and analyses (additional mention e or i within the coding correspond to strata in contact with the environment (e) and internal strata (i),
