# HEADREST OR HORSE BIT VFIG 2003.7 - LEADED BRONZE - MODERN TIMES

**Artefact name** Headrest or horse bit VFig 2003.7

**Authors** Christian. Degriigny (HE-Arc CR, Neuchâtel, Neuchâtel, Switzerland) & Valentin. Boissonnas (HE-Arc CR, Neuchâtel, Neuchâtel, Switzerland)

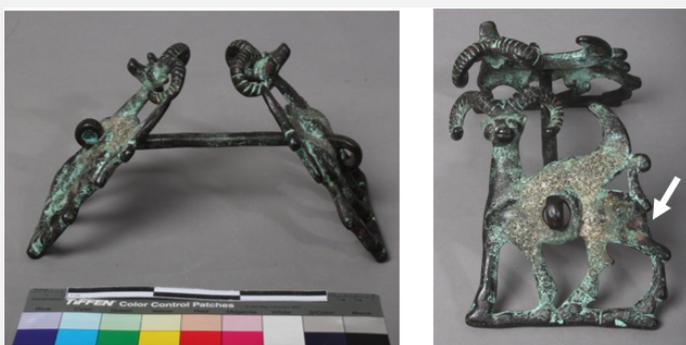
Fig. 1: Headrest or horse bit, side and front view,

<b>Description of the artefact</b>	Artefact made of two figurative (winged wild sheep) plates attached by a central bar (Fig. 1). One of the volutes of the bar is filled with metal suggesting it was cast with its end rolled up already. The surfaces of the plates (both sides) and the central bar are covered with a black adherent layer. A heterogeneous green layer is visible over this black layer. Well adhering hard brown-grey sediment-like deposits are present mostly in the middle of the plates on both sides. Red and orange spots are unevenly distributed on the surface (white arrow). Dimensions: W plates = 13mm; H plates = 105mm, L bar = 185mm, WT = 925g.
<b>Type of artefact</b>	Headrest or horse bit
<b>Origin</b>	Luristan (?)
<b>Recovering date</b>	Date unknown
<b>Chronology category</b>	Modern Times
<b>chronology tpq</b>	<input type="text" value="1000"/> B.C. ▾
<b>chronology taq</b>	<input type="text" value="650"/> B.C. ▾

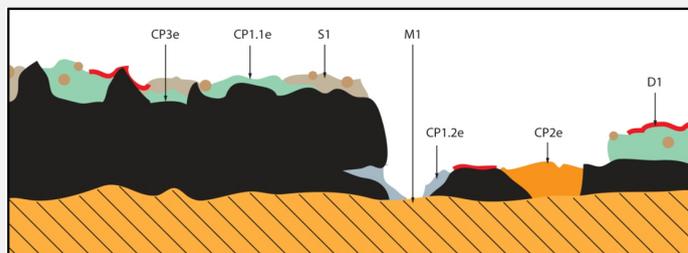
Fig. 3: Stratigraphic representation of the artefact in cross-section by macroscopic observation,

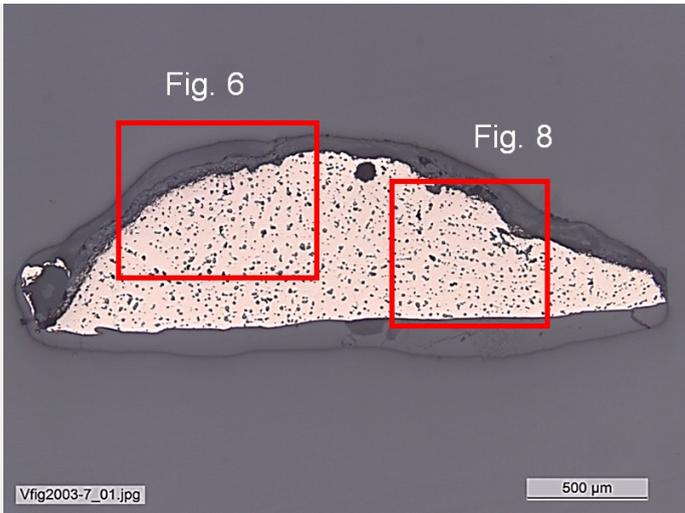
Fig. 4: Micrograph of the cross-section of sample from Fig. 2 showing the location of Figs. 6 and 8,

<b>Description of sample</b>	The sample was cut on the bottom of one of the plates (Fig. 2). On Fig. 4, the top and round shape of the sample is the outer part of the metal. It is covered with corrosion layers. The lower part of the sample corresponds to the cut metal with no corrosion products.
<b>Alloy</b>	Leaded Bronze
<b>Technology</b>	Cast and cold worked (with final annealing?)
<b>Lab number of sample</b>	None
<b>Sample location</b>	HE-Arc CR, Neuchâtel, Neuchâtel
<b>Responsible institution</b>	Bible & Orient Museum, Fribourg, Fribourg
<b>Date and aim of sampling</b>	2014, metallography and chemical analyses

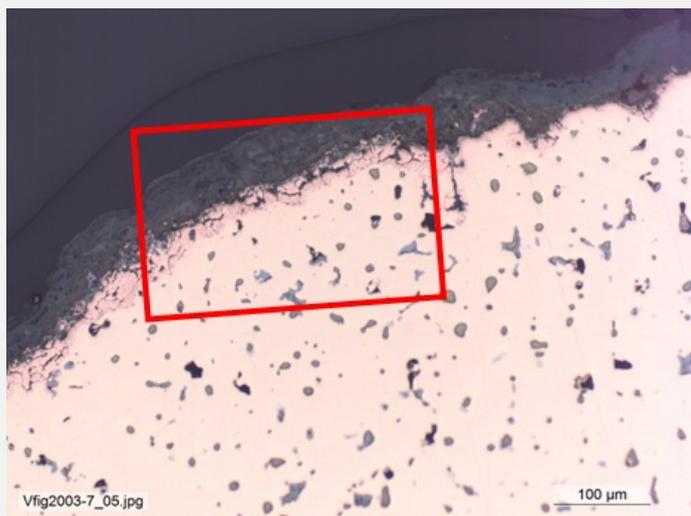
The remaining metal is a leaded bronze (Table 1) containing numerous copper sulphide and lead (Pb) inclusions (Figs. 6 and 7). The porosity is difficult to distinguish since the pores seem to have similar dimensions as the inclusions that could have been removed during the polishing of the sample (Fig. 6). After etching, the structure of the metal appears to be made up mostly of dendrites, but a grain structure seems to have developed on the right side of the sample, with occasional twin lines (Figs. 8 and 9). The twinned grain

Fig. 6: Micrograph of the cross-section of Fig. 4 (detail), unetched, bright field. Light grey copper sulphide and tiny round Pb inclusions as well as "porosities" can be observed. Area of Fig. 10 is marked by a rectangle,

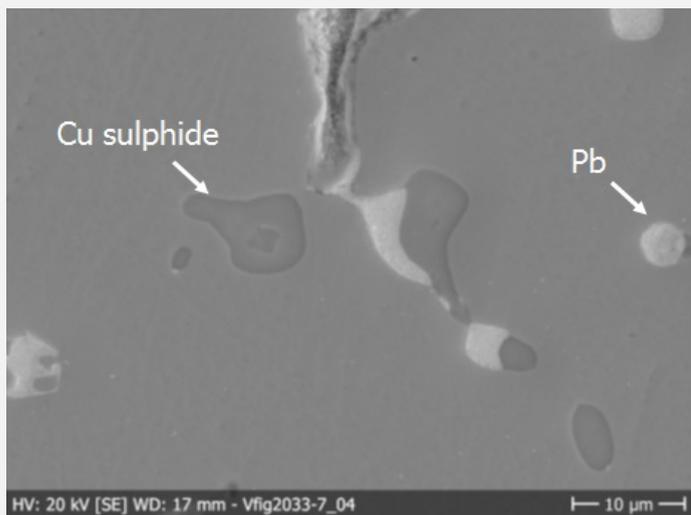
Fig. 7: SEM image, SE-mode, showing copper sulphide and lead inclusions,

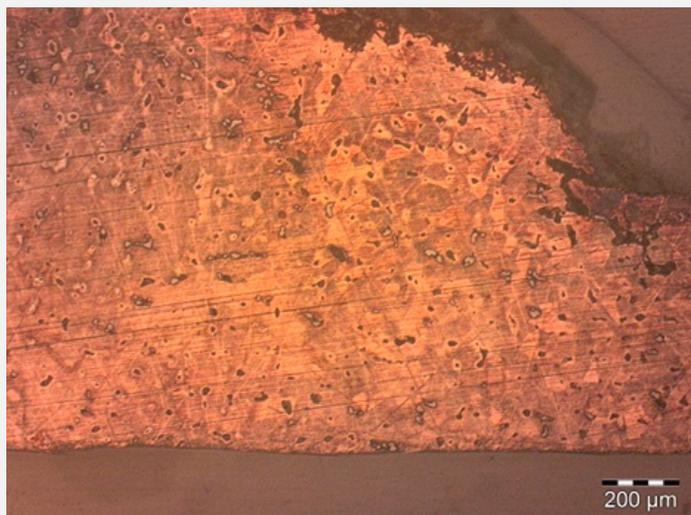
Fig. 8: Micrograph of the metal sample from Fig. 4 showing a dendritic structure and grains,

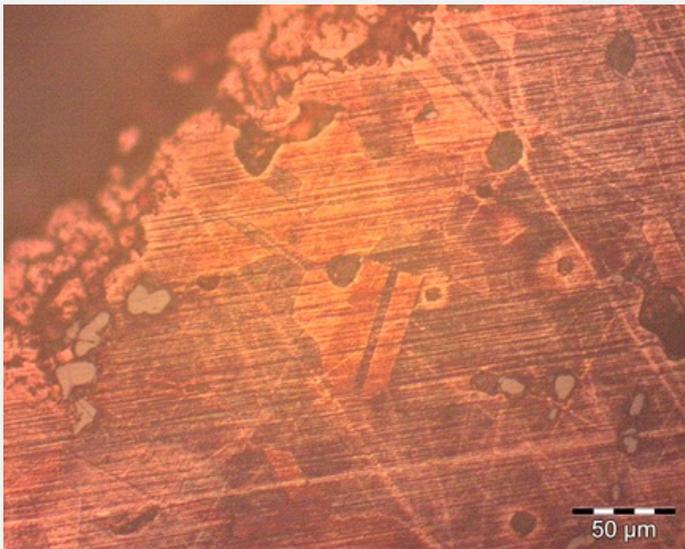
structure could be the result of cold work and annealing after casting, possibly through the application of an artificial patina under heat.

Fig. 9: Micrograph of a selected area showing grains and twin lines,

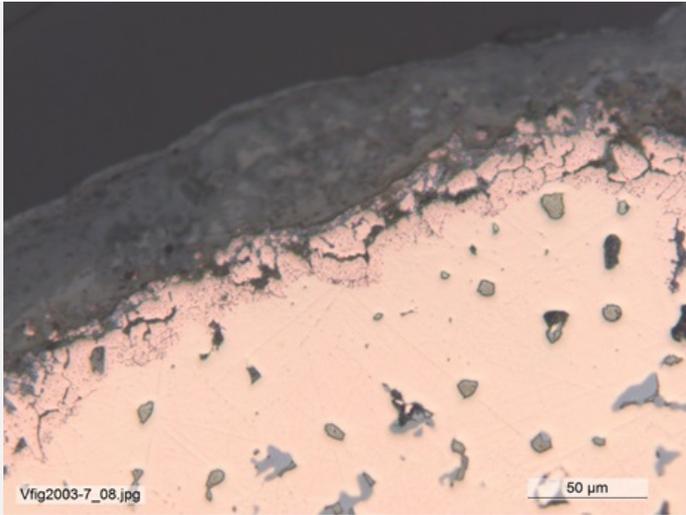
The remaining metal seems to have developed intergranular corrosion at the interface metal / corrosion layer (Fig. 10) slightly enriched in Sn (Fig. 12). The outer green corrosion product (CP2) is matte, powdery and mixed with sediments. It looks regular on Figs. 10 and 11 (around 50μm). This corrosion layer is mainly composed of lead (and/or sulphur), oxygen, silicon, chlorine and is depleted in Cu (Fig. 12 and table 2) except in its top part (CP1) where it is Cl, Cu and O-rich (Fig. 12 and table 2). FTIR seems to indicate that it is constituted of atacamite ( $Cu_2Cl(OH)_3$ , Fig. 13). This is confirmed on the EDS spectra of figure 14 where Pb is clearly detected. The inner black corrosion product (CP3) is a dark brown, matte layer (Figs. 2 and 11). It covers all the surface of the object, and forms a very thin layer. It is sulphur and oxygen-rich (Fig. 15). FTIR analysis could not reveal the presence of a specific corrosion product.

Fig. 10: Micrograph of the metal sample from Fig. 6, unetched, bright field,

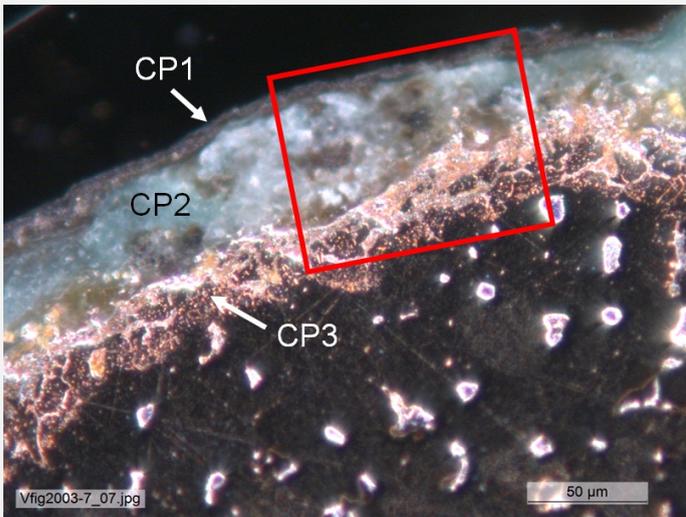
Fig. 11: Micrograph similar to Fig. 10 and corresponding to the stratigraphy of Fig. 5, polarised light. The mapped area (Fig. 12, SEM) is marked by a rectangle,

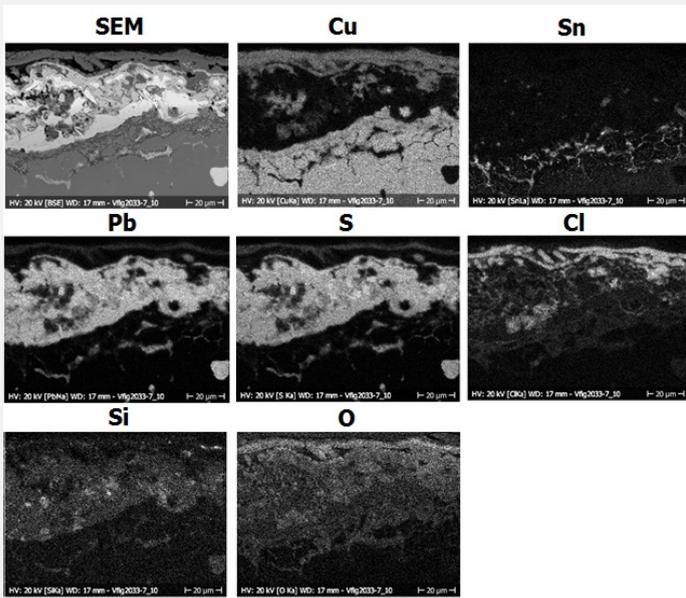
Fig. 12: SEM image, SE-mode, and elemental chemical distribution of the selected area of Fig. 11. Method of examination: SEM-EDS, Lab of Electronic Microscopy and Microanalysis, IMA (Néode), HEI Arc,

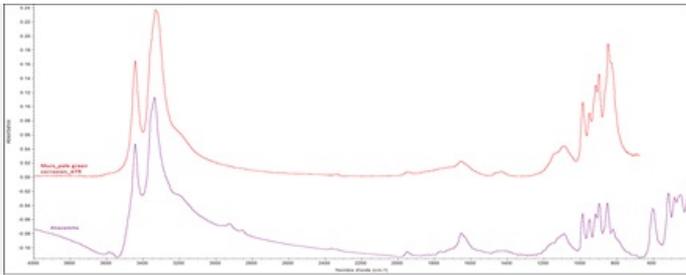
Fig. 13: FTIR spectrum (ATR mode) of the green corrosion powder and comparison to atacamite (purple) spectrum. Method of analysis: FTIR spectroscopy, HE- Arc CR,

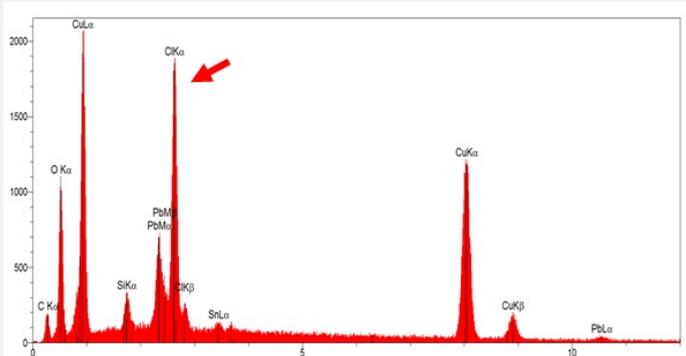
Fig. 14: EDS analysis of the green corrosion powder (Fig. 2). Method of analysis: SEM-EDS, Lab of Electronic Microscopy and Microanalysis, IMA (Néode), HEI Arc,

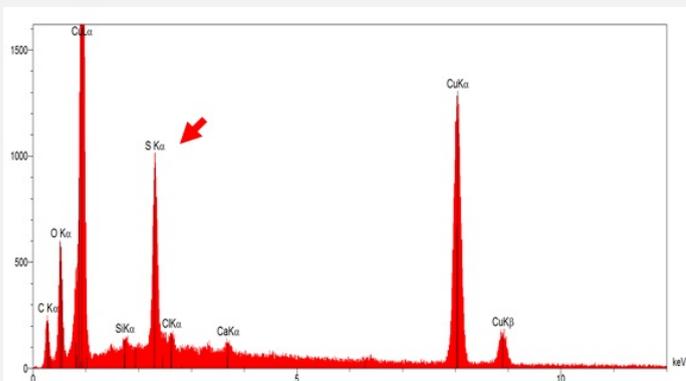
Fig. 15: EDS analysis of the black corrosion powder (Fig. 2). Method of analysis: SEM-EDS, Lab of Electronic Microscopy and Microanalysis, IMA (Néode), HEI Arc,

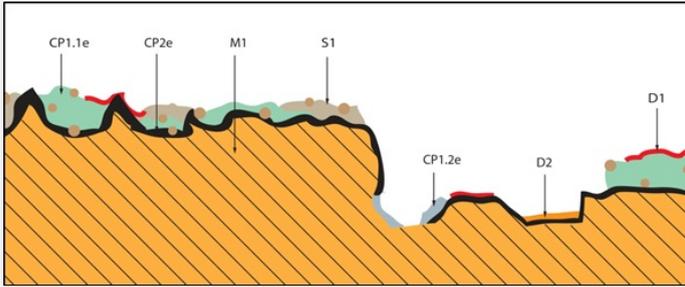
Based on the analyses carried out, the schematic representation of the stratigraphy of corrosion layers has been corrected: a thin, black sulphur-rich layer covers the metal surface. A thick green layer has developed on top and seems to be constituted mainly of atacamite enriched in lead with sediments on top.

Fig. 16: Improved stratigraphic representation of the artefact from visual observations and analyses (additional mention e or i within the coding correspond to strata in contact with the environment (e) and internal strata (i),
