CIRCULAR DOOR KNOCKER STRIKING PLATE – CU ALLOY – MODERN TIMES – SWITZERLAND

Artefact name	Circular door knocker striking plate
Authors	Marianne. Senn (EMPA, Dübendorf, Zurich, Switzerland) & Christian. Degriigny (HE-Arc CR, Neuchâtel, Neuchâtel, Switzerland)
Url	/artefacts/396/

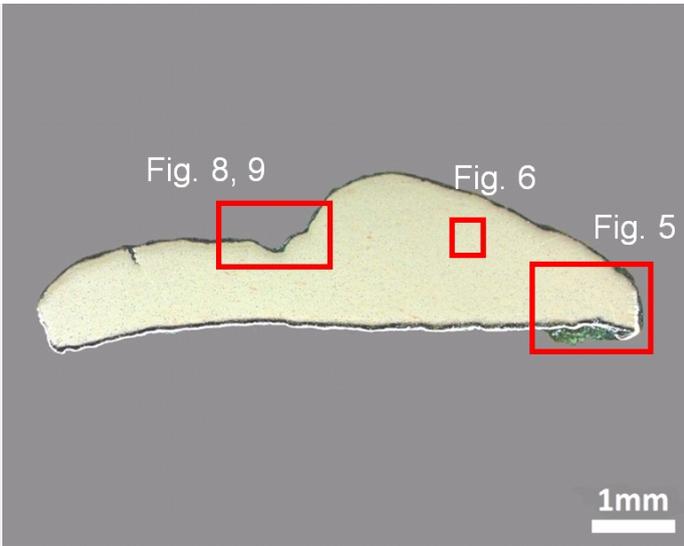
Fig. 3: Micrograph of the cross-section showing the location of Figs. 5 to 6 and 8 to 9,

Description of sample	No information is given on where the sample has been taken. A supposed location is however illustrated in Fig. 2. The polished sample shows a well preserved metal surface with some cracks covered by a thin corrosion crust (Fig. 3).
Alloy	Cu Alloy
Technology	Rolled, annealed after cold working
Lab number of sample	MAH 94-156-001
Sample location	Musées d'art et d'histoire, Genève, Geneva
Responsible institution	Musées d'art et d'histoire, Genève, Geneva
Date and aim of sampling	1994, metallography and presence or not of a gilding treatment

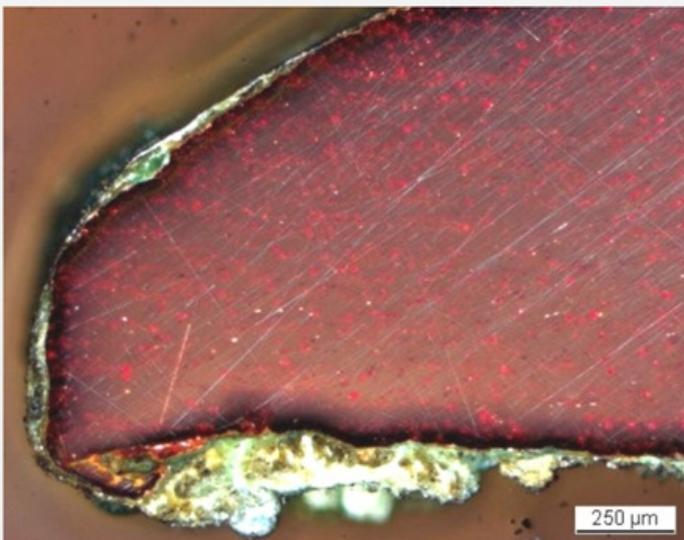
red (Figs. 5 and 8) while with SEM in BSE-mode they look light-grey (Fig. 9). Heavy metals inclusions appear white with SEM (BSE-mode, Fig. 9). Due to the rolling process the copper oxide inclusions are parallel to the longitudinal orientation of the sample (Figs. 5 and 6). They were identified as cuprite by Raman spectroscopy (Fig. 7). The etched alloy shows a structure of polygonal grains with annealing twins (Fig. 6). The grain size is variable. The average hardness of the alloy is HV1 80, which is quite high compared to the average hardness of a pure annealed copper of around HV1 40-50 (Schumann 1991, 627).

Fig. 5: Micrograph of the metal sample from Fig. 3 (reversed picture), unetched, polarised light. The red copper oxide inclusions form rows in the copper alloy matrix.,

The average thickness of the corrosion crust is about 90µm, but may be thinner or thicker depending on the area of origin (Fig. 5). Under polarized light, we observe a multilayer system with a dense and thin inner red corrosion layer (CP2, probably cuprite/Cu₂O) on the metal (Fig. 8) containing chlorides (Fig. 9 and Table 3). This is followed by bands of heterogeneous green corrosion products (CP1, possibly copper chloride / sulphate / carbonate). This outer corrosion layer is contaminated with atmospheric components (Si, Al, Cl, C and O and perhaps gypsum particles (CaSO₄)) (Fig. 9).

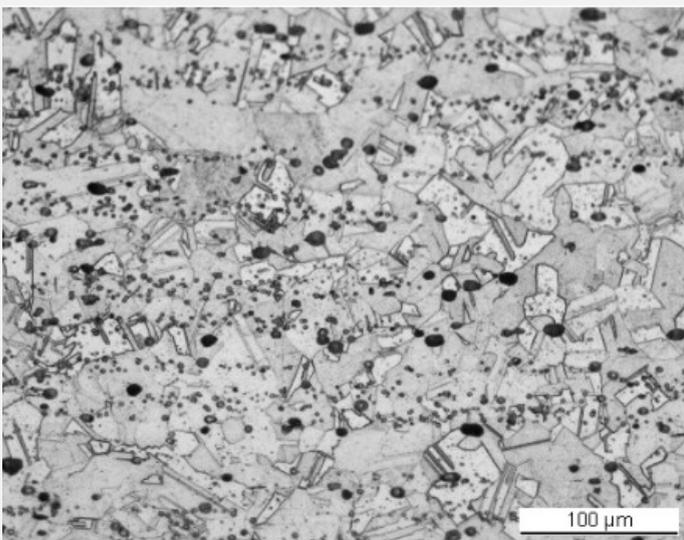
Fig. 6: Micrograph of the metal sample from Fig. 3 (detail), etched, bright field. The metal shows a structure of polygonal and twinned grains. Copper oxide inclusions are visible as dark spots,

Microstructure Polygonal and twinned grains, elongated inclusions

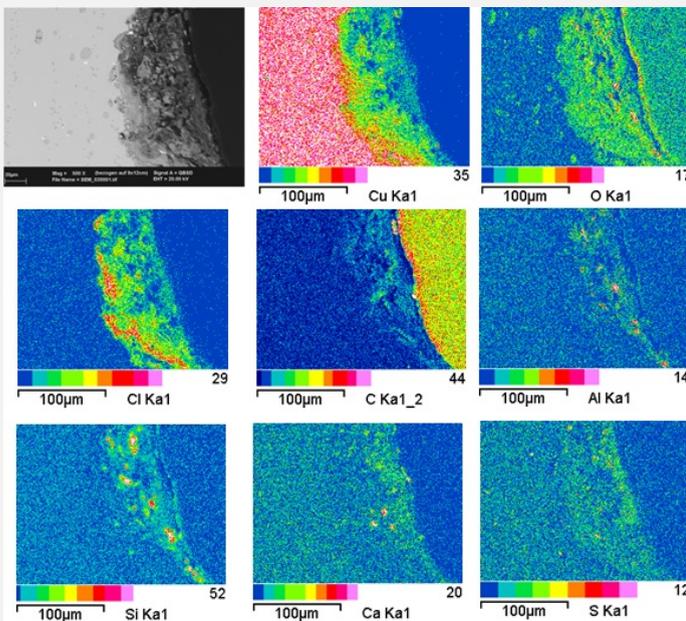
Table 2: Chemical composition (mass %) of the inclusions (light-grey and white in Fig. 9) in the metal. Method of analysis: SEM/EDS, Laboratory of Analytical Chemistry, Empa.

Table 3: Chemical composition (mass %) of the inner corrosion layer (CP2). Method of analysis: SEM/EDS, Laboratory of Analytical Chemistry, Empa.

Fig. 9: SEM image, BSE-mode, and elemental chemical distribution of the selected area of Fig. 8. Method of examination: SEM/EDS, Laboratory of Analytical Chemistry, Empa,

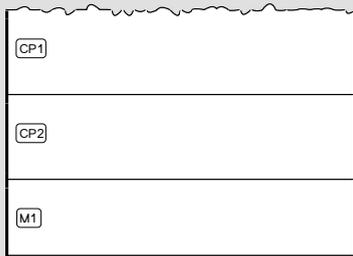
Fig. 4: Stratigraphic representation of the object in cross-section using the MiCorr application. This representation can be compared to Fig. 8, Credit HE-Arc CR.
