CIRCULAR DOOR KNOCKER STRIKING PLATE - CU ALLOY - MODERN TIMES - SWITZERLAND

Artefact name Circular door knocker striking plate

Authors Marianne. Senn (EMPA, Dübendorf, Zurich, Switzerland) & Christian. Degrigny (HE-Arc CR, Neuchâtel, Neuchâtel, Switzerland)

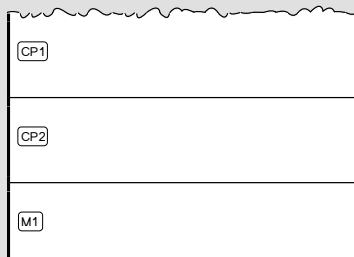
Fig. 4: Stratigraphic representation of the object in cross-section using the MiCorr application. This representation can be compared to Fig. 8, Credit HE-Arc CR.
