# CIRCULAR DOOR KNOCKER STRIKING PLATE – CU ALLOY – MODERN TIMES – SWITZERLAND

<b>Artefact name</b>	Circular door knocker striking plate
<b>Authors</b>	Marianne. Senn (EMPA, Dübendorf, Zurich, Switzerland) & Christian. Degriigny (HE-Arc CR, Neuchâtel, Neuchâtel, Switzerland)
<b>Url</b>	/artefacts/396/

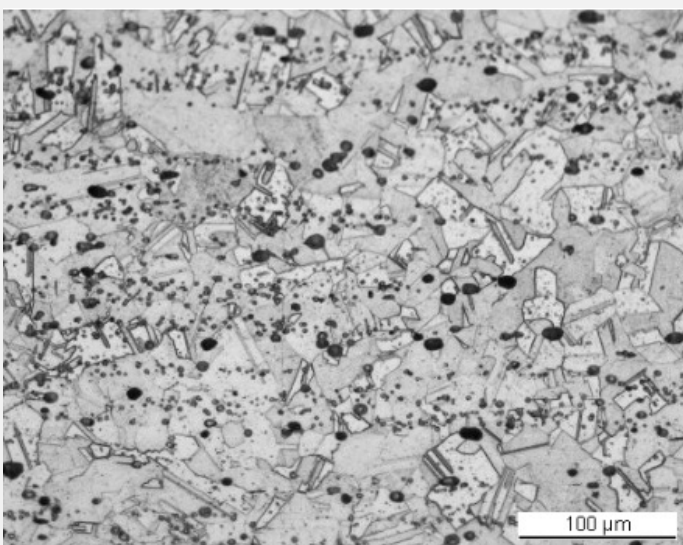
Fig. 6: Micrograph of the metal sample from Fig. 3 (detail), etched, bright field. The metal shows a structure of polygonal and twinned grains. Copper oxide inclusions are visible as dark spots,

**Microstructure** Polygonal and twinned grains, elongated inclusions

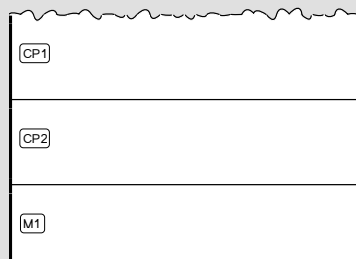
Fig. 4: Stratigraphic representation of the object in cross-section using the MiCorr application. This representation can be compared to Fig. 8, Credit HE-Arc CR.
