CIRCULAR DOOR KNOCKER STRIKING PLATE - CU ALLOY - MODERN TIMES - SWITZERLAND

Artefact name	Circular door knocker striking plate
Authors	Marianne. Senn (EMPA, Dübendorf, Zurich, Switzerland) & Christian. Degriigny (HE-Arc CR, Neuchâtel, Neuchâtel, Switzerland)
Url	/artefacts/396/

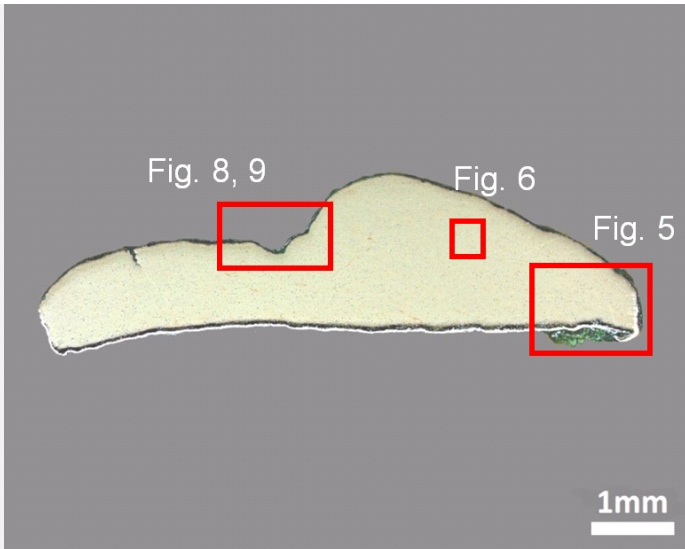
Fig. 3: Micrograph of the cross-section showing the location of Figs. 5 to 6 and 8 to 9,

Description of sample	No information is given on where the sample has been taken. A supposed location is however illustrated in Fig. 2. The polished sample shows a well preserved metal surface with some cracks covered by a thin corrosion crust (Fig. 3).
Alloy	Cu Alloy
Technology	Rolled, annealed after cold working
Lab number of sample	MAH 94-156-001
Sample location	Musées d'art et d'histoire, Genève, Geneva
Responsible institution	Musées d'art et d'histoire, Genève, Geneva
Date and aim of sampling	1994, metallography and presence or not of a gilding treatment

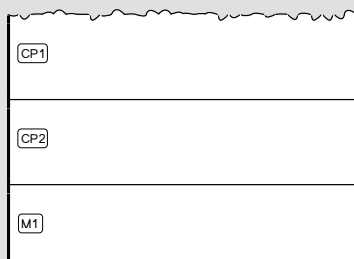
Fig. 4: Stratigraphic representation of the object in cross-section using the MiCorr application. This representation can be compared to Fig. 8, Credit HE-Arc CR.
