# CIRCULAR DOOR KNOCKER STRIKING PLATE – CU ALLOY – MODERN TIMES – SWITZERLAND

Artefact name	Circular door knocker striking plate
Authors	Marianne. Senn (EMPA, Dübendorf, Zurich, Switzerland) & Christian. Degrigny (HE-Arc CR, Neuchâtel, Neuchâtel, Switzerland)
Url	/artefacts/396/

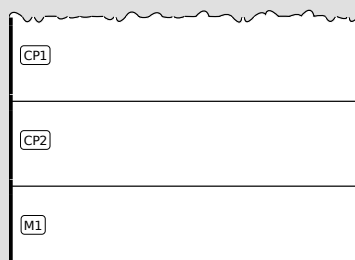
Fig. 4: Stratigraphic representation of the object in cross-section using the MiCorr application. This representation can be compared to Fig. 8, Credit HE-Arc CR.
