CIRCULAR DOOR KNOCKER STRIKING PLATE – CU ALLOY – MODERN TIMES – SWITZERLAND

Artefact name	Circular door knocker striking plate
Authors	Marianne. Senn (EMPA, Dübendorf, Zurich, Switzerland) & Christian. Degriigny (HE-Arc CR, Neuchâtel, Neuchâtel, Switzerland)
Url	/artefacts/396/

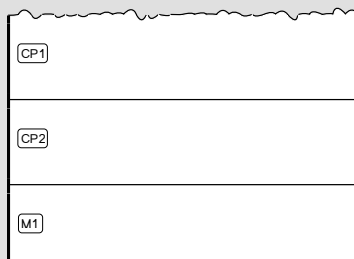
Fig. 4: Stratigraphic representation of the object in cross-section using the MiCorr application. This representation can be compared to Fig. 8, Credit HE-Arc CR.
